## Technical Service Bulletin (TSB)

### Liftgate Will Not Properly Open Or Close

| REFERENCE: | TSB: 23-021-25<br>GROUP: 23 - Body | Date: | April 23, 2025 | REVISION: | – |
| VEHICLES AFFECTED: | 2024 - 2025 (WS) Jeep Wagoneer /Grand Wagoneer<br>This bulletin applies to vehicles built on or before December 02, 2024 (MDH 1202XX). | | | MARKET APPLICABILITY:<br><div><input checked="" type="checkbox"/> NA<input type="checkbox"/> MEA<br/><input type="checkbox"/> SA<input type="checkbox"/> IAP<br/><input type="checkbox"/> EE<input type="checkbox"/> CH</div> | |

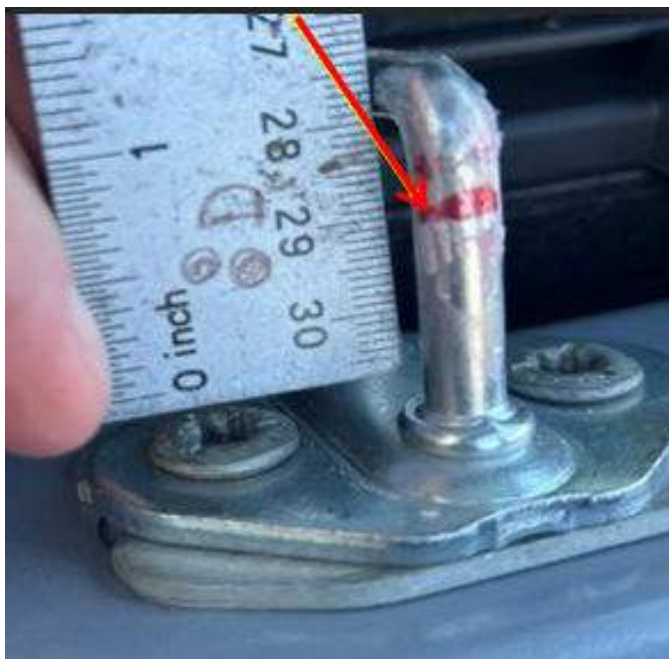
**Fig. 2**

Striker Spacer Installed

2. Mark the mounting location of the striker, then remove striker. Refer to the detailed procedures available in DealerCONNECT > Service Library> under: 23 - Body / Decklid/Hatch/Liftgate/Tailgate/Swing Gate / Striker, Liftgate Latch / Removal.
3. Insert the door latch striker spacer underneath the liftgate striker.

4. Install striker using marked reference. Refer to the detailed procedures available in DealerCONNECT > Service Library> under: 23 - Body / Decklid/Hatch/Liftgate/Tailgate/Swing Gate / Striker, Liftgate Latch / Installation. Tighten fasteners to 28 N·m (21 Ft. Lbs) [Fig. 2](#).
