## Technical Service Bulletin

| <b>Topic</b> | 57 Various complaints regarding the front or rear door lock, DTC(s) B122D29, B14FF29 or B122B13 |
| <b>Brand</b> | Audi |
| <b>Transaction No.</b> | 2063236/8 |

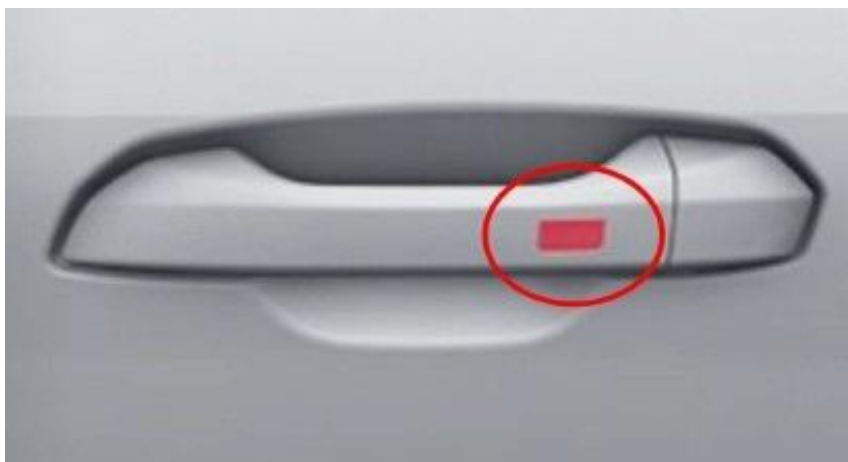
**Figure 1.** Convenience key sensor on door handle.

For vehicles with a mechanical exterior door handle and convenience key (Figure 1; sensor on the door handle), be aware of the possibility of incorrect operation by the customer:

To lock the vehicle, close the door and touch the sensor on the door handle once. Do not take hold of the door handle when doing so, otherwise the vehicle will not be locked. Once the doors have been locked, they cannot be opened again immediately. This will enable you to check that the doors are properly closed.

When opening the doors, care must be taken not to touch the sensor on the exterior door handle at the same time (e.g. with the thumb), as otherwise the vehicle will be locked again → incorrect operation by the user.
