## Technical Service Bulletin (TSB)

### Service Hybrid Electric Vehicle System Warning Message

| REFERENCE: | TSB: 08-116-25 REV. C<br>GROUP: 08 - Electrical | Date: | September 27, 2025 | REVISION: | 08-116-25 REV. B |
| VEHICLES AFFECTED: | 2023 - 2025 (JL) Jeep Wrangler<br>This bulletin applies to vehicles built on and before October 14, 2024 (MDH 1014XX) equipped with **2.0L I4 DOHC DI Turbo PHEV Engine** (Sales Code ECX). | | | MARKET APPLICABILITY:<br><div><div><input checked="" type="checkbox"/> NA</div><div><input type="checkbox"/> SA</div><div><input checked="" type="checkbox"/> EE</div></div> <div><div><input checked="" type="checkbox"/> MEA</div><div><input checked="" type="checkbox"/> IAP</div><div><input checked="" type="checkbox"/> CH</div></div><br>NOTE: This bulletin applies to North America, Enlarged Europe, India & Asia Pacific, Middle East & Africa and China markets. | |

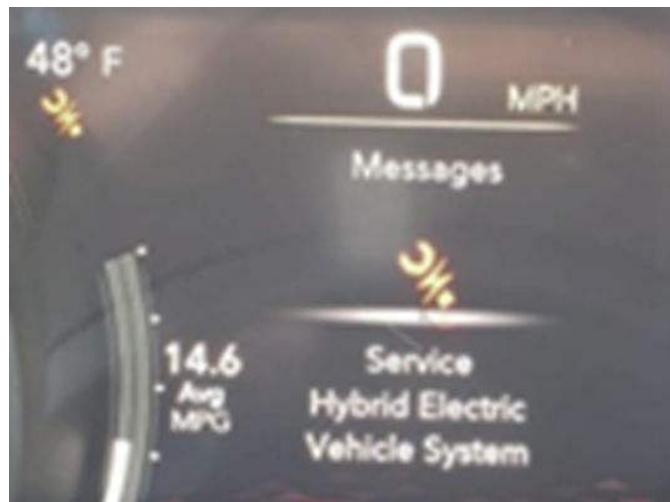
**Fig. 1**

| CUSTOMER SYMPTOM: | Customers must experience a Malfunction Indicator Lamp (MIL) illumination and the vehicle must exhibit/set the following Diagnostic Trouble Code (DTC): <ul style="list-style-type: none"><li>B273C-00 - Digital Crash Input.</li></ul> NOTE: Technicians may find the DTC is stored or pending in the Hybrid Control Processor (HCP).<br>Customers may experience one or more of the following: <ul style="list-style-type: none"><li>The "Service Hybrid Electric Vehicle System Warning" message and Light are displayed in the Instrument Panel Cluster (IPC) <a href="#">Fig. 1</a>.<br/>NOTE: This message may be displayed for a few seconds and then disappear.</li><li>The vehicle may no longer enter Electric or Hybrid drive modes.</li></ul> | | | | |

Service Hybrid Electric Vehicle System Warning IPC Message

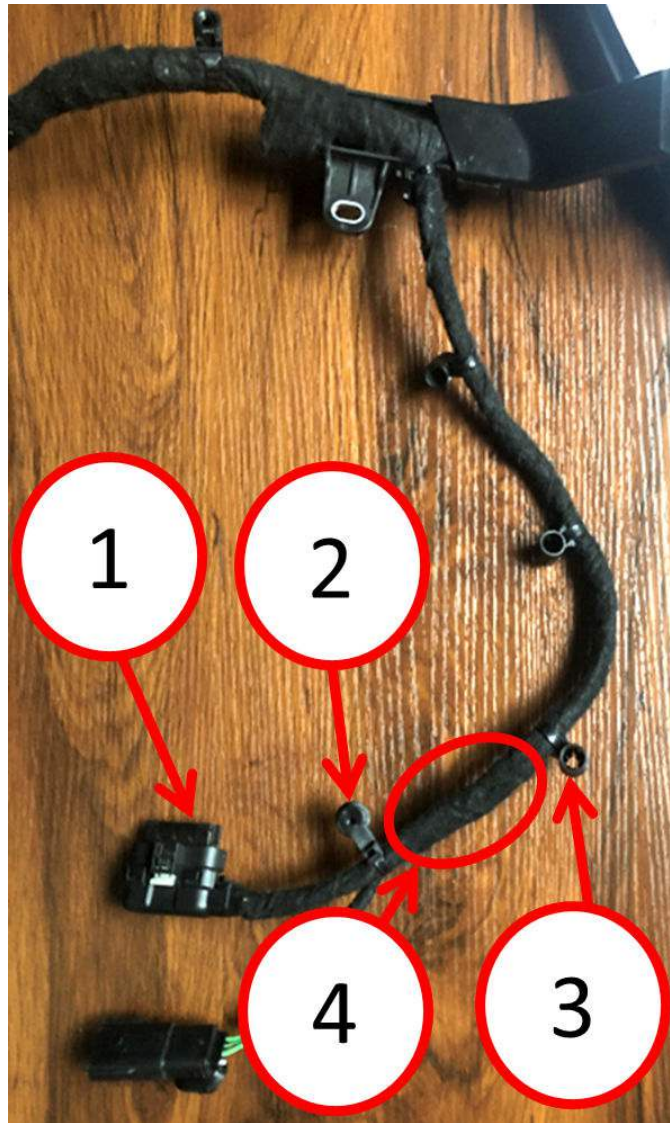
**Fig. 2**

| CAUSE: | Electromagnetic noise on R414 circuit | | | | |

High Voltage Battery Connectors Body Harness And Ferrite Bead Placement

- 1 - Connector D8119E
- 2 - Offset Clip 1108
- 3 - Stud Clip 1107
- 4 - Area To Install Ferrite Bead

5. Locate on the body harness high voltage battery connector D8119E [Fig. 2](#).

- 
6. Remove the cover on D8199E connector [Fig. 2](#).
7. Remove offset clip 1108 [Fig. 2](#) from wire harness. **If necessary to gain better accessibility to the harness, remove stud clip 1107 from the stud.**
8. **Carefully remove** the harness protective tape from D8119E to the remaining stud clip 1107 [Fig. 2](#) from the wire harness.

9. Locate R414A in cavity 16, located in connector D8119E [Fig. 2](#) and remove the dark green/beige circuit wire [Fig. 3](#).

14. Install wire circuit R414A back into connector D8119E [Fig. 2](#) cavity 16.
15. Install conduit from kit over ferrite bead assembly.
16. Install protective tape from D8119E over ferrite bead conduit and to clip 1107. **If removed to gain better accessibility to the harness, install clip 1107 on the stud.**

17. Install the D8119E connector cover [Fig. 2](#).
18. Install the high battery voltage closeout panel. Refer to the detailed procedures available in DealerCONNECT > Service Library> under: 23 - Body / Interior / Panel, High Voltage Battery Closeout / Installation.

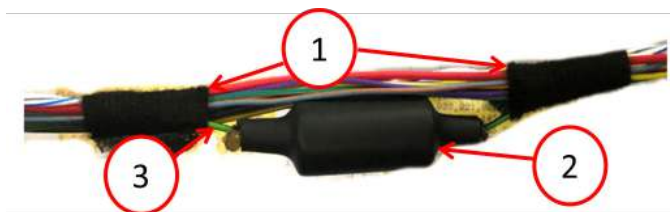
**Fig. 3**  
Ferrite Bead Assembly

- 1 - Butyl Patches  
2 - Ferrite Bead With Heat Shrink  
3 - Dark Green/Beige Wire

10. Place circuit R414A through the ferrite bead and install the ferrite bead **between clips 1107 and 1108**, [Fig. 2](#) and [Fig. 3](#).
11. Install two butyl patches around wire circuit R414A at both openings of the ferrite bead [Fig. 3](#).

12. Place heat shrink tube over circuit R414A and ferrite bead [Fig. 3](#).
13. Using a heat gun, heat the heat shrink tubing around ferrite bead, ensuring sealant flows out of each end tubing [Fig. 3](#).
