## Check engine light with fault code P3005CA in MRD1 (CDI)

| Topic number | LI49.20-N-078466 |
| Function group | 49.20 - Exhaust gas aftertreatment |
| Validity | Sprinter 907 OM654 |

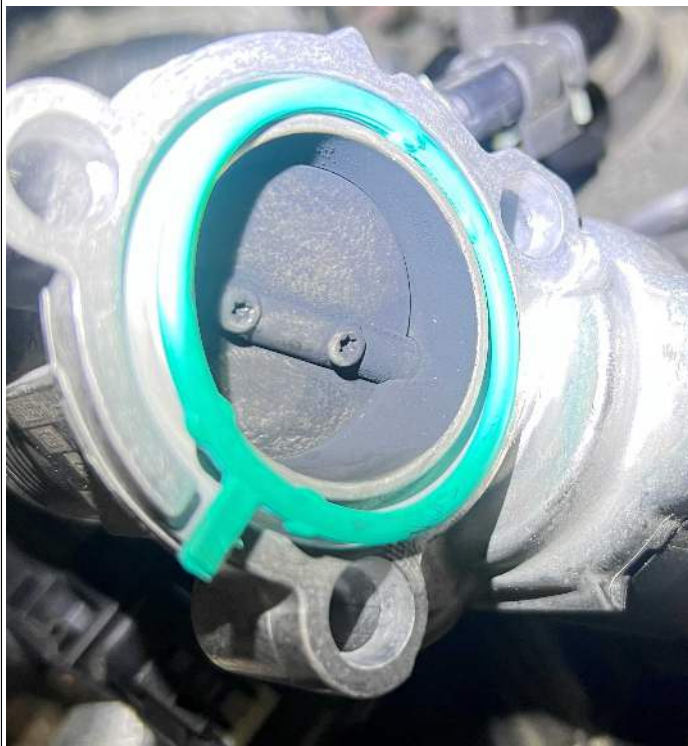
LP EGR.jpg

Low-Pressure EGR Valve

- If soot IS found during the Tailpipe inspection:
- Check the 'Filter screen of Exhaust Gas Recirculation (low pressure)' for carbon fouling:
- If soot IS found in the 'Filter screen of Exhaust Gas Recirculation (low pressure)' replace the component Diesel Particulate Filter (DPF), check components Y87/5 (Exhaust Gas Recirculation Actuator, low pressure) and the Cooler for soot deposits. If soot is found, replace as needed.
- If soot IS NOT found in the 'Filter screen of Exhaust Gas Recirculation (low pressure)', replace only the Diesel Particulate Filter (DPF) component.

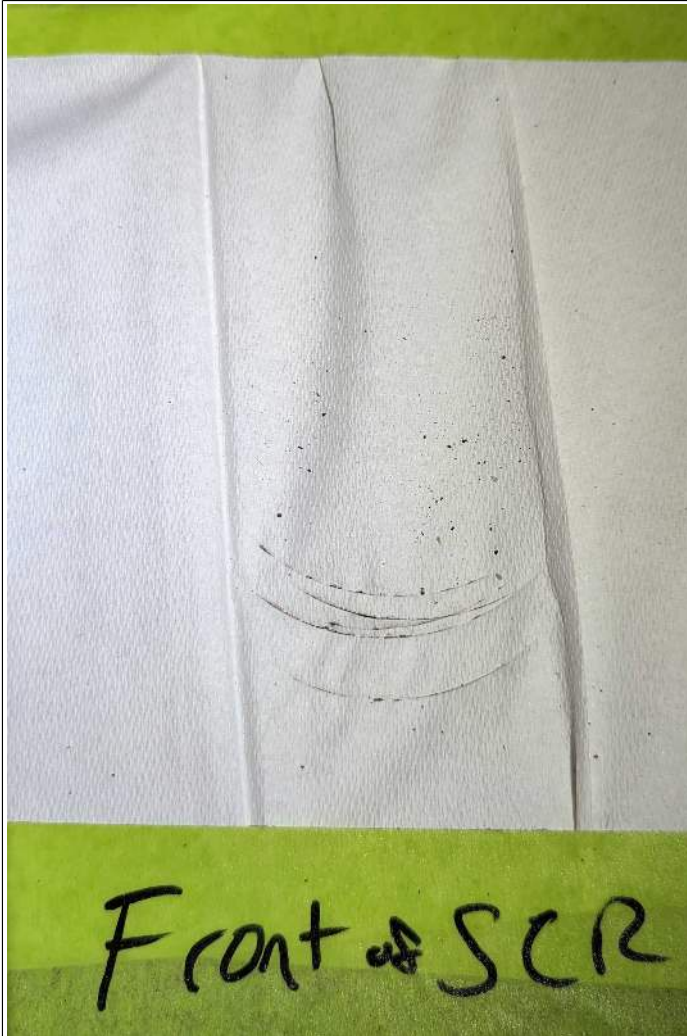
SCR Front.jpg

White Cloth SCR Front Side

Front of SCR

- If soot was found during step 1 or if this vehicle had the Diesel Particulate Filter (DPF) replaced prior due to failure and the fault returned, please complete the below steps:
- Remove the 'SCR Catalytic Converter, underbody', place a white cloth/rag on the floor, and lightly tap the 'SCR Catalytic Converter, underbody' onto the floor to see if any soot comes out. Repeat this inspection on both ends of the SCR catalytic converter. If soot is found on the rag, please replace the 'N74 (Soot Particulate Sensor Control Unit)' and 'SCR Catalytic Converter, underbody' with the needed components.

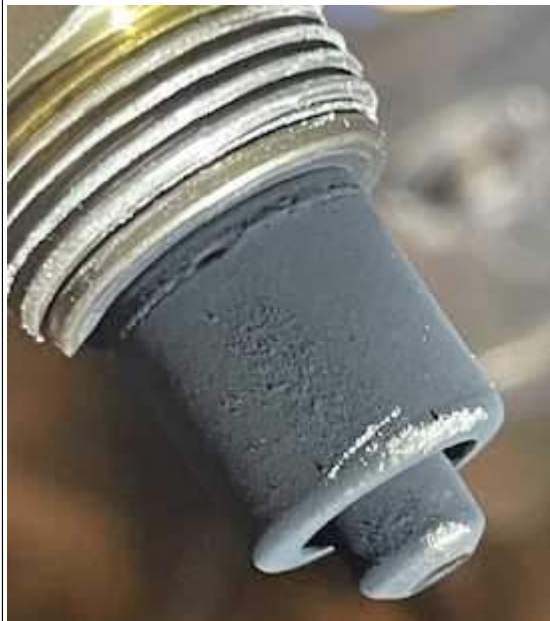
[Soot Sensor.jpg](#)

Soot Sensor Covered in Soot
