# Technical Service Bulletin

| Topic | Rotating display/screen - Fault diagnosis - Mechanical malfunction DTC B140107 is evident within 005F |

Rotating display/screen - Fault diagnosis - Mechanical malfunction DTC B140107 is evident within 005F

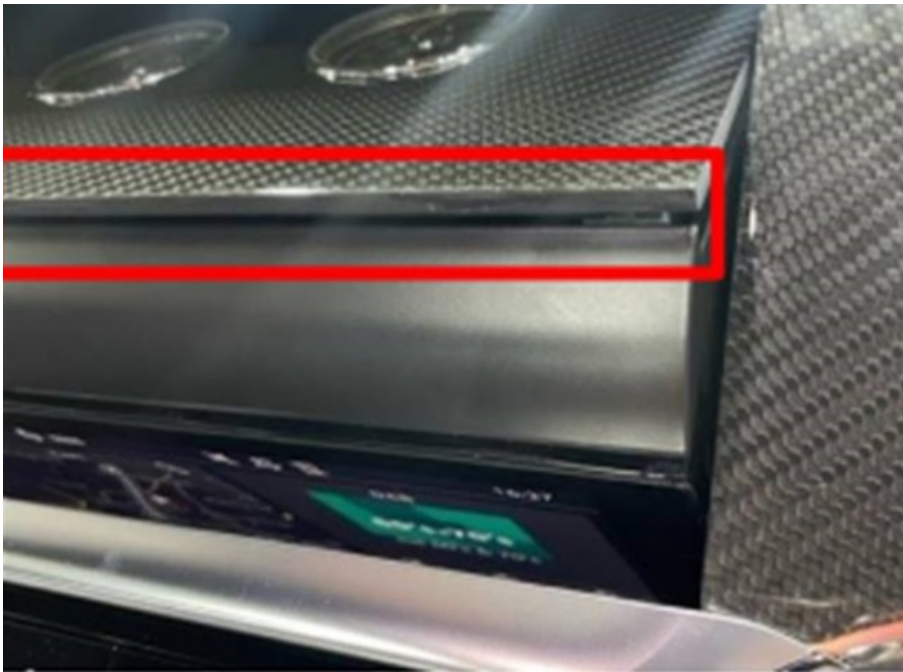
Figure 1

4) Figures 1 and 2 show an example of the display clocks and/or dials fascia unclipped)

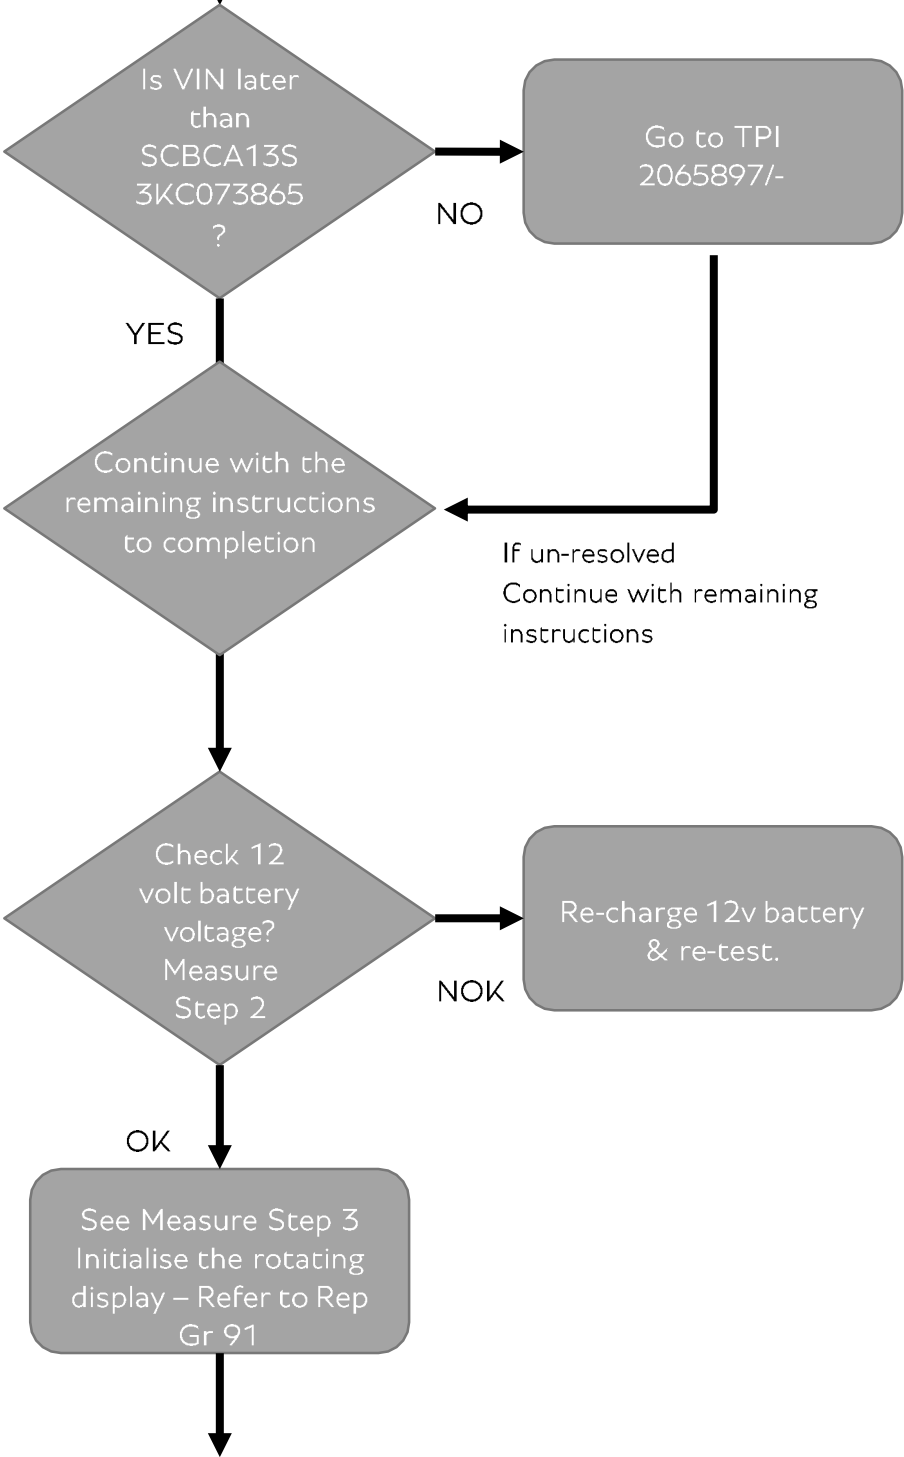
Confirm symptom is relevant for TPI.

DTC B140107 Mechanics of display unit 1 for multimedia system  
mechanical malfunction is evident within 005F.

Bentley Rotational Display (BRD) operational issues.

See Measure Step 1
