## STAR ONLINE PUBLICATION

**Case Number:** S2208000064

**Symptom/Vehicle Issue:** Check Engine Light Is On. P0480 Cooling Fan 1 Control Circuit/Open

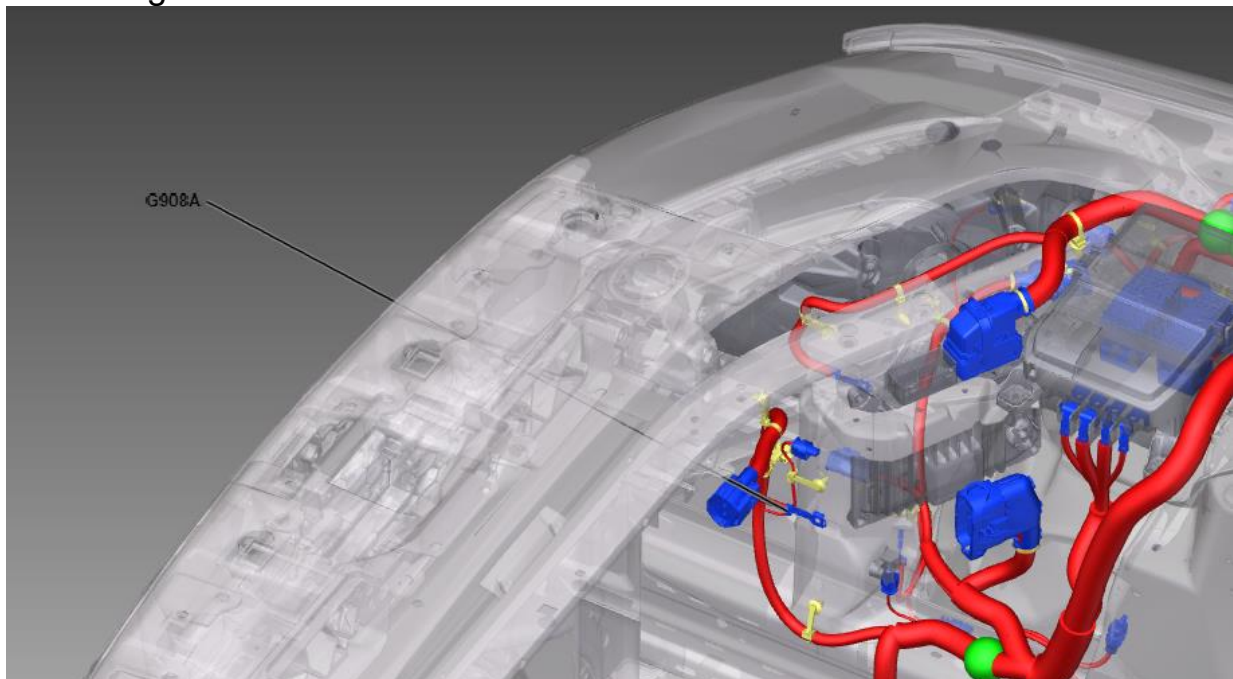
**Discussion:** The customer may bring in their vehicle because the check engine light (MIL) is on. Upon scanning the vehicle for DTC's you may find P0480 Cooling Fan 1 Control Circuit/Open. This may be caused by the ground wire not being fully welded/secured to the ground eyelet.

**Diagnosis:** Inspect the G908A ground located in the engine bay, below the PCM behind the passenger side headlight. Determine if the ground eyelet is properly secured to the ground wire.

**Repair Procedure:** It is recommended to spot solder the ground wire onto the eyelet terminal.
