## SERVICE BULLETIN

**APPLICABILITY:** 2011-2012MY Legacy/Outback, H-6  
 2011-2012MY Tribeca, H-6

**SUBJECT:** P0128 Coolant Thermostat (Engine  
 Coolant Temperature below Thermostat  
 Regulating Temperature)

**NUMBER:** 11-111-12R

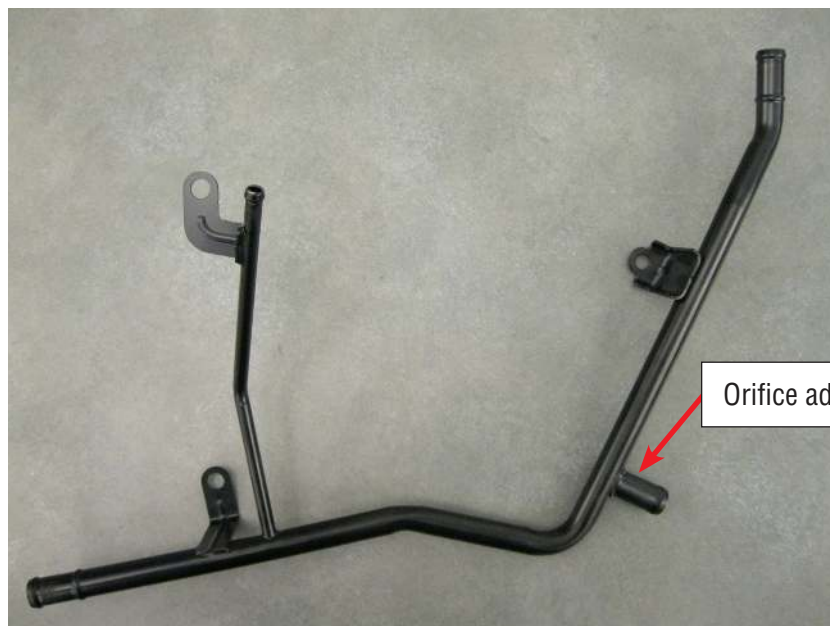
The slight variations can be contributed to owner driving patterns. As an example, how long a vehicle is permitted to warm up, heater use during cold or hot engine temperatures, etc. An air pocket within the coolant system can also cause the code to set. A countermeasure heater hose pipe is now available which contains an orifice, designed to regulate coolant flow past the coolant temperature sensor.

| PART NAME | NEW PART # | OLD PART # |
|---|---|---|
| Pipe, Heater Hose | 14070AA361 | 14070AA360 |

The heater hose pipe is located under the intake manifold attached by 3 bolts. Refer to the applicable service manual for replacement.

**Note:** When refilling the coolant system make sure to follow the steps listed in the service manual to insure all air is purged from the coolant system, if not P0128 can be set again in memory.
