## Technical product information

| <b>Topic</b> | Rotating display/screen - Fault diagnosis - Mechanical malfunction DTC B140107 is evident within 005F |
| <b>Brand</b> | Bentley |
| <b>Transaction No.</b> | 2067955/3 |

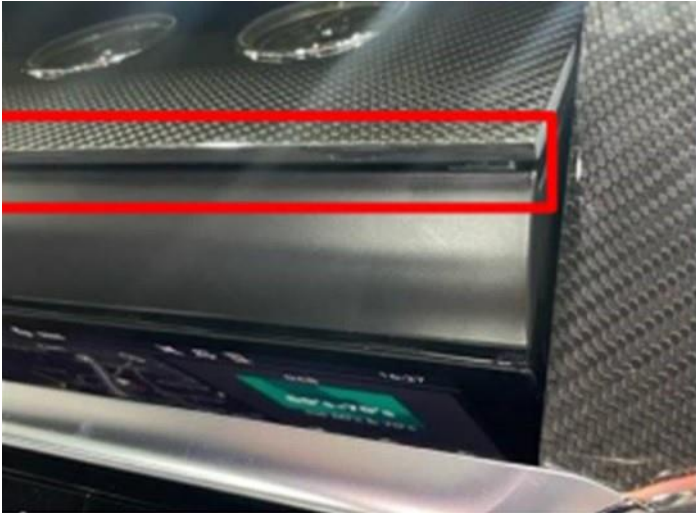
Figure 1

4) Figures 1 and 2 show an example of the display clocks and/or dials fascia unclipped)

**Please note: The BRD must be removed (Rep.Gr 91) to allow visual inspection of the panel at the back of the BRD for signs of unclipping (Figure 1)**

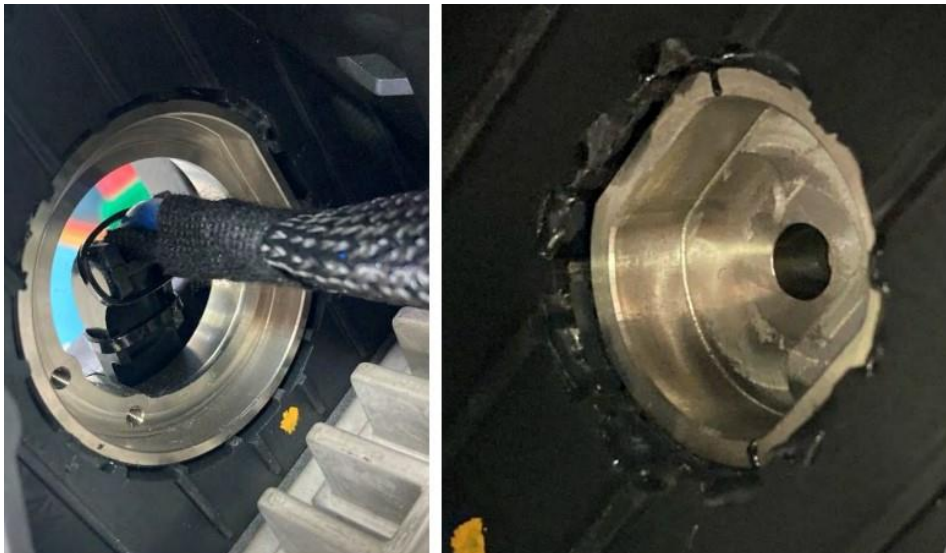
Figure 6

7) Bearing displacement check

- **HINT: Referring to Figures 4 and 5, if there is a large gap on one side of the fascia panel and a small gap on the opposing side or a report of clashing with driver fascia or clunking the operative should check to confirm the bearings of the unit have not displaced as shown in Figure 6**
