# Service Bulletin

Bulletin No.: PIT5278A

**Subject:** Power Liftgate Erratic Operation Will Not Power Close DTC B153A And/Or Motor Running But Does Not Move

**Models:** 2015 Cadillac Escalade Models  
2015 Chevrolet Tahoe, Suburban  
2015 GMC Yukon Models

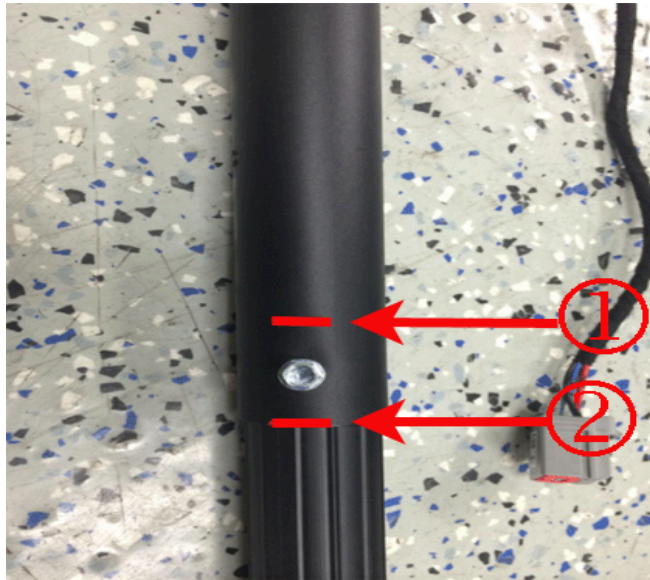
3825803

1. Obtain one #8 self-tapping screw 1 1/2 inches long.
2. Fully open the liftgate.
3. Install the self-tapping screw any place in the 30 mm space (from the bottom of the smooth tube) between location 1 and 2. As reflected below, a location of 20 mm (approximately 3/4") is ideal to secure the tubes.

**Note:** The screw will hold the strut together for removal.
