**Technical Service Bulletin (TSB)**  
**Service Hybrid Electric Vehicle System Warning Message**

| REFERENCE: | TSB: 08-116-25 REV. B<br>GROUP: 08 - Electrical | Date: | September 3, 2025 | REVISION: | 08-116-25 REV. A |
| VEHICLES AFFECTED: | 2023 - 2025 (JL) Jeep Wrangler<br>This bulletin applies to vehicles built on and before October 14, 2024 (MDH 1014XX) equipped with 2.0L I4 DOHC DI Turbo Engine W/ESS (Sales Code ECX). | | | MARKET APPLICABILITY:<br><div><div><input checked="" type="checkbox"/> NA</div><div><input type="checkbox"/> SA</div><div><input checked="" type="checkbox"/> **EE</div></div> <div><div><input checked="" type="checkbox"/> MEA</div><div><input checked="" type="checkbox"/> IAP</div><div><input checked="" type="checkbox"/> CH**</div></div><br>NOTE: **This bulletin applies to North America, Enlarged Europe, India & Asia Pacific, Middle East & Africa and China markets.** | |

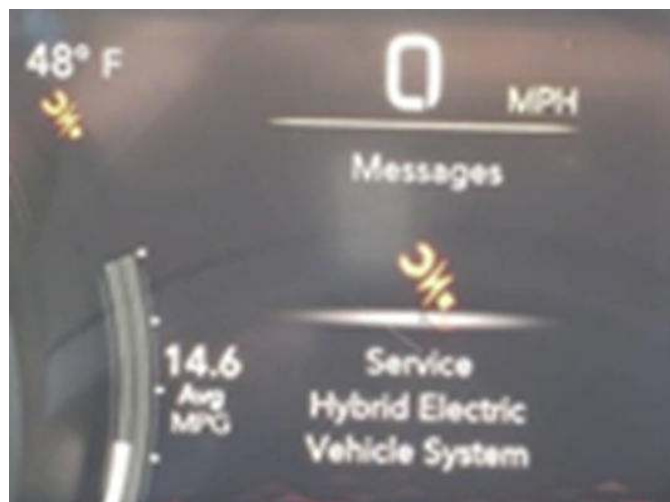
**Fig. 1**

| CUSTOMER SYMPTOM: | Customers must experience a Malfunction Indicator Lamp (MIL) illumination and the vehicle must exhibit/set the following Diagnostic Trouble Code (DTC): <ul style="list-style-type: none"><li>B273C-00 - Digital Crash Input.</li></ul> NOTE: Technicians may find the DTC is stored or pending in the Hybrid Control Processor (HCP).<br>Customers may experience one or more of the following: <ul style="list-style-type: none"><li>The "Service Hybrid Electric Vehicle System Warning" message and Light are displayed in the Instrument Panel Cluster (IPC) Fig. 1.<br/>NOTE: This message may be displayed for a few seconds and then disappear.</li><li>The vehicle may no longer enter Electric or Hybrid drive modes.</li></ul> | | | | |

Service Hybrid Electric Vehicle System Warning IPC Message

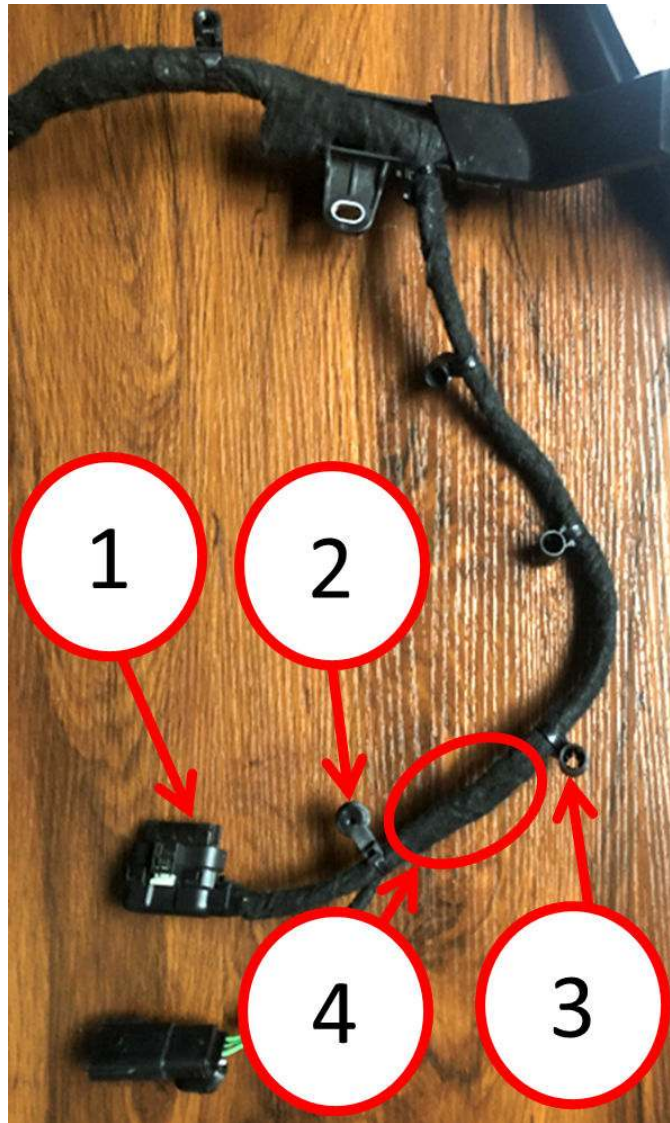
**Fig. 2**

| CAUSE: | Electromagnetic noise on R414 circuit | | | | |

High Voltage Battery Connectors Body Harness And Ferrite Bead Placement

- 1 - Connector D8119E  
2 - Offset Clip 1108  
3 - Stud Clip 1107  
4 - Area To Install Ferrite Bead

5. Locate on the body harness high voltage battery connector D8119E [Fig. 2](#).

6. Remove the cover on D8199E connector [Fig. 2](#).
7. Remove offset clip 1108 [Fig. 2](#) from wire harness. **If necessary to gain better accessibility to the harness, remove stud clip 1107 from the stud.**
8. **Carefully remove** the harness protective tape from D8119E to the remaining stud clip 1107 [Fig. 2](#) from the wire harness.

9. Locate R414A in cavity 16, located in connector D8119E [Fig. 2](#) and remove the dark green/beige circuit wire [Fig. 3](#).

10. Place circuit R414A through the ferrite bead and install the ferrite bead **between clips 1107 and 1108**, [Fig. 2](#) and [Fig. 3](#).
11. Install two butyl patches around wire circuit R414A at both openings of the ferrite bead [Fig. 3](#).

14. Install wire circuit R414A back into connector D8119E [Fig. 2](#) cavity 16.
15. Install conduit from kit over ferrite bead assembly.
16. Install protective tape from D8119E over ferrite bead conduit and to clip 1107. **If removed to gain better accessibility to the harness, install clip 1107 on the stud.**

17. Install the D8119E connector cover [Fig. 2](#).
18. Install the high battery voltage closeout panel. Refer to the detailed procedures available in DealerCONNECT > Service Library> under: 23 - Body / Interior / Panel, High Voltage Battery Closeout / Installation.

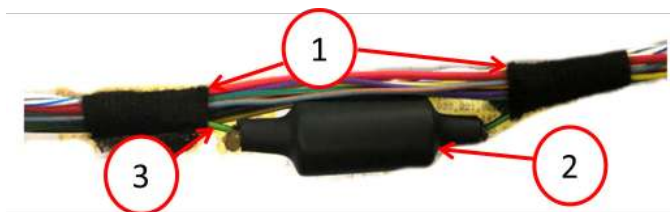
**Fig. 3**  
Ferrite Bead Assembly

- 1 - Butyl Patches  
2 - Ferrite Bead With Heat Shrink  
3 - Dark Green/Beige Wire

12. Place heat shrink tube over circuit R414A and ferrite bead [Fig. 3](#).
13. Using a heat gun, heat the heat shrink tubing around ferrite bead, ensuring sealant flows out of each end tubing [Fig. 3](#).
