## Check engine light with fault code P3005CA in MRD1 (CDI)

| Topic number | LI49.20-N-078466 |
| Function group | 49.20 - Exhaust gas aftertreatment |
| Validity | Sprinter 907 OM654 |

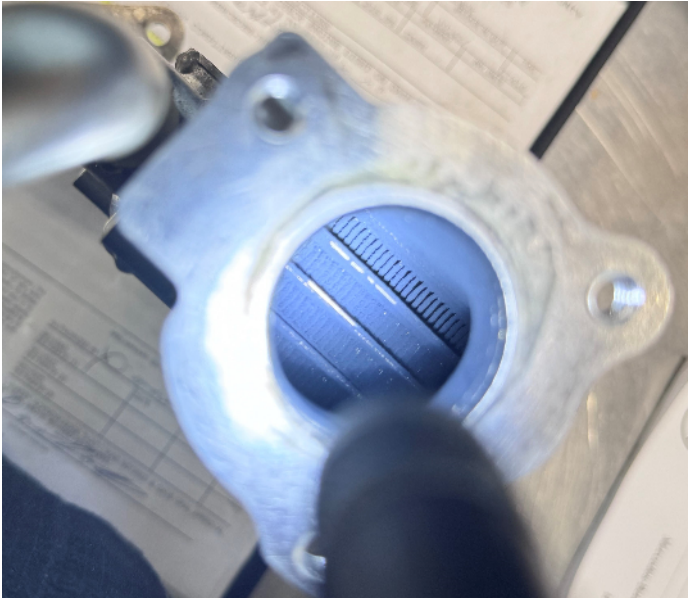
| Attachments | |
|---|---|
| <a href="#">LP EGR Cooler.jpg</a> | Low-Pressure EGR Cooler |

- Check component 'Exhaust pipe and Filter screen of Exhaust Gas Recirculation (low pressure)' for carbon fouling. If no soot is present at the Tailpipe outlet, recommended to separate the exhaust pipe downstream of the Diesel Particulate Filter (DPF) at the outlet to inspect.

- If soot IS found during the Tailpipe inspection:
- Check the 'Filter screen of Exhaust Gas Recirculation (low pressure)' for carbon fouling:
- If soot IS found in the 'Filter screen of Exhaust Gas Recirculation (low pressure)' replace the component Diesel Particulate Filter (DPF), check components Y87/5 (Exhaust Gas Recirculation Actuator, low pressure) and the Cooler for soot deposits. If soot is found, replace as needed.
- If soot IS NOT found in the 'Filter screen of Exhaust Gas Recirculation (low pressure)', replace only the Diesel Particulate Filter (DPF) component.

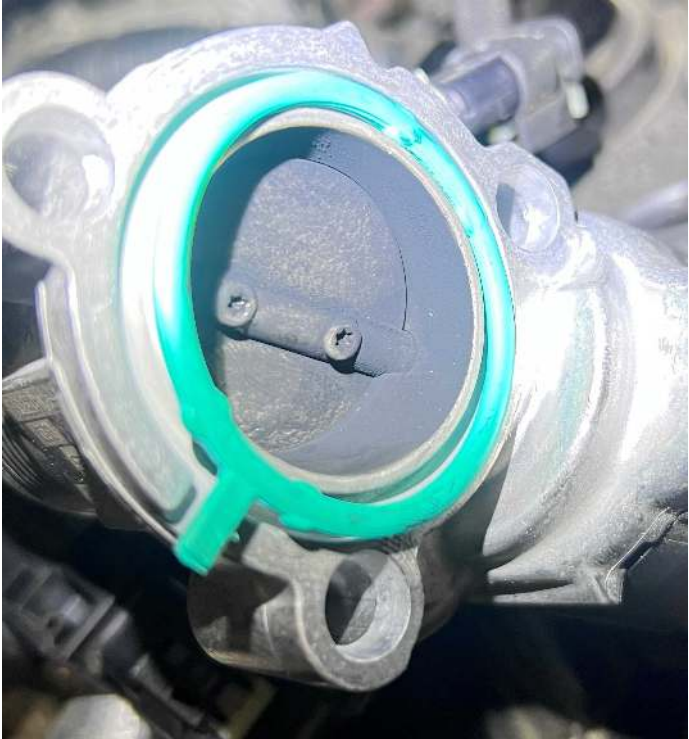
| Attachments | |
|---|---|
| <a href="#">LP EGR.jpg</a> | Low-Pressure EGR Valve |

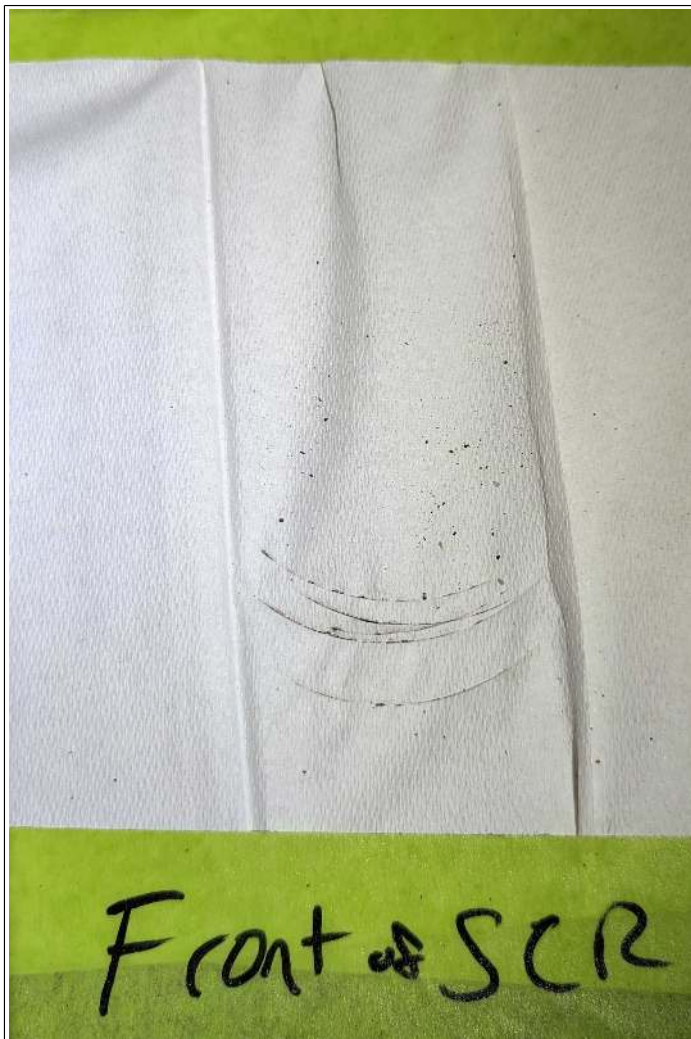
[SCR Front.jpg](#)

White Cloth SCR Front Side

Front of SCR

- If soot was found during step 1 or if this vehicle had the Diesel Particulate Filter (DPF) replaced prior due to failure and the fault returned, please complete the below steps:
- Remove the 'SCR Catalytic Converter, underbody', place a white cloth/rag on the floor, and lightly tap the 'SCR Catalytic Converter, underbody' onto the floor to see if any soot comes out. Repeat this inspection on both ends of the SCR catalytic converter. If soot is found on the rag, please replace the 'N74 (Soot Particulate Sensor Control Unit)' and 'SCR Catalytic Converter, underbody' with the needed components.

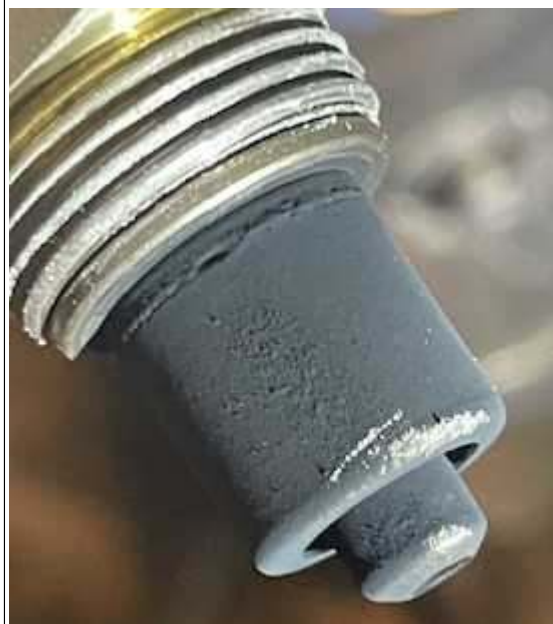
[Soot Sensor.jpg](#)

Soot Sensor Covered in Soot
