# Technical product information

| Topic | Engine Overheating - Warning in the DIP V8 Kovomo |
| Brand | Bentley |
| Transaction No. | 2061369/12 |

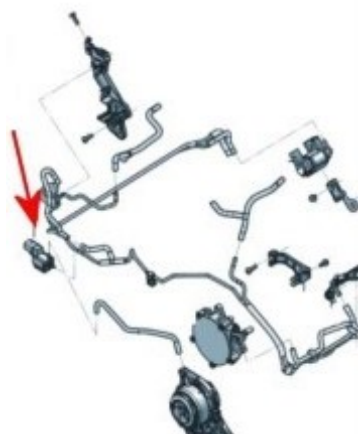
To allow the engine coolant to heat as quickly as possible (from cold start) coolant delivery from the mechanical coolant pump is interrupted by switch valve N649

Figure 2 - New Continental GT/ GTC and Flying Spur
