| <b>Topic</b> | Bentayga V8 Kovomo - DTC P310B00 with Symptom Code 2638 - Check Engine Lamp - Fuel Pressure Regulation |
| <b>Transaction No.</b> | 2058484/16 |
| <b>Release date</b> | 16 Jul 2026 |

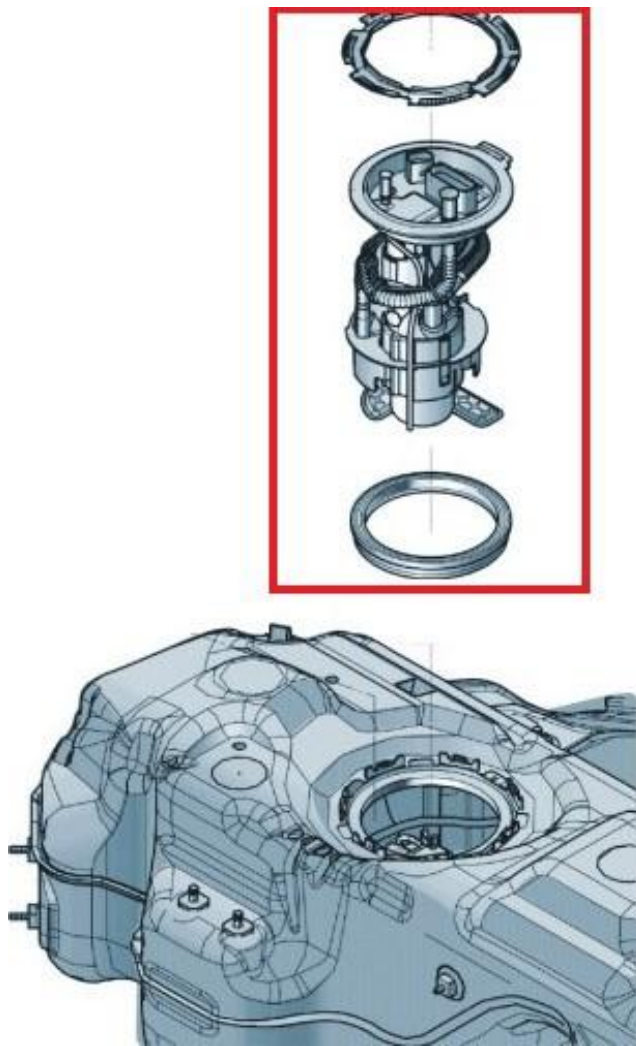
1) Referring to the example shown in Figure 1 - Check the actual pressure value

| Low fuel pressure, specified value | 450.0 | kPa |
| Fuel low pressure, actual value | 501.3 | kPa |

- In the event the fuel pressure actual value is above 450kPa the Fuel Delivery Module within the fuel tank (Figure 2) should be replaced

- In the event the fuel pressure actual value is above 475kPa (2023MY) the Fuel Delivery Module within the fuel tank (Figure 2) should be replaced
