| <b>Topic</b> | Engine Overheating - Warning in the DIP V8 Kovomo |
| <b>Brand</b> | Bentley |
| <b>Transaction No.</b> | 2061369/13 |

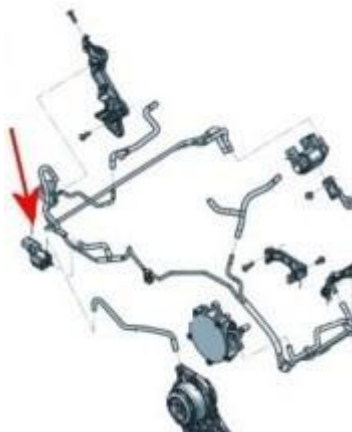
To allow the engine coolant to heat as quickly as possible (from cold start) coolant delivery from the mechanical coolant pump is interrupted by switch valve N649

Figure 2 - New Continental GT/ GTC and Flying Spur
