## Technical product information

| Topic | Engine Overheating - Warning in the DIP V8 Kovomo |
| Transaction No. | 2061369/14 |

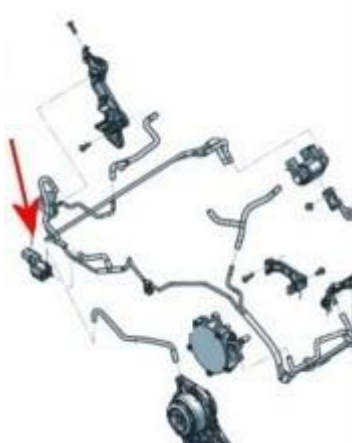
To allow the engine coolant to heat as quickly as possible (from cold start) coolant delivery from the mechanical coolant pump is interrupted by switch valve N649

Figure 2 - New Continental GT/ GTC and Flying Spur
