**NUMBER:** 08-121-19

Power Take Off (PTO) is Inoperable

This bulletin involves installing a PTO diode jumper harness.

| 2019 | (DD) | RAM 3500 Cab Chassis |

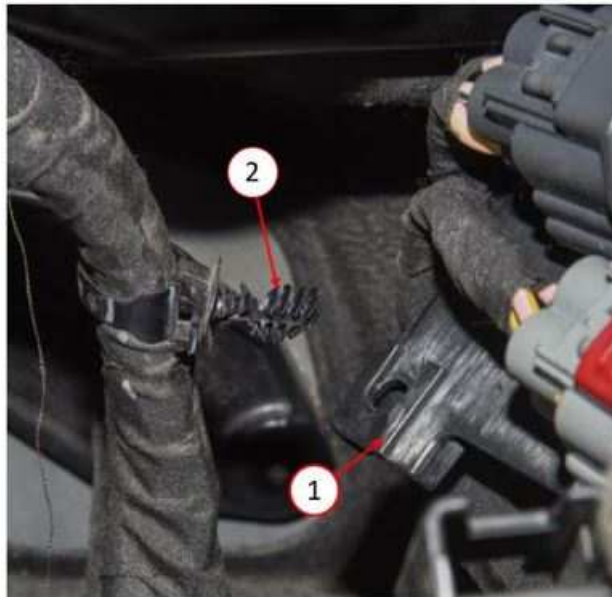
**Fig. 4**  
**Connector Bracket**

1 - AUX PDC Connector Bracket  
2 - Wire Harness Retainer (Diesel Engine Only)

6. Turn the AUX PDC over and see if the PTO jumper harness was already installed.
7. Was the PTO jumper harness already installed?
- YES>>> Put the vehicle back together. Use inspection LOP (08-90-65-9C) to close the active RRT. Proceed to [Step 16](#).
  - NO>>> Install the PTO jumper harness. Proceed to [Step 8](#).
8. (Diesel engine only). Remove the wire harness retainer from the connector bracket, (Fig. 4) .

13. Install the new wire harness retainer on the connector bracket, (Fig. 4) .  
14. Put the light gray PTO jumper harness connector on the connector bracket.  
15. Put the connector bracket back on the AUX PDC.  
16. Install the AUX PDC back onto the PDC mounting bracket, (Fig. 2) .

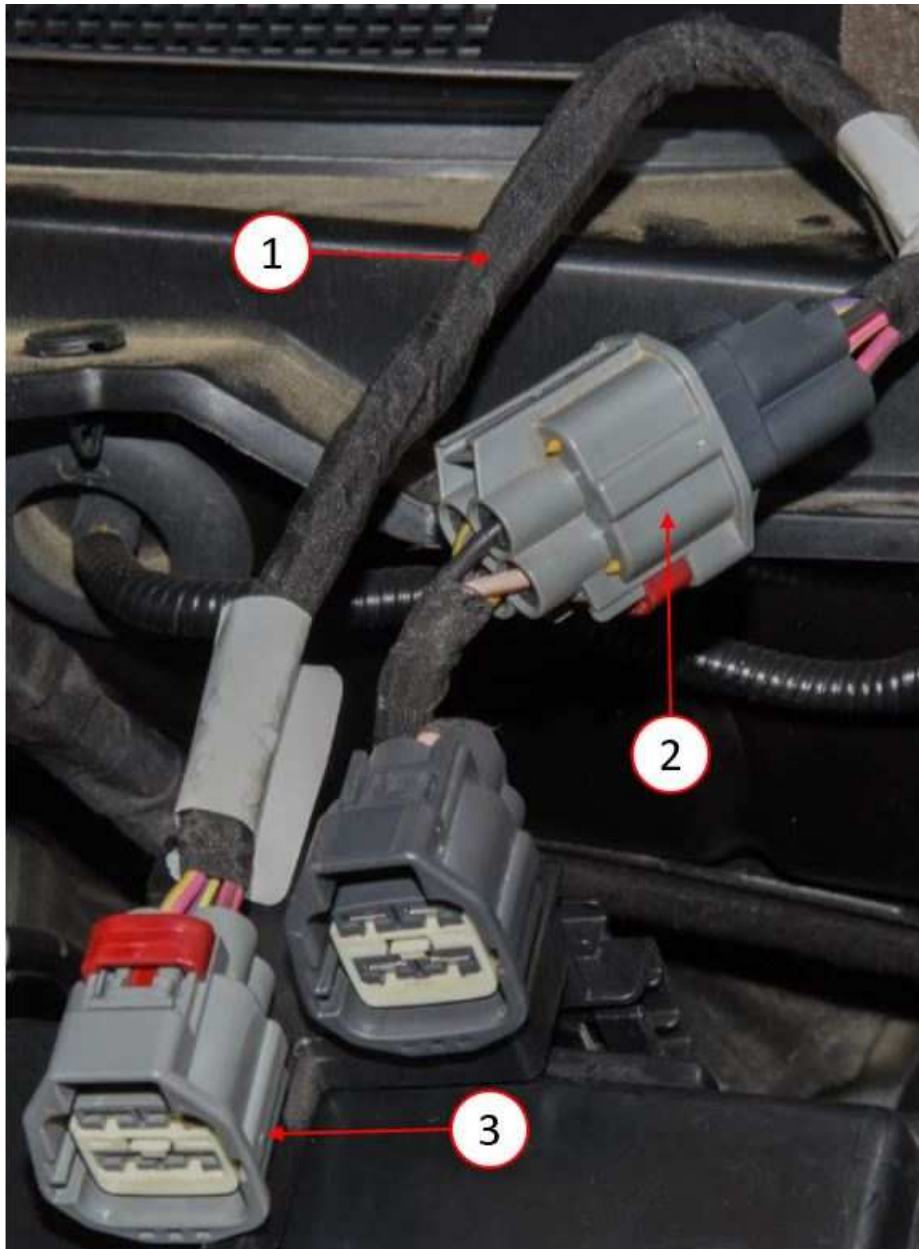
**Fig. 6**  
**PTO Diode Jumper Harness**

- 1 - Diode Jumper Harness
  - 2 - Original Light Gray Connector
  - 3 - Light Gray Jumper Harness Connector
-

11. Connect the original light gray connector to the PTO jumper harness, (Fig. 6) .
