# Service Bulletin

Bulletin No.: 19-NA-246

Subject: Engine Runs Rough, Misfire, Malfunction Indicator Lamp (MIL) Illuminated - DTC P0300 Set

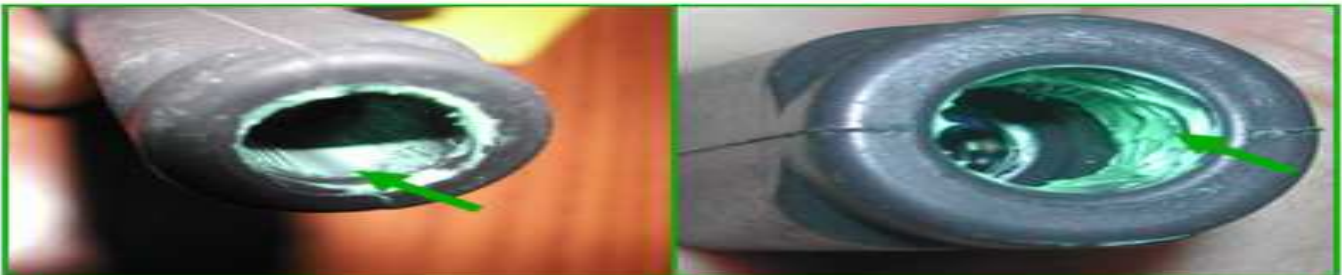
5424009

The graphic above depicts grease applied evenly to the inside of the boot, from the end of the terminal to the end of the boot.

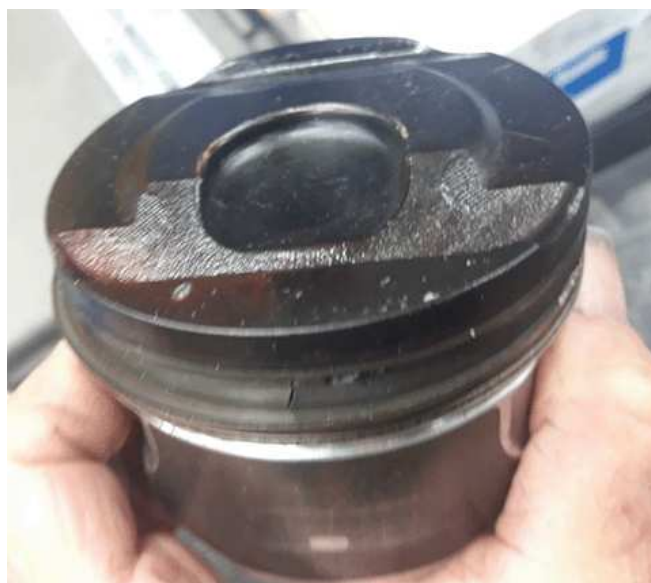
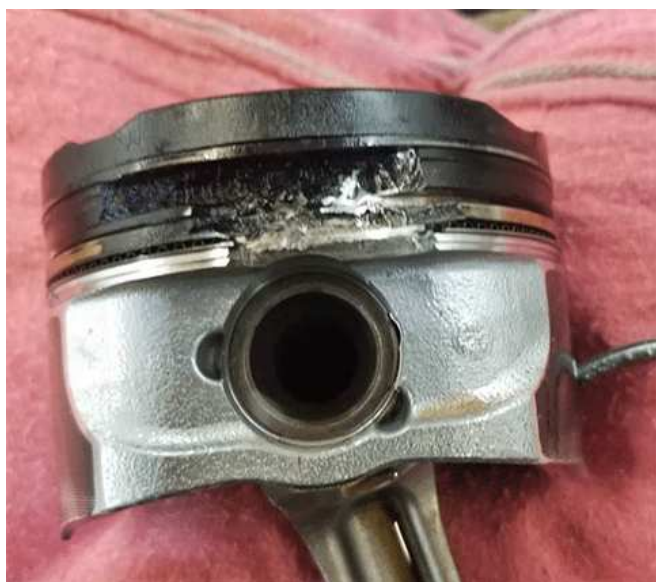
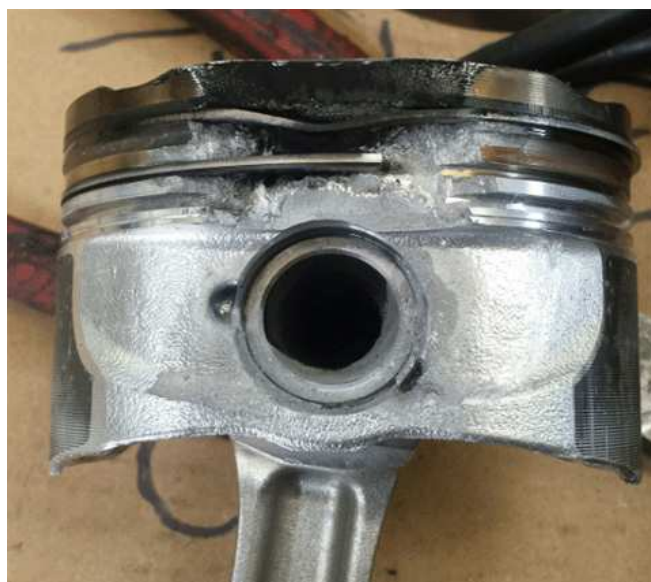
The pictures below are some examples of what might be found.

If the cylinder walls are not damaged and one or more of the pistons are found fractured, replace all four spark plugs, all four ignition coils (apply dielectric grease to the spark plug boots. Refer to Dielectric Grease Application section above), the fuel injector of the cylinder(s) that had damaged pistons, all four piston kits, all ring sets for all four pistons, all rod bearings, all four connecting rod assemblies and other components necessary when pistons are replaced.

Note: When installing pistons, make sure to use the tapered ring compressor J-43953 special tool. Use care when installing the piston assemblies into the cylinder so the rings are not damaged.
