| <b>HYUNDAI</b><br><b>Technical Service Bulletin</b> | GROUP<br><b>CAMPAIGN</b> | NUMBER<br><b>20-01-004H</b> |
| <b>SUBJECT:</b> THETA GDI ENGINE DTC P1326 - ENGINE INSPECTION / REPLACEMENT (SERVICE CAMPAIGN T3G) | | |

**Description:** Applicable vehicles with 2.0L Turbo and 2.4L GDI engines may experience the Check Engine warning lamp illuminated with DTC P1326. Follow the procedure to inspect the vehicle and replace the engine or update the engine ECU software based on the inspection results.

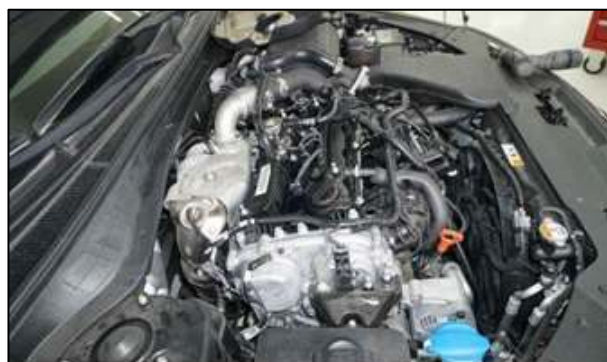
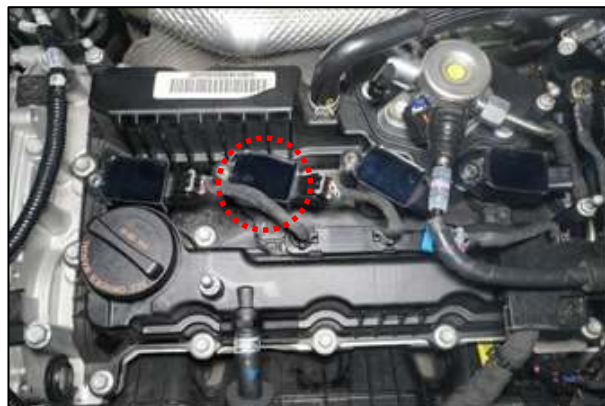
2. Remove the engine cover and the 4 ignition coils.

**Tightening Torque (ignition coils):**

**9.8 - 11.8 N·m (1.0 - 1.2 kgf·m, 7.2 - 8.7 lb·ft)**

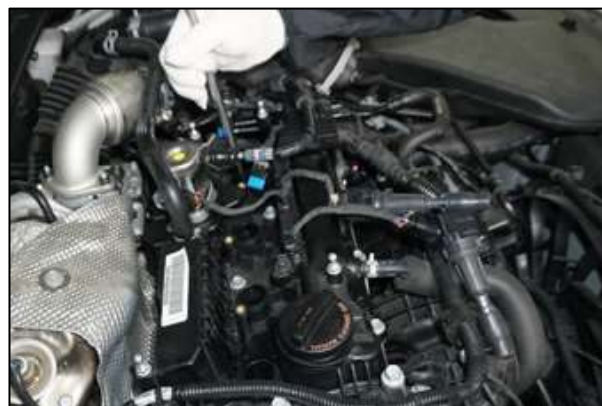
3. Remove the 4 spark plugs.

***Tightening Torque:***

***14.7 - 24.5 N·m***

***(1.5 - 2.5 kgf·m, 10.9 - 18.0 lb·ft)***

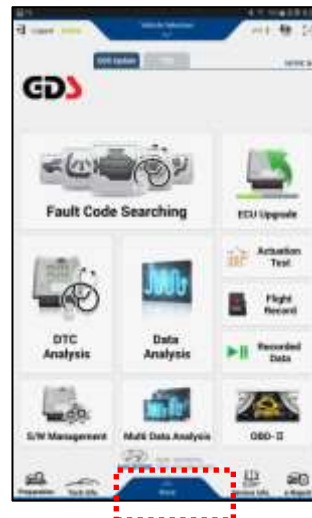
6. Swipe up on the 'More' tab at the bottom of the GDS home screen. Select the 'Special Inspection' function.

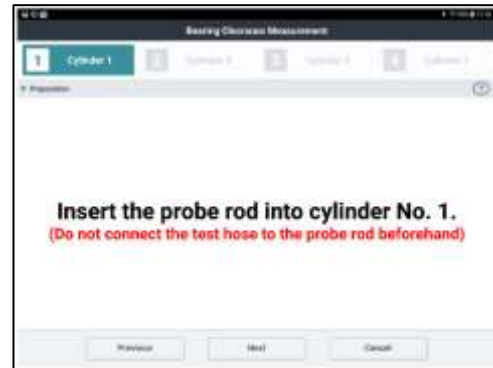
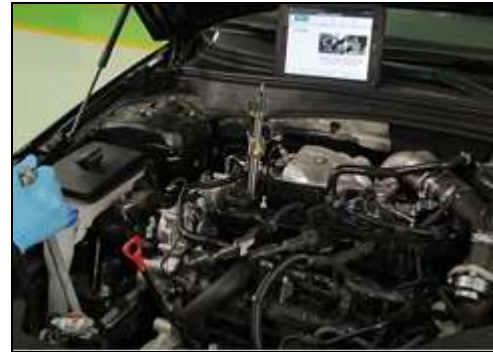
If TDC is difficult to find, refer to the shop manual: Engine Mechanical System > Timing System > Timing chain.

**Ensure the test hose is disconnected from the clearance gauge when finding TDC.**

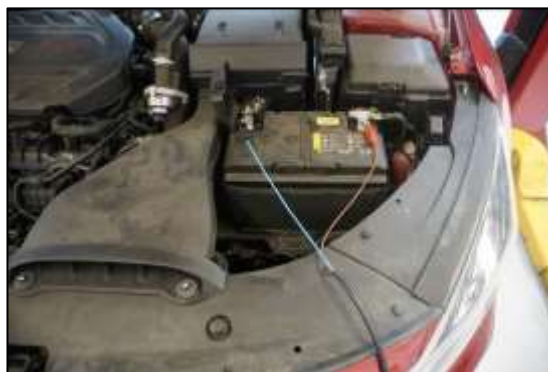
16. Connect the SST power cables to the vehicle's 12V battery. Turn the bearing tool SST power switch 'ON'.

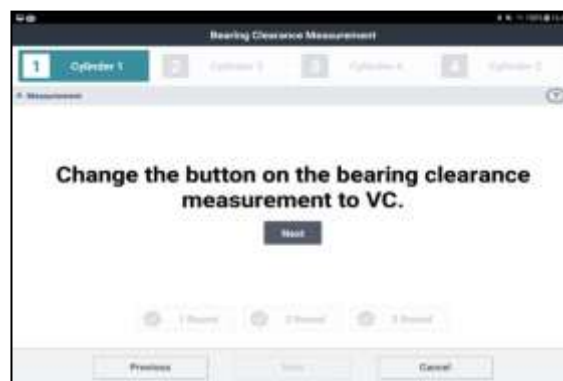
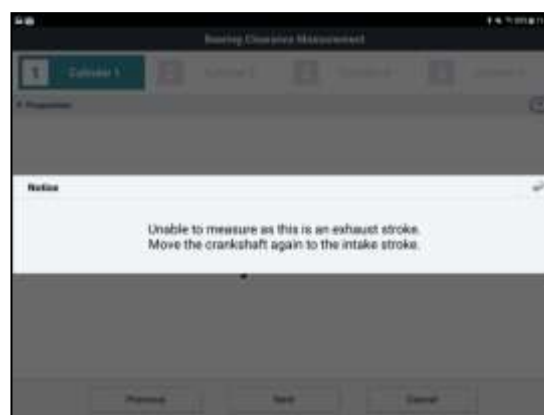
19. On the bearing tool SST, change the AP/VC switch to the VC position when instructed by the GDS.

If the bearing measurement value does not change when the AP/VC is switched or the “Unable to measure” message appears on the GDS, rotate the crankshaft further as the exhaust valves could be open. Set the crankshaft to TDC again (Step 11).

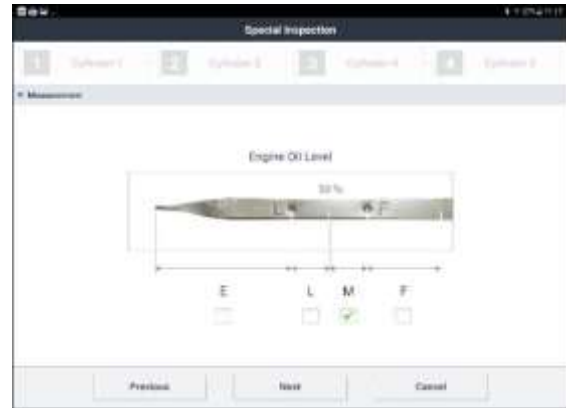
20. Continue following the instructions on the GDS to complete the bearing inspection. Check the engine oil level and select the level in the GDS.

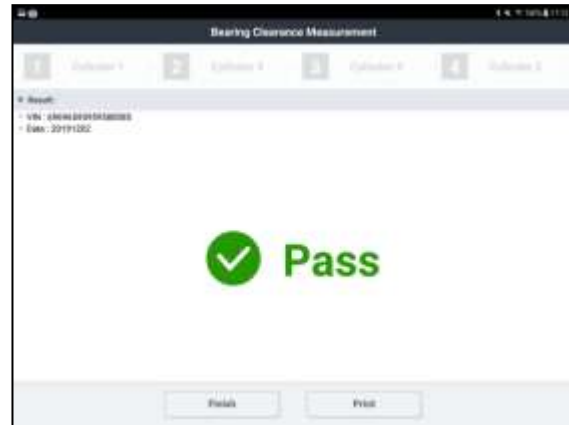
21. If the test result is “PASS”:

- Save a screenshot of the results screen.
- Refer to Campaign 953 to update the Engine ECM if new software is available.
- Reinstall all components in the reverse order of removal.
- Check for DTCs and perform the appropriate diagnostic service. Ensure no warning lights are present to complete the procedure.

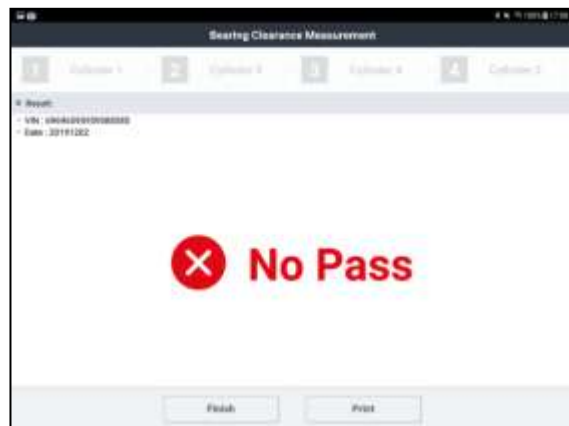
If the test result is “NO PASS”:

- Save a screenshot of the results screen.
- Continue to the engine replacement procedure.
- Refer to Campaign 953 to update the Engine ECM if new software is available.
- Check for DTCs and perform the appropriate diagnostic service. Ensure no warning lights are present to complete the procedure.

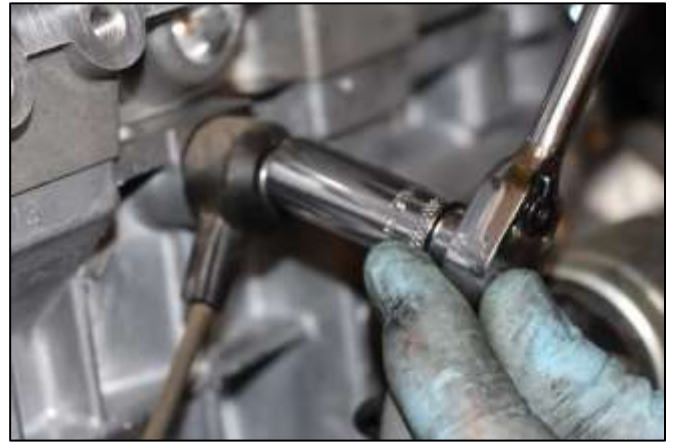
5. Remove and reinstall the engine knock sensor from the old engine to the new engine.

Ensure the knock sensor is torqued to specification using a torque wrench. Improper installation can result in DTC codes.

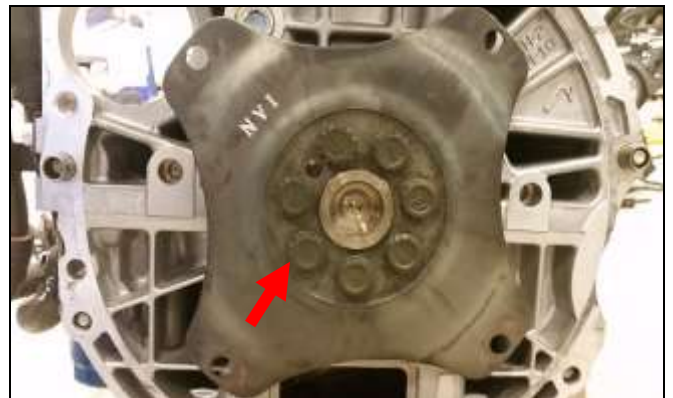
6. **If 21101-2GK70QQA engine is used:**

- Install the oil filler cap from the old engine to the new one.
- Install the drive plate/flywheel on the new engine using new bolts (QTY 7).

**Drive Plate Tightening torque :**

111.7 ~ 127.5 Nm (86.8 ~ 94.1 lb-ft)

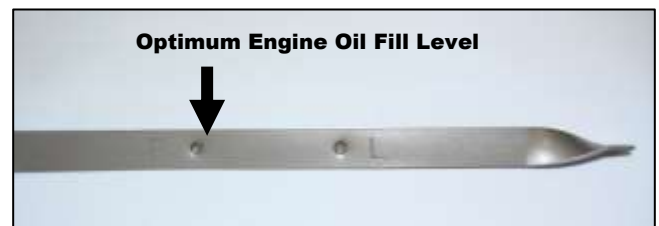
13. Start the engine to warm it up and begin the cooling system air bleeding process.
  - Check for any leaks during this time.
  - After the engine has warmed up to normal operating temperature, turn the engine off, wait a few minutes, and then **adjust the engine oil level to near the “F” mark as shown.**
