# Technical Service Bulletin

## 34 Vehicle Electronics Malfunction message, DTC B116229 is stored in the steering wheel or vehicle electronics module Q3

34 20 45 2058612/1 March 16, 2020.

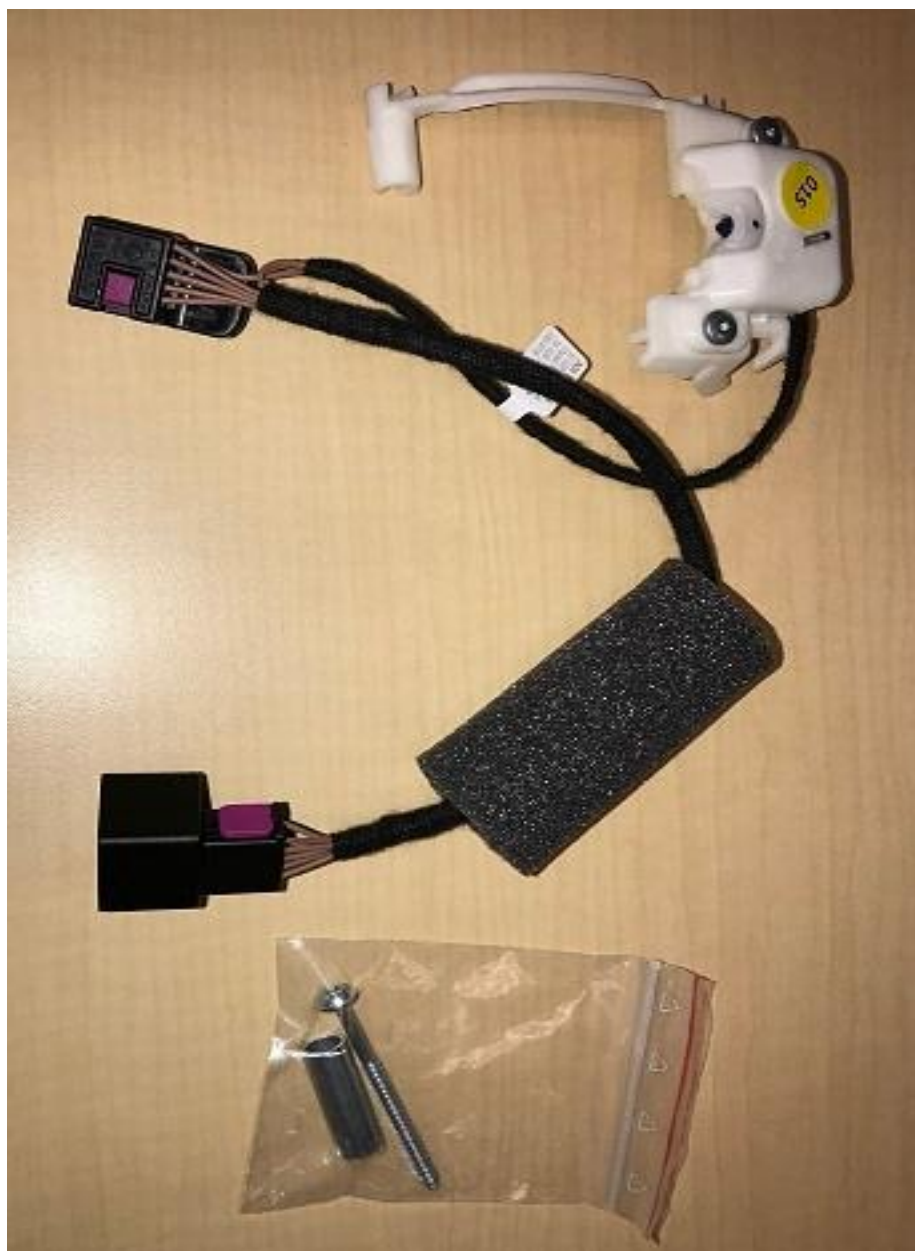
**Figure 1.** New microswitch module.

Component-related deviation in microswitch of the selector lever.

If the customer has the above condition and the DTC B116229 is stored in the steering wheel electronics module, J527 (address word 0016) or the vehicle central electrical system module J519 (address word 0009), then install the new externally mounted microswitch module and selector lever handle sleeve per the instructions below (Figure 1).

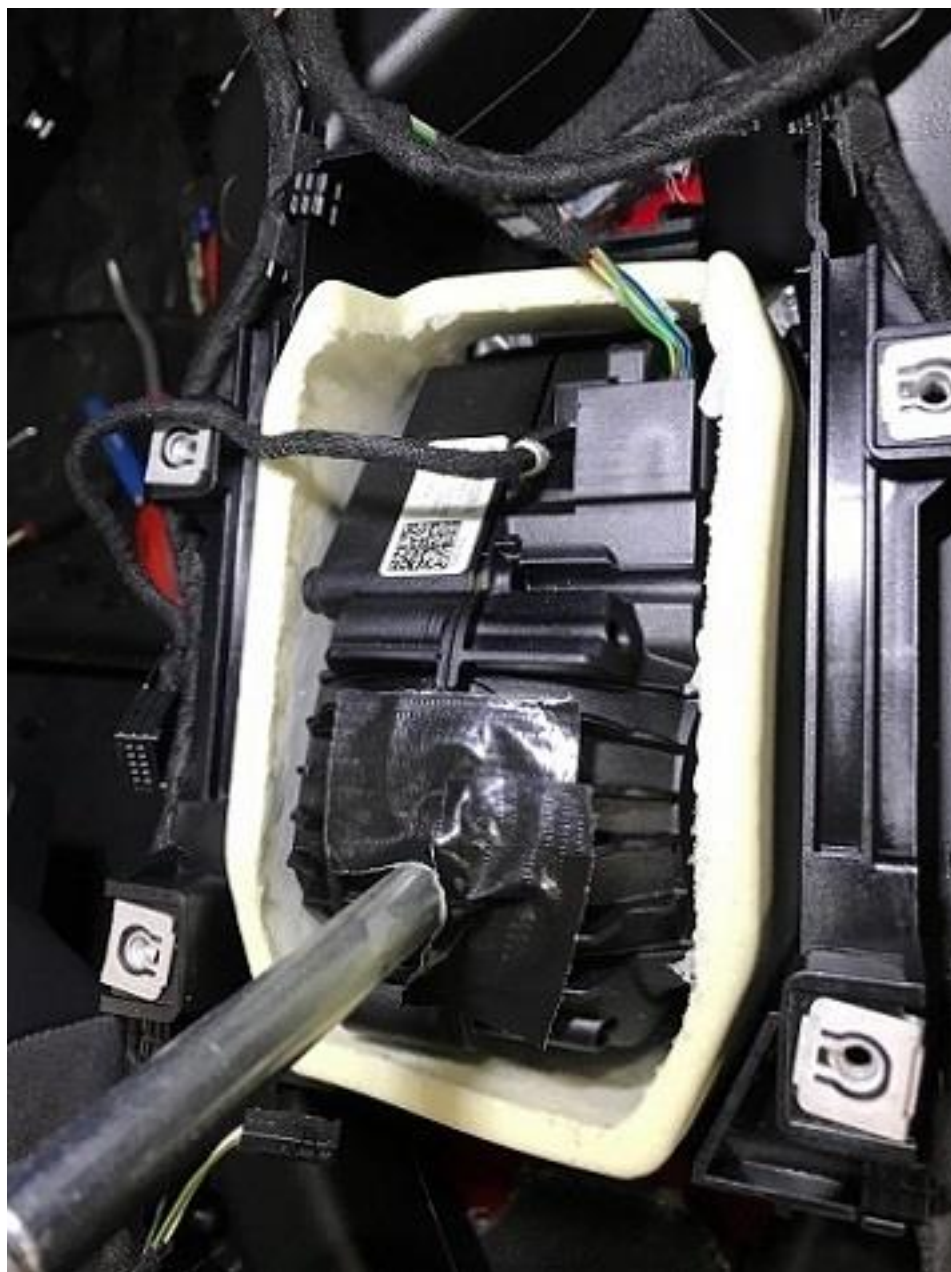
**Figure 3.** Tape covered shift gate.

2. Place the selector lever in "D" (Drive) and tape the opening of the shift gate to protect the selector lever control module from screws or tools falling into the control module (Figure 3).

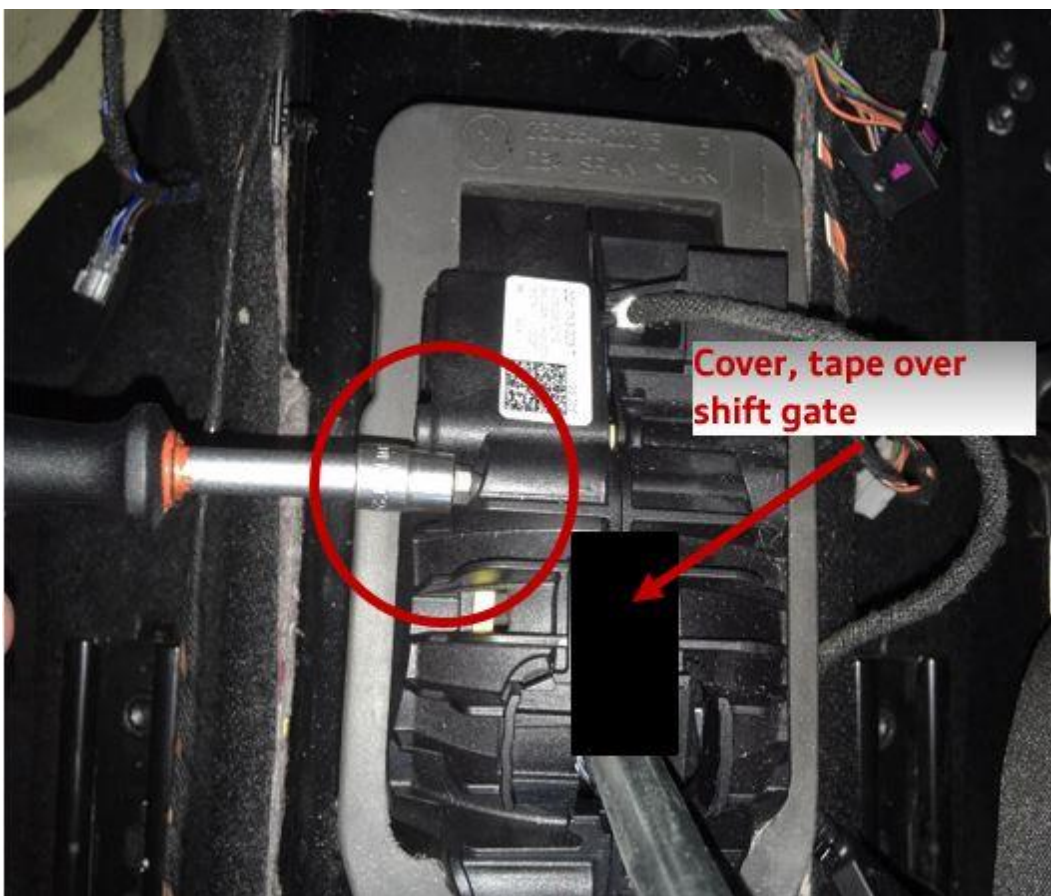
**Figure 4.** Removing T-20 screw.

3. Remove the T-20 screw circled in red (Figure 4). The screw can be discarded as it will not be used in the repair.

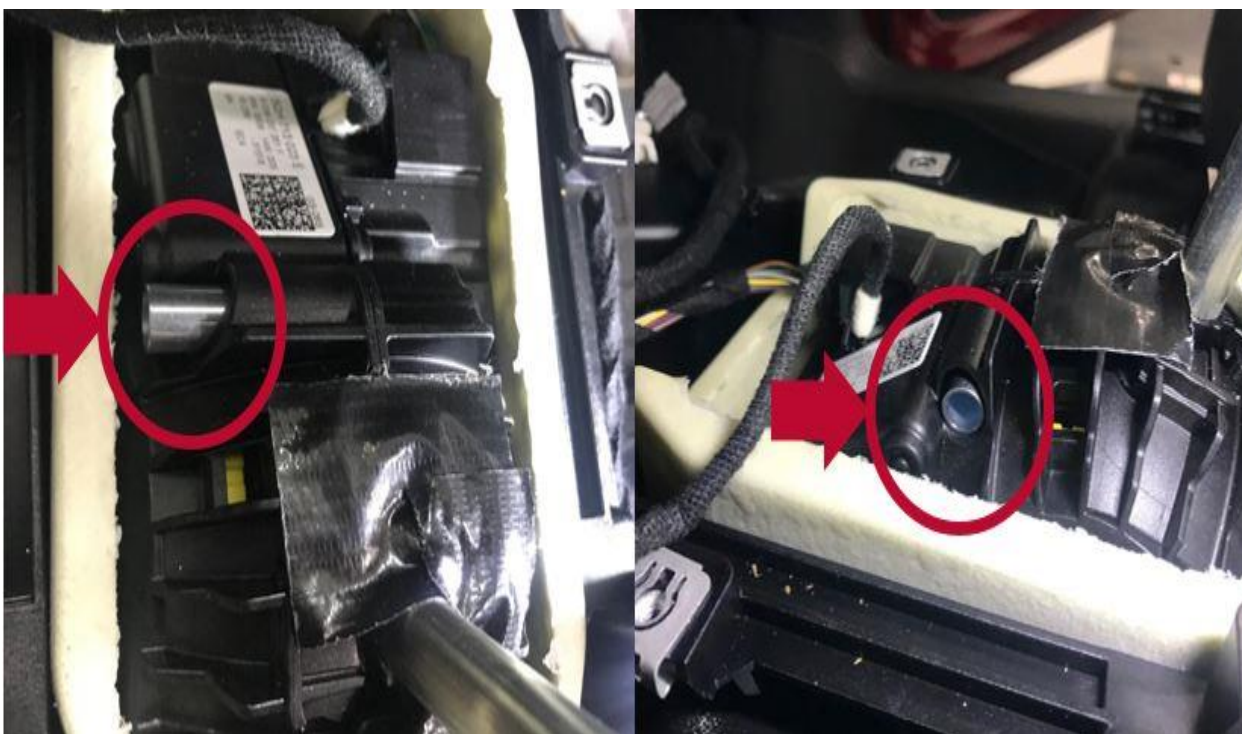
**Figure 5.** *Installing the spacer sleeve.*

4. Install the spacer sleeve from the repair kit as shown below (Figure 5).

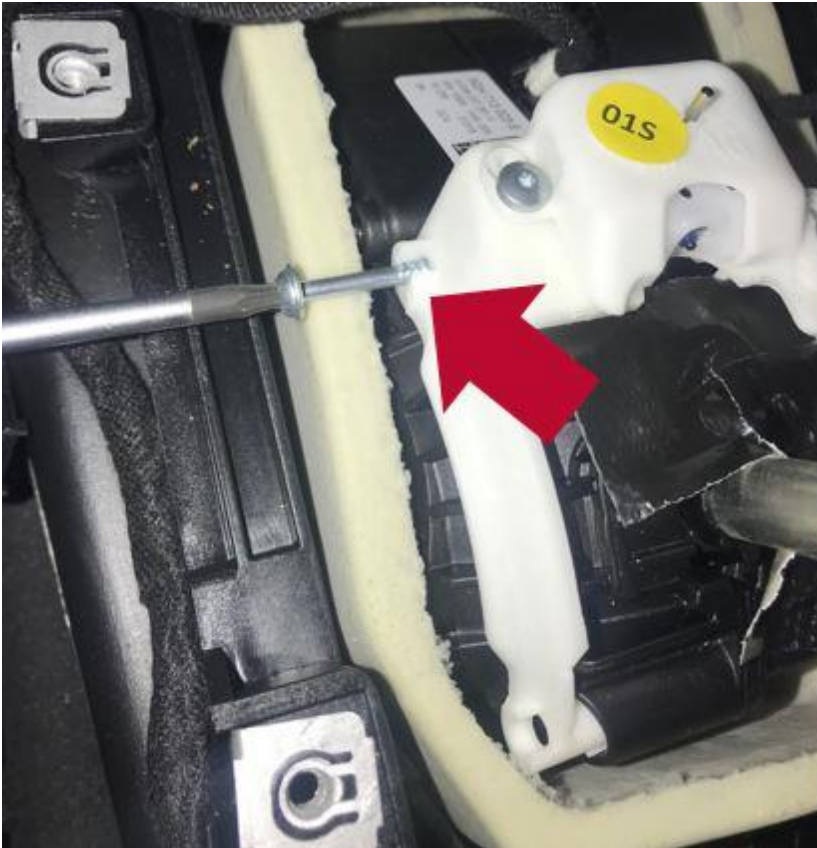
**Figure 8.** Installation of the screw.

7. Secure the microswitch module to the selector lever housing with the new longer T-20 screw included in the repair kit. Tighten the screw to 2.0 Nm (Figure 8).

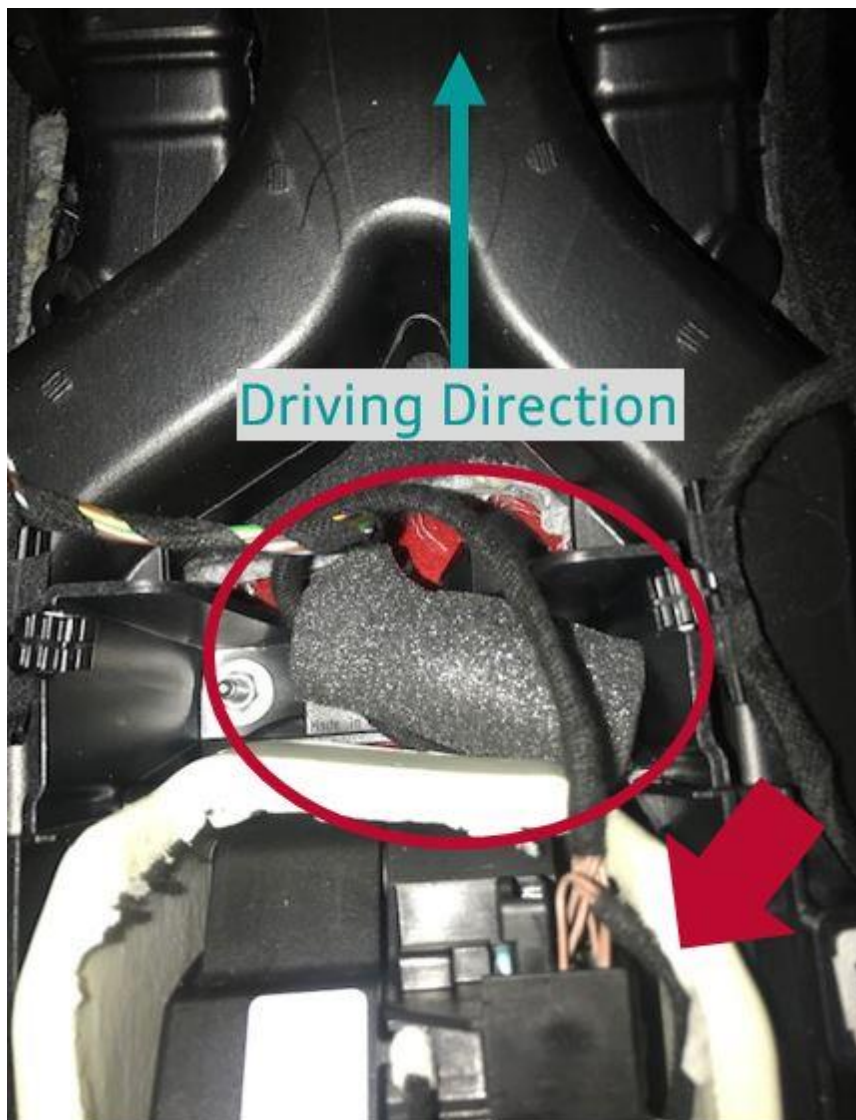
**Figure 9.** Electrical connection.

8. Disconnect the electrical connector from the selector lever control module. Plug one end of the microswitch module Y cable into the selector lever control module and the other end into the existing vehicle harness that was just disconnected. Pull the foam cover over the connection to the vehicle harness. Place the connection with the foam cover in front of the selector lever control module as circled below (Figure 9) route the smaller wiring in a loop in-between the foam and the selector lever control module as shown below with the red arrow (Figure 9).

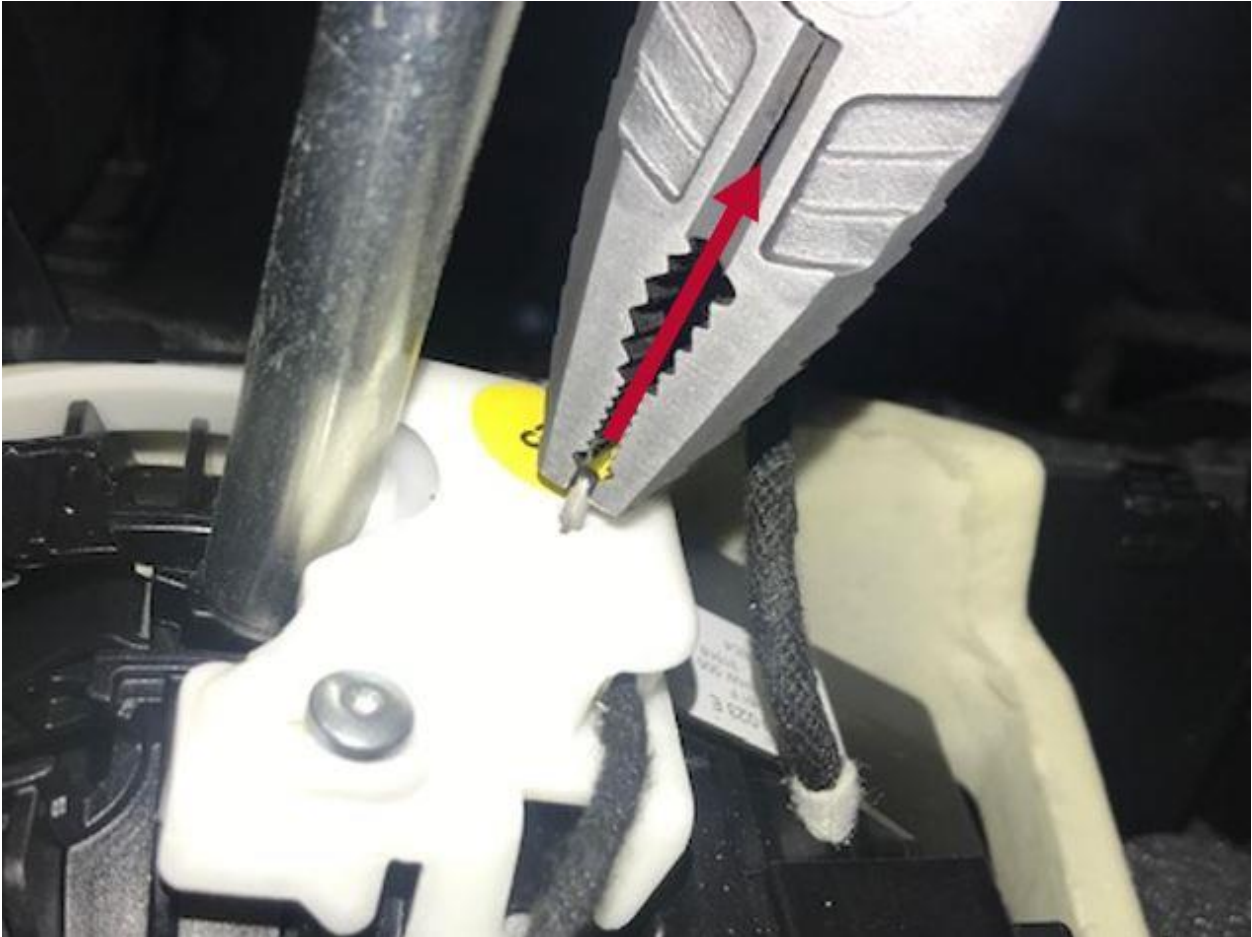
**Figure 11.** Removing lock pin from the microswitch module.

Once the screws are tightened, remove the locking pin as shown below (Figure 11). Save the pin in case you have to make another adjustment.

10. Reinstall the complete center console and the shift knob per the repair manual.
11. Perform the GFF test plan for the DTC B116229 (Selector lever park position lock switch implausible signal) for fine-tuning of the microswitch module. Check for proper operation. If a 2<sup>nd</sup> adjustment is required, reinsert the lock pin and follow the steps in Step 9.
12. Confirm the proper operation of the module.
