# Technical Service Bulletin

## 94 Rear lights do not switch from bumper to hatchgate after closing

94 20 24 2050234/4 April 21, 2020. Supersedes Technical Service Bulletin Group 94 number 19-02 dated February 7, 2019 for reasons listed below.

| Model(s) | Year | VIN Range | Vehicle-Specific Equipment |
|---|---|---|---|
| Q5 | 2018 - 2020 | All | Not Applicable |

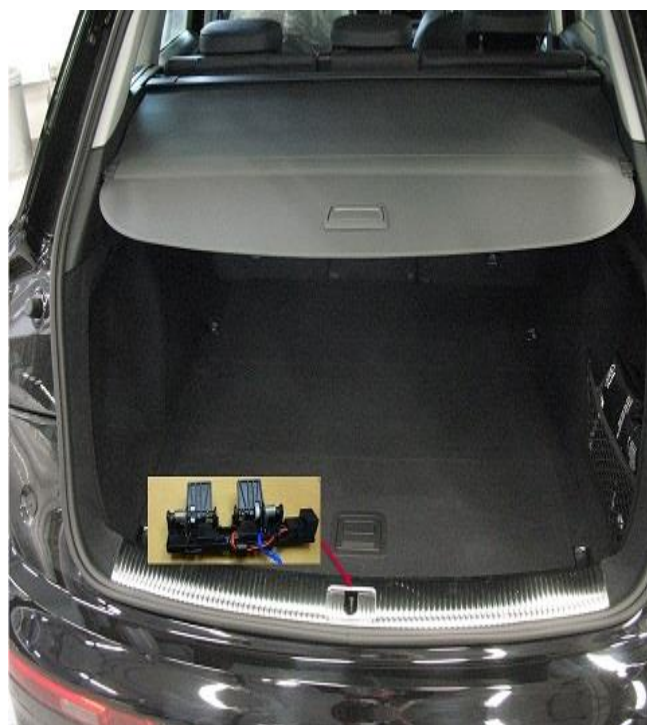
The two micro switches for the reverse light change-over are under the loading sill cover on the rear cross panel and are secured to the striker for the rear lid lock (Figure 1).

1. The paddle on the micro switch was broken due to adjustment of the rear hatch or the striker in production.
2. Dirt can block one/both paddles on the micro switch, which is fastened to the striker of the rear lid (Figure 2).

**Figure 1.** Rear lid closed sensor.

1. Replace the rear lid closed sensor if found broken (Figure 1).
2. If debris is found to be obstructing proper switch activation/deactivation, activate the switch paddles using your fingers and remove the debris. Using compressed air is effective.
3. Then check the measuring values for the G525 and G526 switches and replace the rear lid closed sensor if the malfunction persists. Only the improved rear lid closed sensor with the protective enclosure is available.

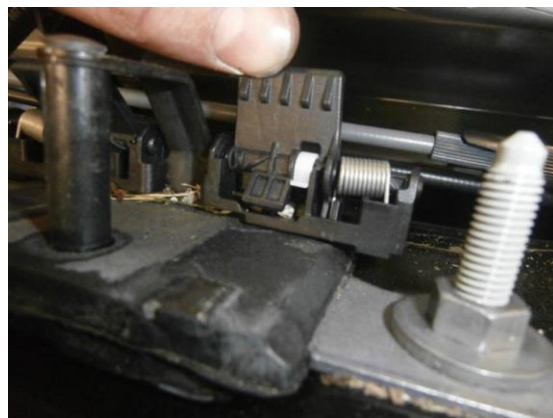
**Figure 2.** Debris trapped in the rear lid closed sensor.

- Adjustment of rear hatch optimized.
- The rear lid closed sensor assembly with additional enclosure to protect the switches from debris ingress is now installed. This improves the debris resistance of the switches but cannot eliminate it entirely.
