# Technical Service Bulletin

**01 MIL on, DTCs P218100, P017B00, P308100, and/or P01E400 are stored in the ECM**

01 20 82 2058767/6 August 26, 2020. Supersedes Technical Service Bulletin Group 01 number 20-65 dated June 8, 2020 for reasons listed below.

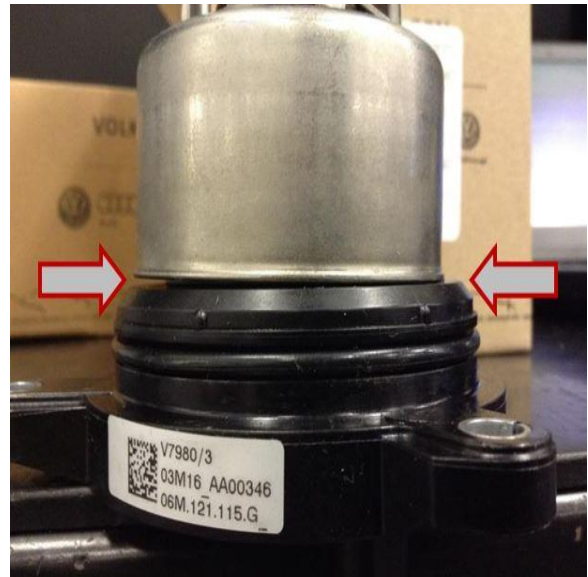
**Figure 1.** Gap between chamber and seal.

1. Remove the thermostat and check whether it closes completely. If the coolant is still warm, put the thermostat in cold water to restore its original condition. If there is a gap between chamber and seal, the thermostat is faulty and needs to be replaced.
2. Attach photos to the repair order which clearly shows that the thermostat does not close neatly.

After the repair, fill with G12evo coolant in the coolant circuit.
