## SERVICE BULLETIN

**APPLICABILITY:** 2014-15MY XV Crosstrek Hybrid Electric Vehicle (HEV) **NUMBER:** 16-94-15R

**SUBJECT:** Diagnosis and Repair of DTCs P172A and P0B0B

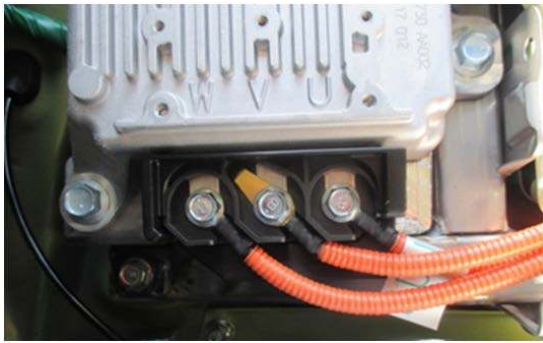
- Remove the rear cargo area floor mat and the sub-trunk (storage tray).
- Remove the orange HEV Service Disconnect plug and put it in your pocket.
- Remove the TORX screws and necessary trim clips securing the aluminum battery cover.
- **ONE AT A TIME**, remove the 3 bolts securing the orange "W", "V", and "U" cables to the electric oil pump inverter. As each cable is removed, cover each terminal end with one piece of electrical tape to insulate it. Connect the RED (+) test lead from the DVOM to the "U" cable end and BLACK (-) lead to the "V" cable end as shown. Confirm the "W" cable end is wrapped with insulating tape.

- Reinstall the orange HEV Service Disconnect plug.
- Turn on the DVOM and set it to measure AC Voltage.
- Start the engine and with the transmission in PARK, hold the engine at 1800 RPM.
- Read the AC voltage on the DVOM display and record your result.

**IF THE DVOM SHOWS 0.5V OR MORE:** the o-ring and drive motor are damaged. The drive motor / case assembly must be replaced. Remove the CVT assembly following the procedure in the applicable Service Manual.

**IF THE DVOM SHOWS LESS THAN 0.5V:** the root cause of the DTC is elsewhere. Continue with the DTC diagnostic procedure in the applicable Service Manual.

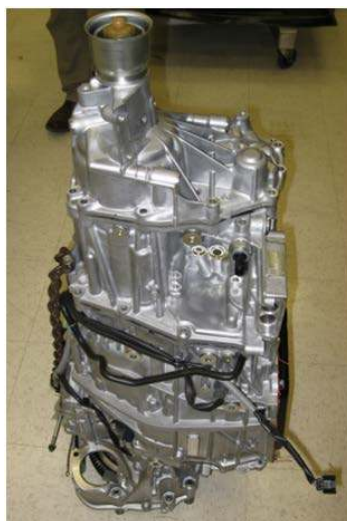
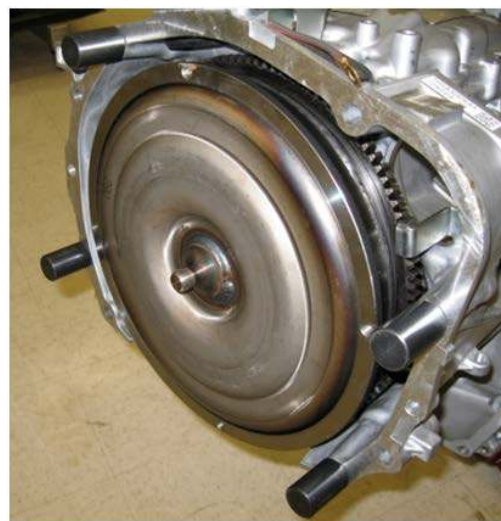
The bulk of this procedure is best performed with the transmission assembly standing vertically. Use the 4- 6M/T stands (S/T# 18632AA000) pictured below for support.

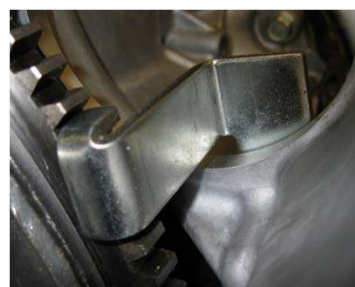
- The torque converter can also be left in place. Either support it from the underside after standing the unit up with a block of wood or use a retainer strap / bracket included with remanufactured and replacement transmission assemblies to keep the torque converter in place.

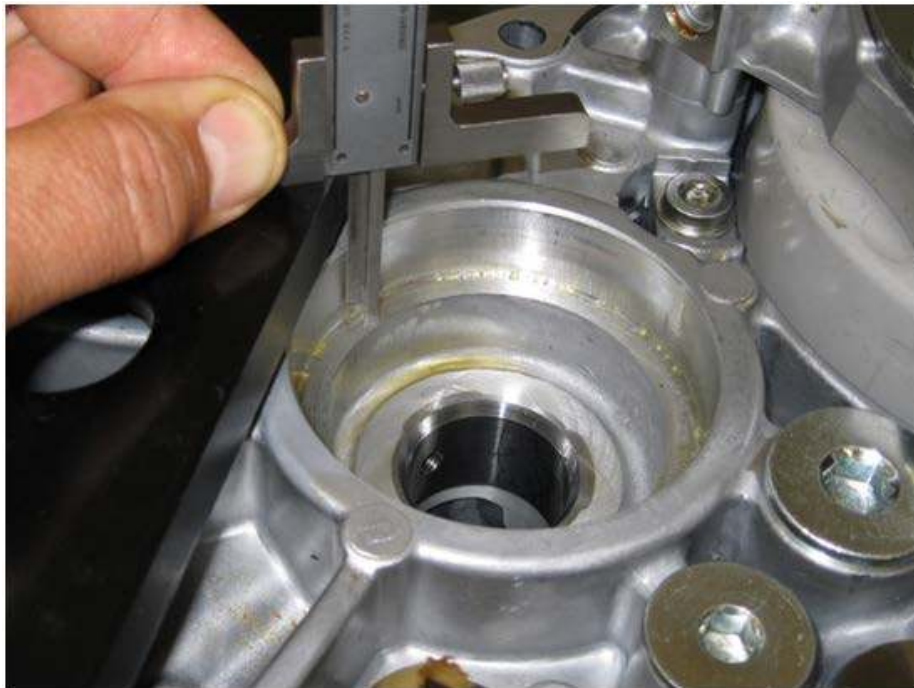
2) Measure the height "A" from the Gauge Block upper face to the ball bearing catch surface.

A: Height from the Gauge Block upper face to the ball bearing catch surface

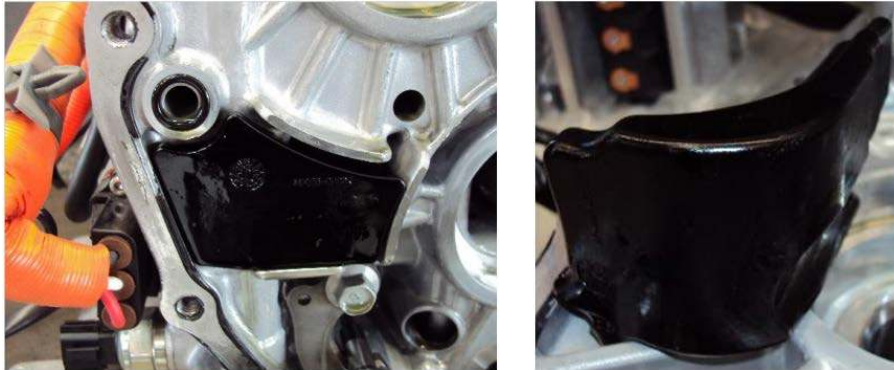
- When installing the secondary pressure sensor and inspection plugs, **ALWAYS** install a new o-ring (with some CVT fluid applied to it) and follow the proper torque specifications as they do vary.
- Remember to transfer both of the oil baffles shown below over to the new assembly.
