## SERVICE BULLETIN

AT15-005f

April 29, 2016

### PATHFINDER, QUEST, MURANO, MAXIMA, ALTIMA V6; CVT JUDDER AND DTC P17F0 OR P17F1 STORED

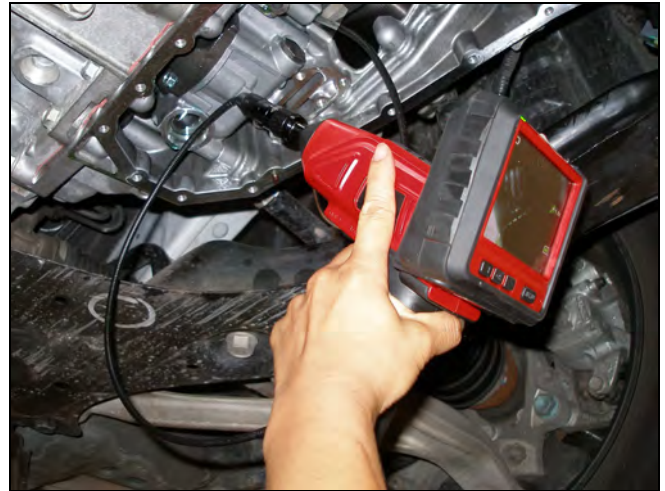
Figure 11

4c. Slowly and carefully turn the left front tire one full turn in the forward rotation to view all of the chain.

- Holding the borescope with one hand allows for turning the tire with the other hand (see Figure 11).

**CAUTION:** If the tire is rotated in the rearward rotation, the camera lens may get caught between the chain and pulley.

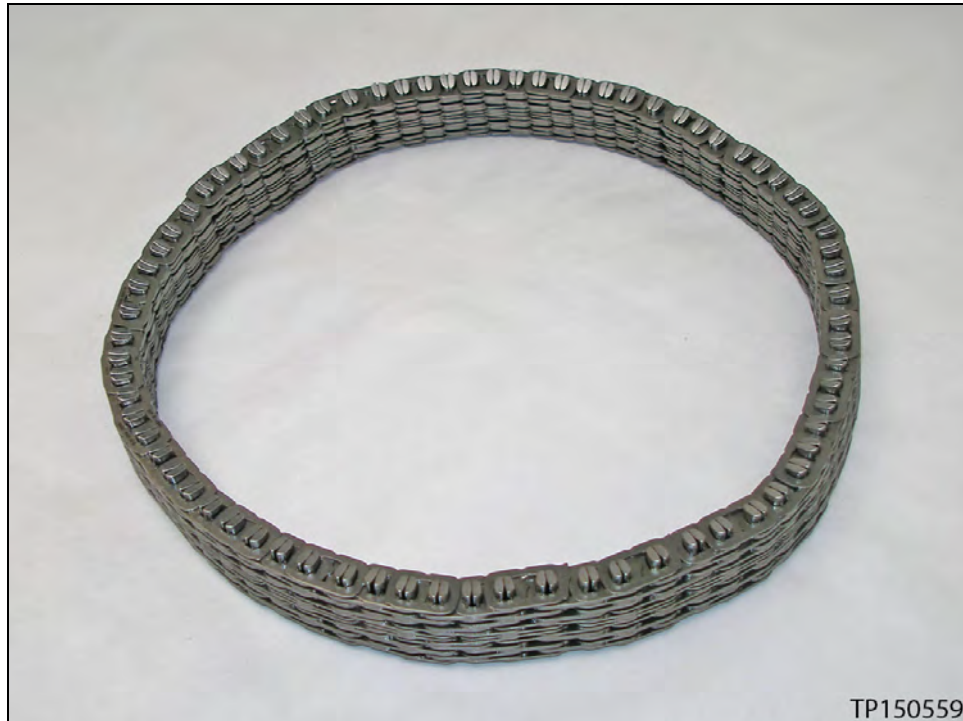
Figure 14: CVT chain

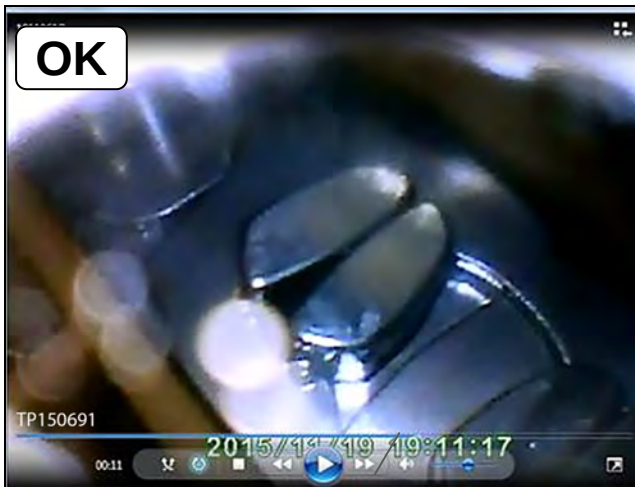
Pictures in Figure 16 and 17 were taken with borescope J-51951.

**NOTE:** Reference the pictures on page 13-15 for comparison.
