Preliminary Information

PIT5677E SES MIL / No Start / No Crank / Runs Rough / Reduced Engine Power / VSS / DTCs (Inspect Engine Harness)

Models

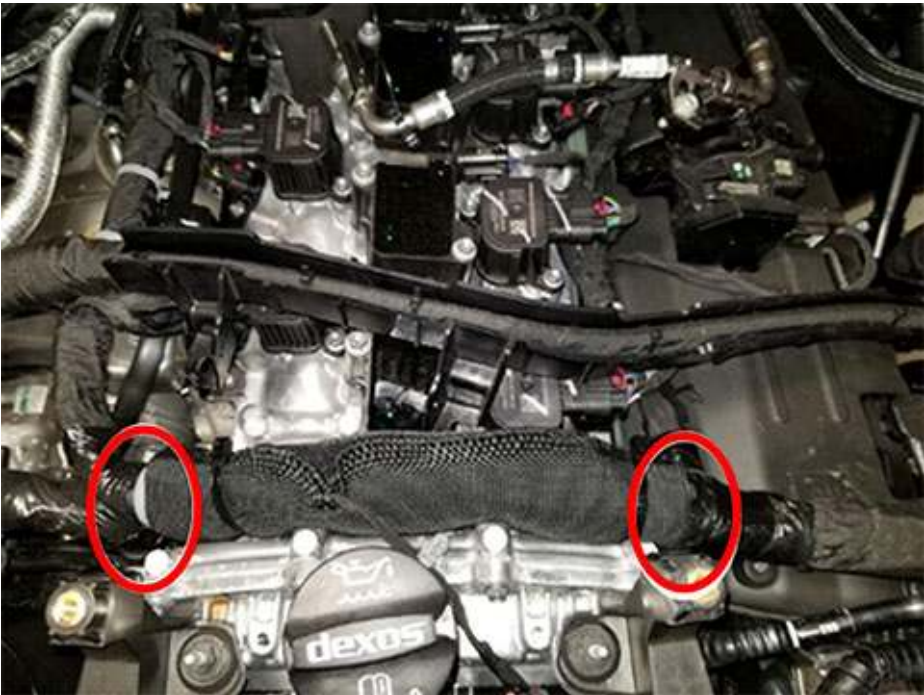
Inspect the engine harness as it crosses over top of the Camshaft Carrier Cover.

Harness damage can occur at any point across the Camshaft Carrier Cover.

Typical inspection locations shown below.

If engine wiring harness contact is isolated during inspection, use a seam ripper type tool to carefully inspect for internal wiring damage.

If found, repair the damaged wiring following the SI wire to wire repair procedures.

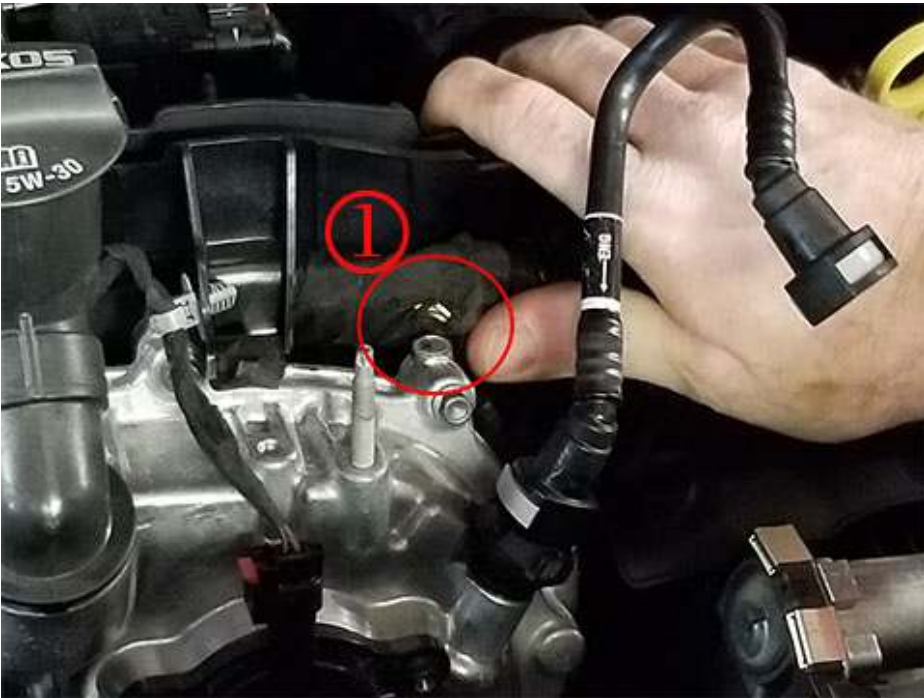
**Example of engine wiring harness damage at Camshaft Carrier Cover shown below.**

Protect the engine wiring harness from future damage at the top of the Camshaft Carrier Cover in the area shown below (1).

Install Kevlar Velcro Sleeve PN 84826758 and tape both ends with Woven Polyester (PET) Electrical/Anti-Abrasive Tape using KENT® AUTOMOTIVE 1089482 to secure in place.

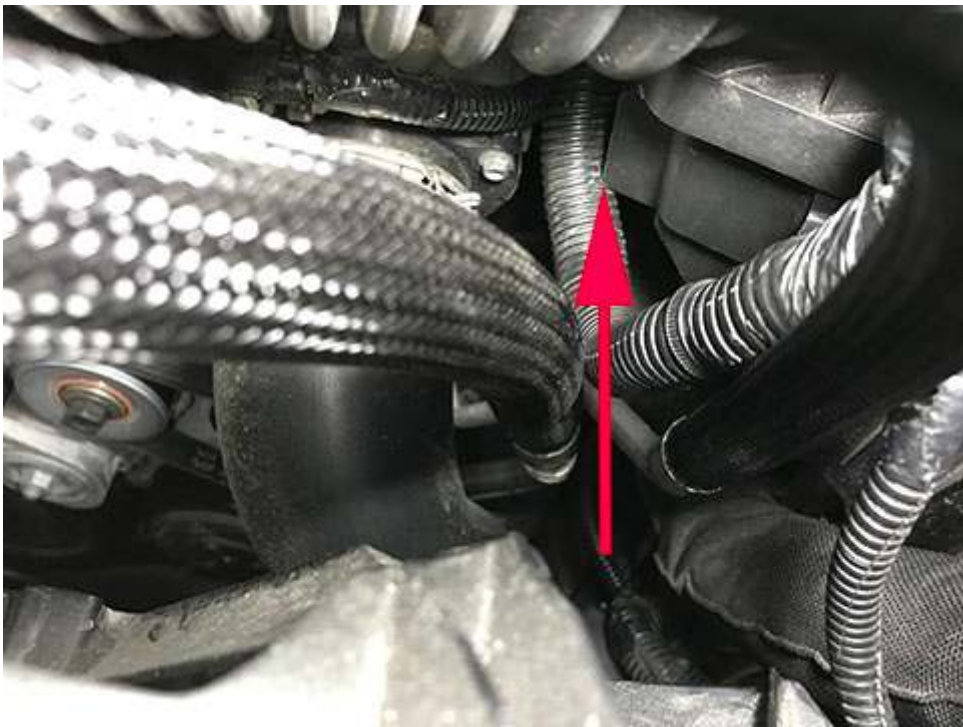
**Inspect the engine harness at the Lower Air Cleaner Housing as shown below.**

Example of engine harness damage, Lower Air Cleaner Housing removed shown below.

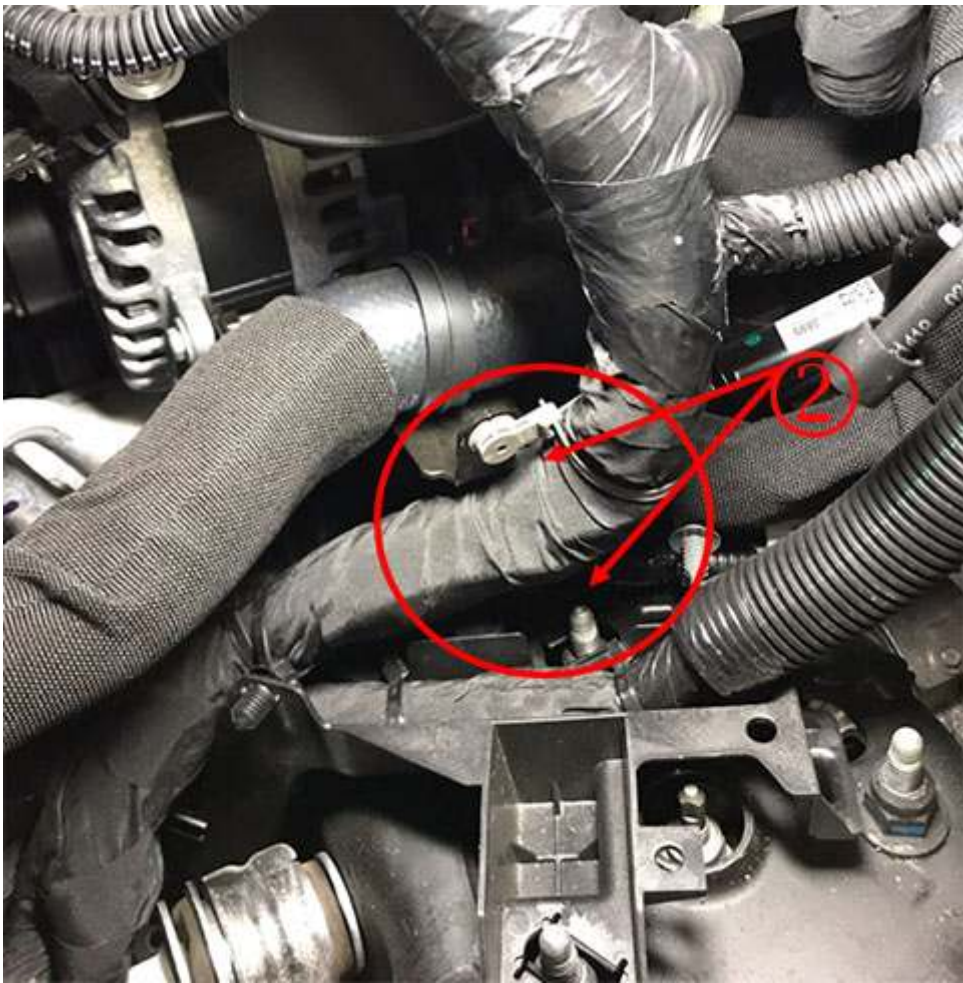
Inspect the engine harness at the Generator Bracket and Left Front Coil Spring stud as shown below.

**Note:** Under normal driving conditions, the engine will rock back and forth in its mounts.

This may result in harness contact with this bracket that may not be present during engine off inspections.

Careful visual inspections are necessary to isolate areas of contact.

It may be necessary to disconnect several engine harness connections to reposition the harness for inspections.

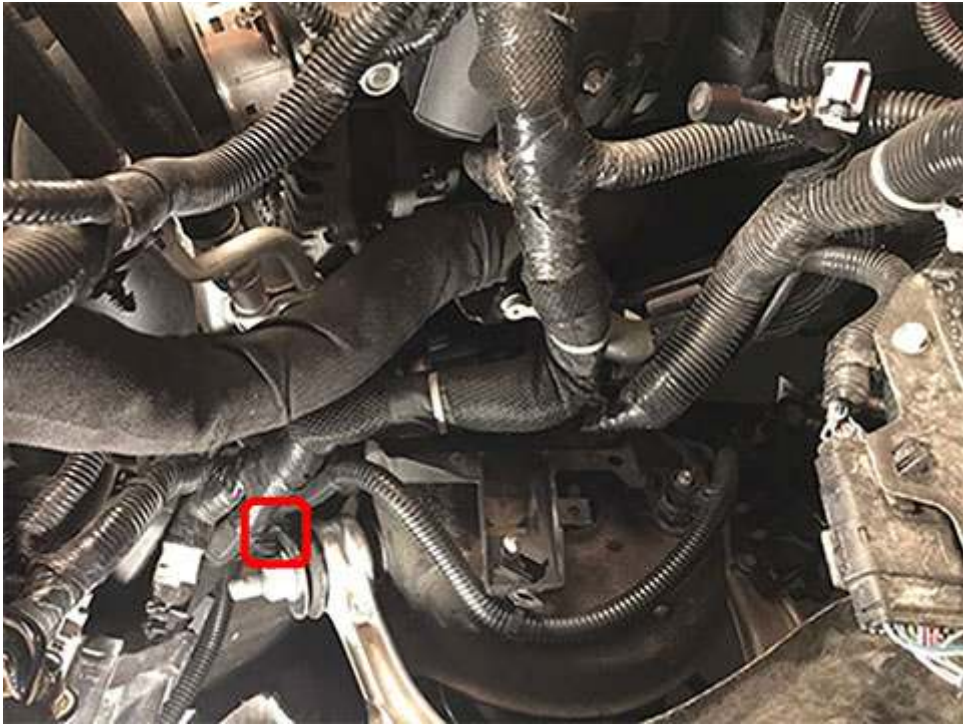
Inspect the engine harness at the Left Front Upper Control Arm Bushing as shown below.

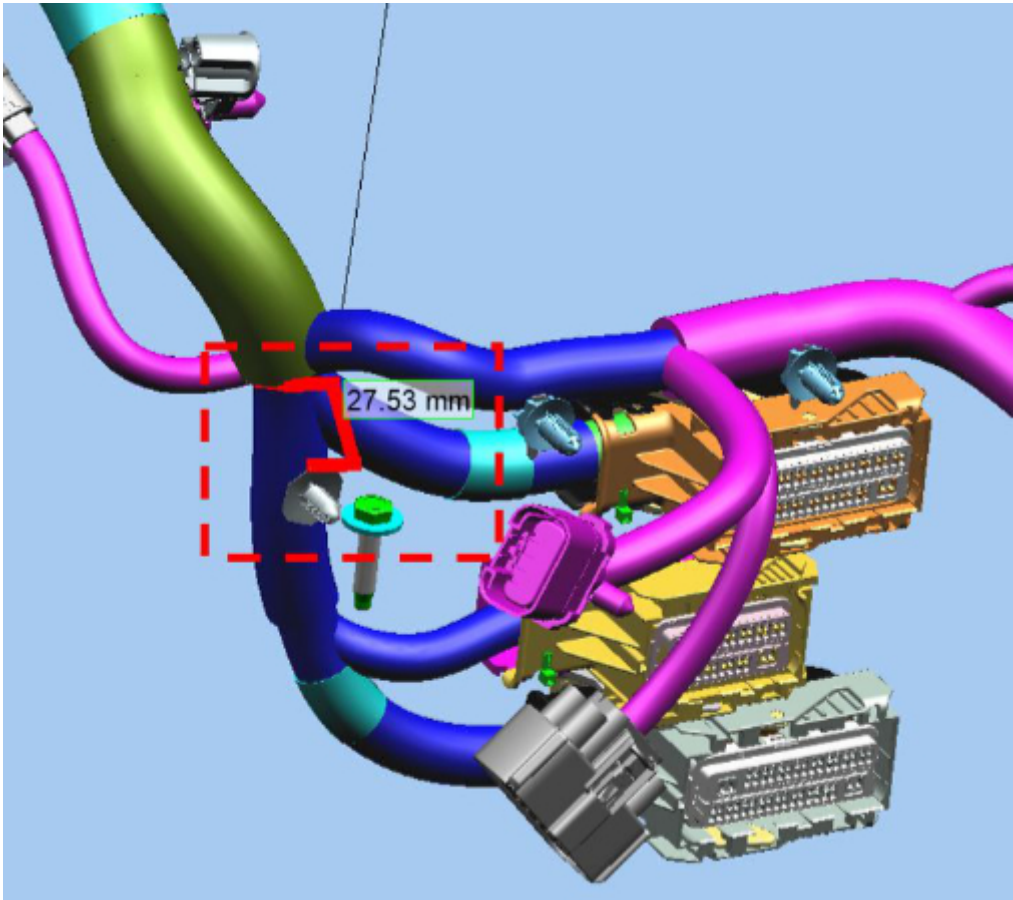
Protect the engine wiring harness from future damage at the ECM Bracket.

Install a Zip Tie Fir Tree Clip GM PN 84659133 or 84677081, 28 millimeters below the branch break out from above as shown below.

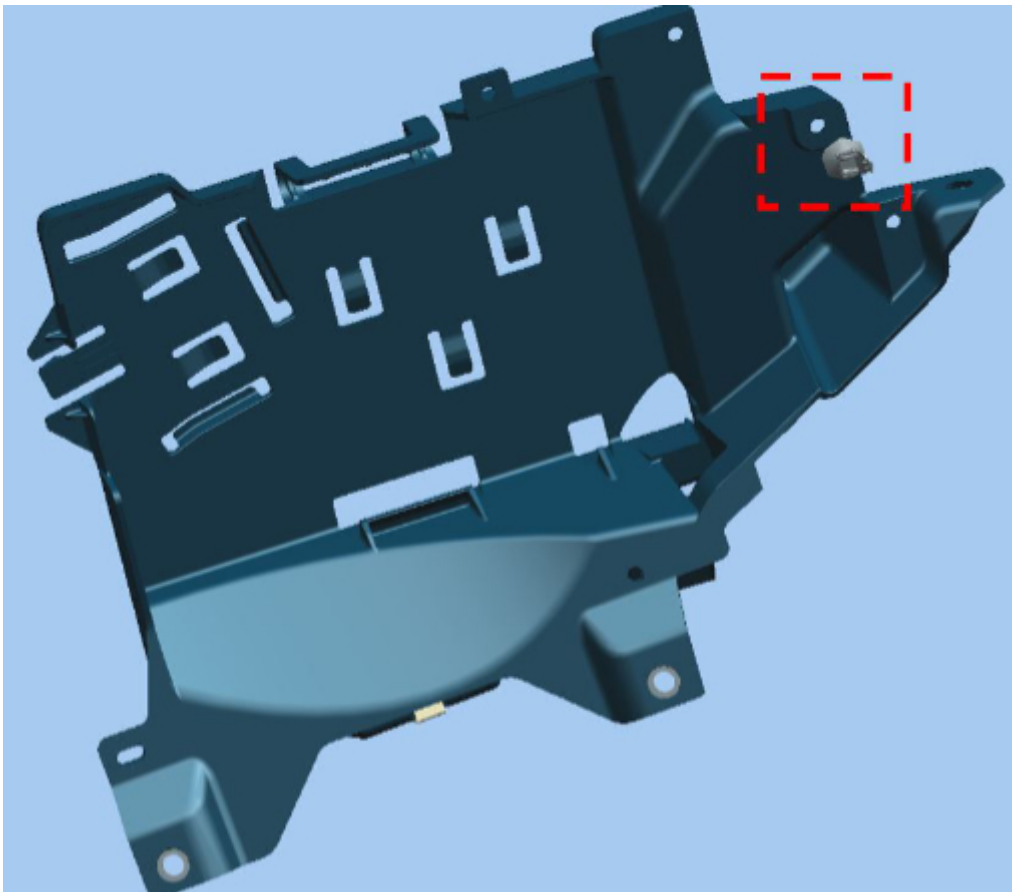
Insert the Zip Tie style Fir Tree Clip into the location shown below in the ECM Mounting Bracket.

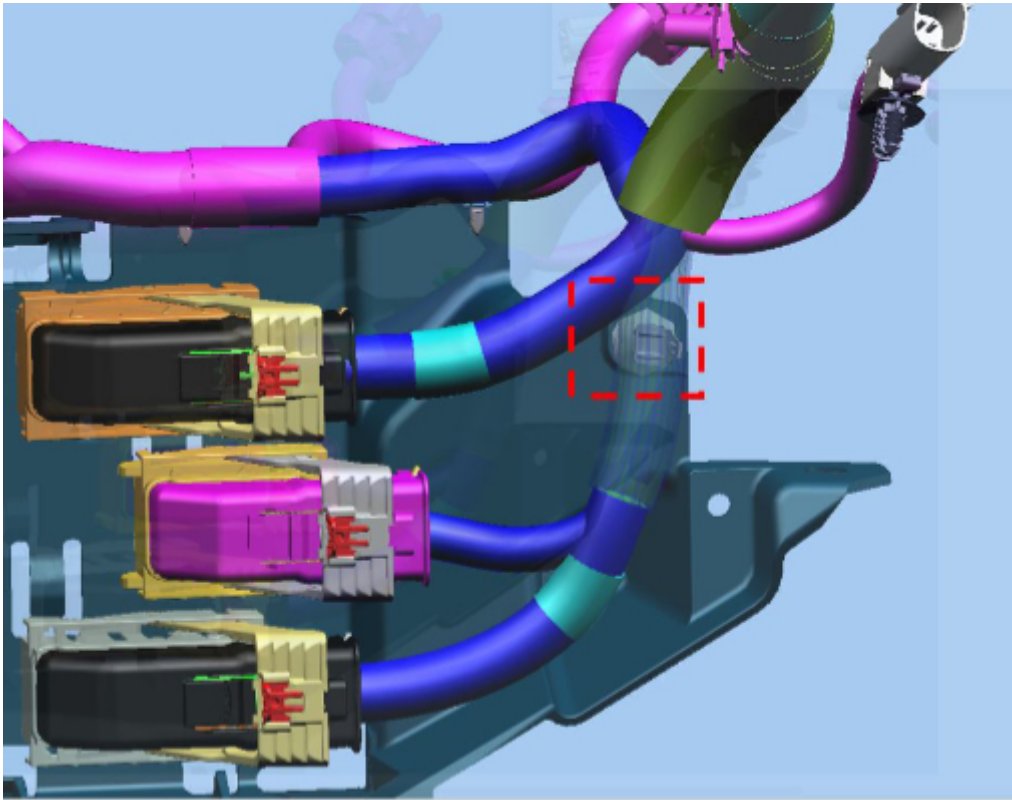
Zip Tie Fir Tree Clip installed securing the harness as show below.

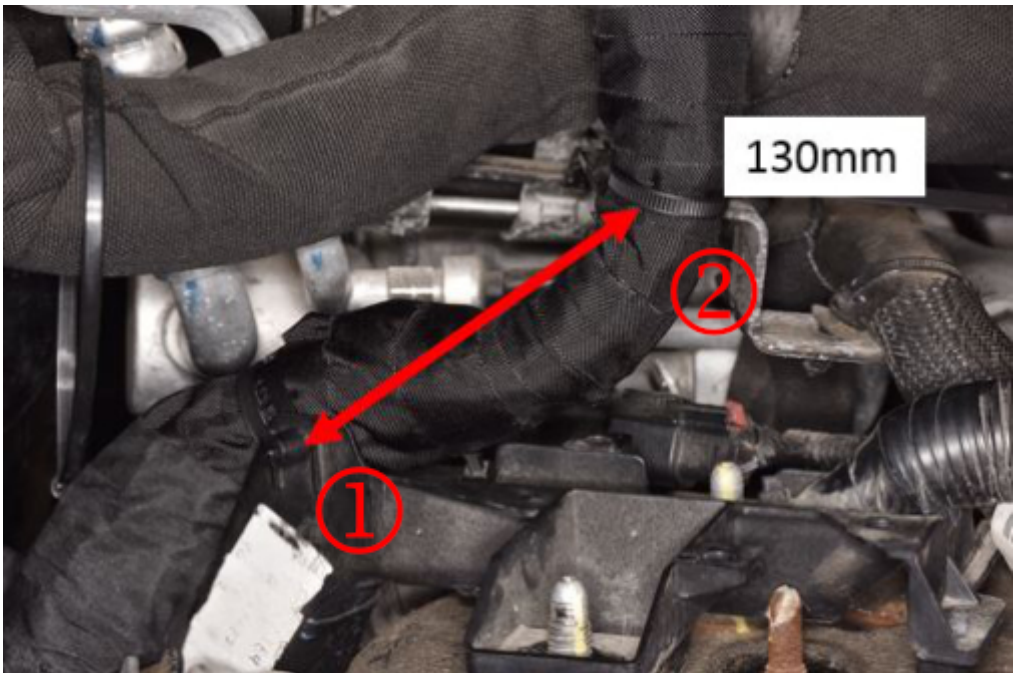
Protect the engine wiring harness from future damage at Generator Bracket.  
Zip Tie style Fir Tree Clips are located on the plastic Channel at #1 and on the Generator Bracket at #2 shown below.

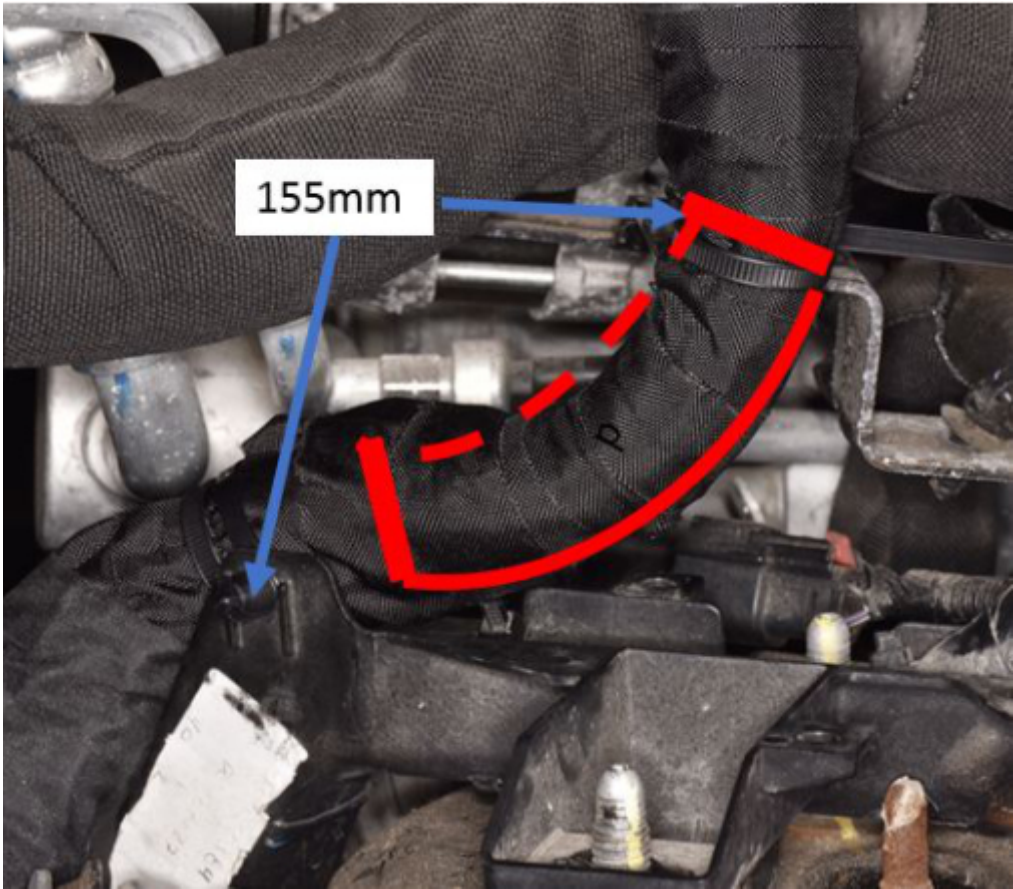
Measure up 155 mm from the Zip Tie style Fir Tree Clip located on the plastic Channel.

Install the Kevlar Velcro Sleeve PN 84820678 155 mm up the engine wiring harness as shown below to ensure that the sleeve extends 25mm above the Zip Tie style Fir Tree Clip located at the Generator Bracket as shown below.

Tape both ends of the Kevlar Velcro Sleeve with Woven Polyester (PET) Electrical/Anti-Abrasive Tape using KENT® AUTOMOTIVE 1089482 to secure in place.

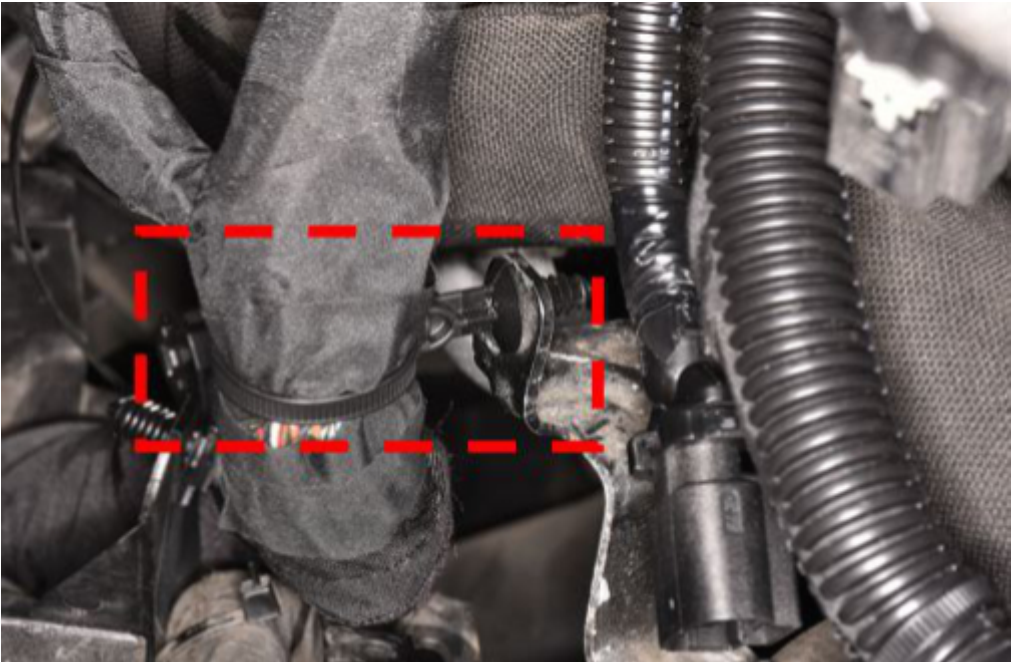
Install the updated Zip Tie style Fir Tree Clip GM PN 13596790 in the Genertor Bracket as shown below.
