## SERVICE BULLETIN

AT15-015c

### 2013-2016 ALTIMA AND 2014-2016 ROGUE; MIL ON WITH DTC P0776

The MIL is ON and ONLY DTC P0776 (PC SOLENOID B – Pressure Control Solenoid “B” Performance/Stuck OFF) is stored in the TCM.

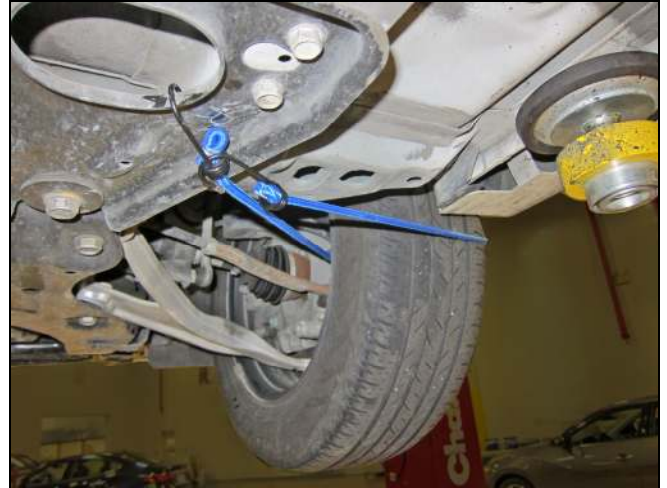
Figure 2

2. Secure the front right tire with a suitable strap.
  - This will assist in making the belt turn.
3. Mark the front left tire with a suitable marking.
  - This will assure all 360° of the belt is inspected.

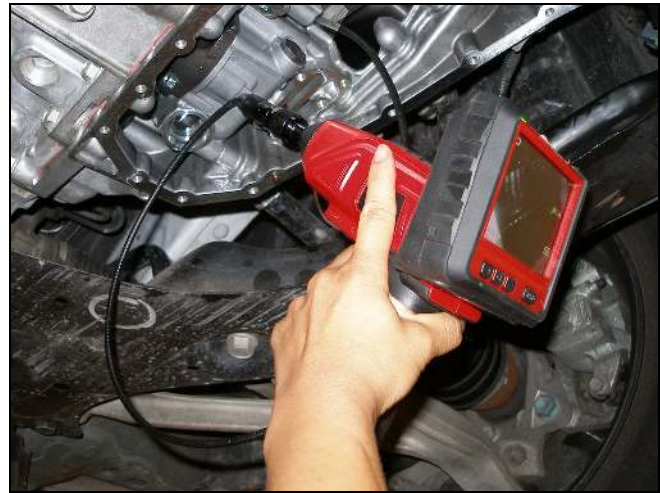
Figure 5

- Holding the borescope with one hand allows for turning the tire with the other hand (see Figure 5).

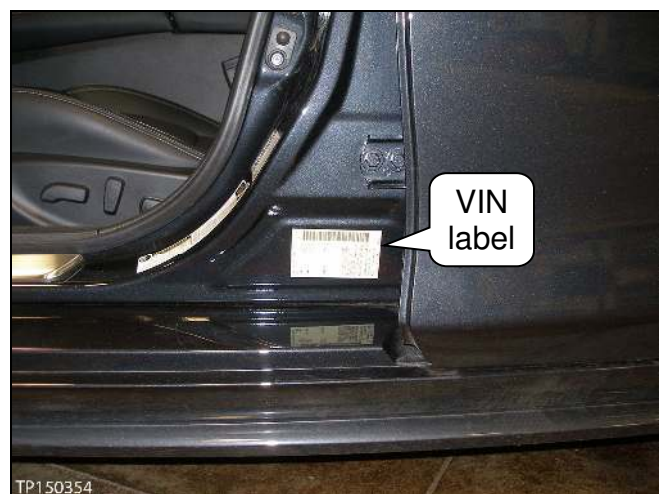
Figure 7

- e. Once CVT replacement is determined as required, use borescope J-51951 to record a 15 second or less continuous video of the most severe evidence of belt slip and the VIN on the F.M.V.S.S. certification label (VIN label). See Figure 7.

- Before starting to record, make sure the camera handle's AA batteries are fresh and the LCD monitor's battery is charged.
  - The whole video will show as backward, or reversed mirror image. This is okay.

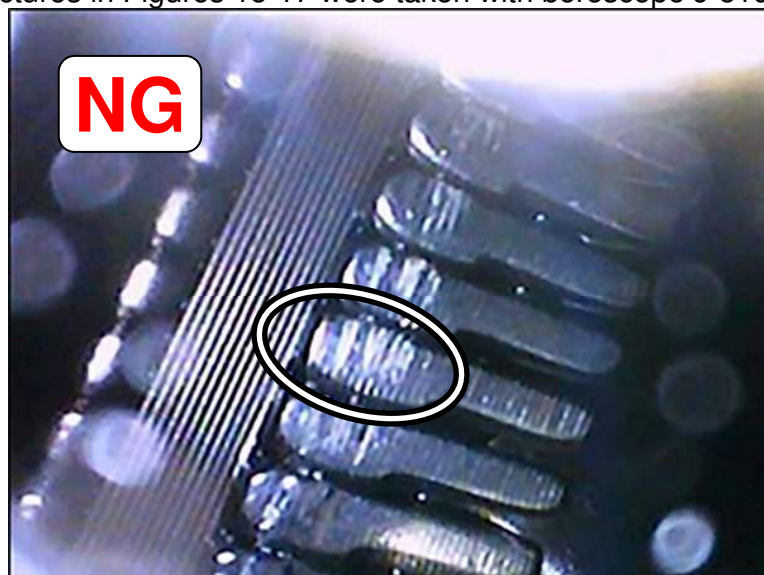
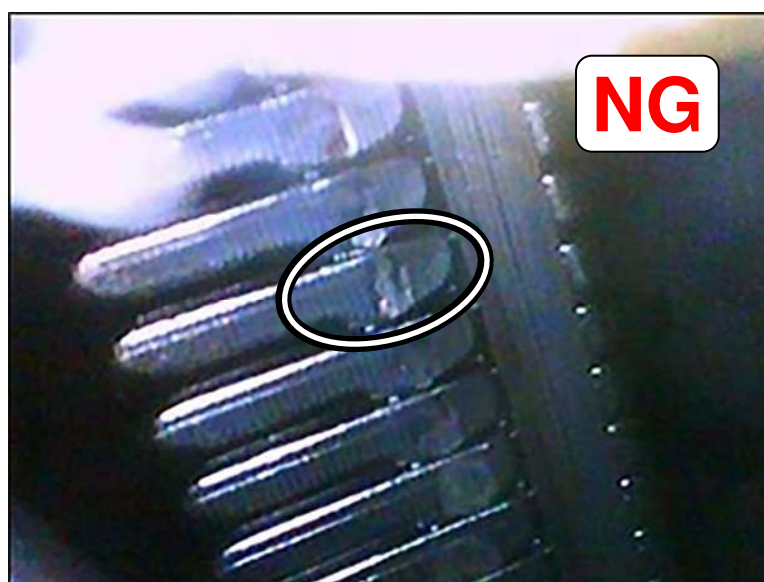
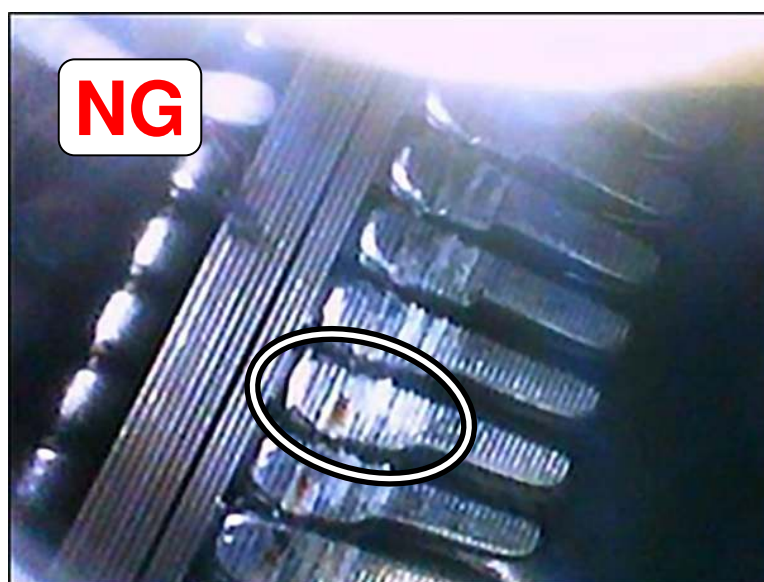
Pictures in Figures 15-17 were taken with borescope J-51951.

Figure 15: Example of NG belt

Figure 16: Example of NG belt

Figure 17: Example of NG belt

6. If the belt inspection result is NG, replace the CVT assembly.
- Get authorization to replace the CVT assembly (see page 19).
  - Make sure to perform step 4e on page 6.

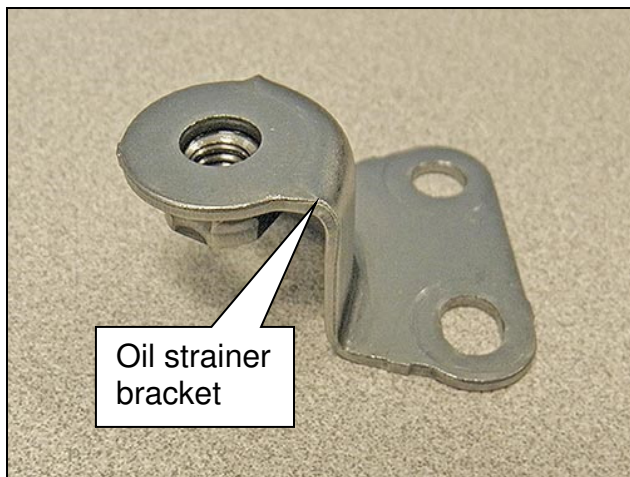
Figure 18

1. Discard the oil strainer bracket (Figure 18).
2. Install a new lip seal. Do NOT reuse the old lip seal (Figure 19).

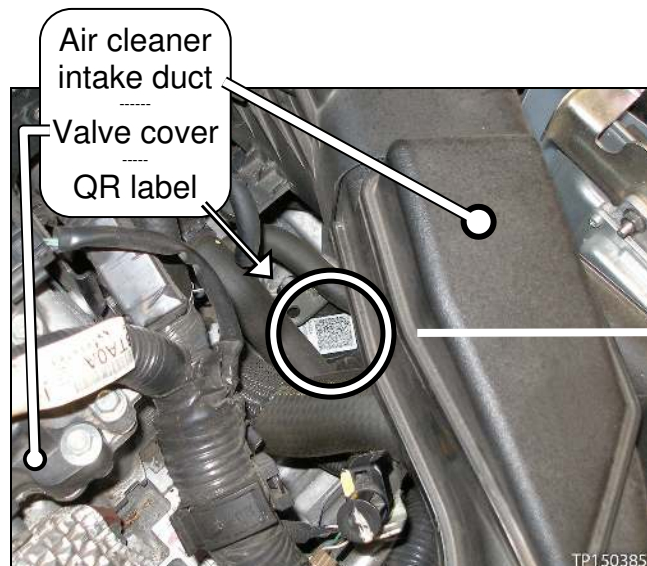
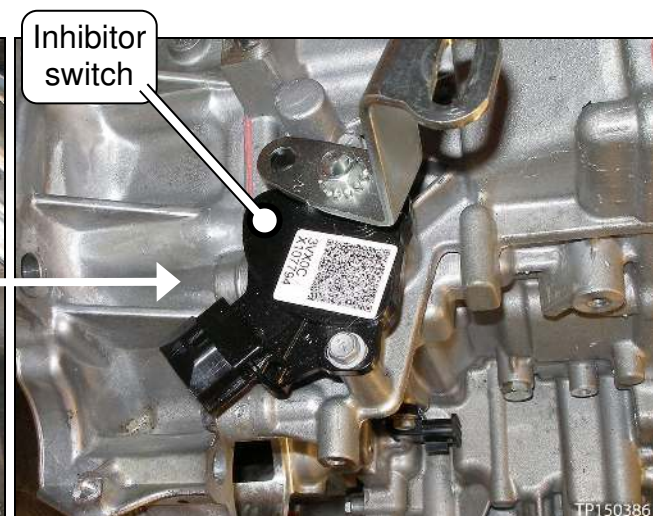
- Refer to **TM – Transaxle & Transmission / RE0F10D / BASIC INSPECTION**, and perform **ADDITIONAL SERVICE WHEN REPLACING TRANSAXLE ASSEMBLY**.
  - Check for fluid leakage.
  - Attach the QR label with the new calibration data onto the transmission range switch (inhibitor switch).
    - See Figure 27 and 28 below.
    - A QR Label and CD-R are included with the replacement valve body.
