NUMBER  
PI2002Y/Z (Rev 1, 06/15/2021)

### ENGINE REPLACEMENT INSTRUCTIONS FOR DTC P1326 (PI2002Y/Z)

This bulletin provides information related to the Technical Service Bulletin previously published in January 2021 (PI2002A and PI2002B, August 2020) titled "Knock Sensor Detection System - ECU Logic Improvement". Specifically, this bulletin provides instructions on which procedures to follow if, after installation of the KSDS, any one of the subject vehicles below return to the dealer with Diagnostic Trouble Code (DTC) P1326 (Knock Signal Range/Performance).

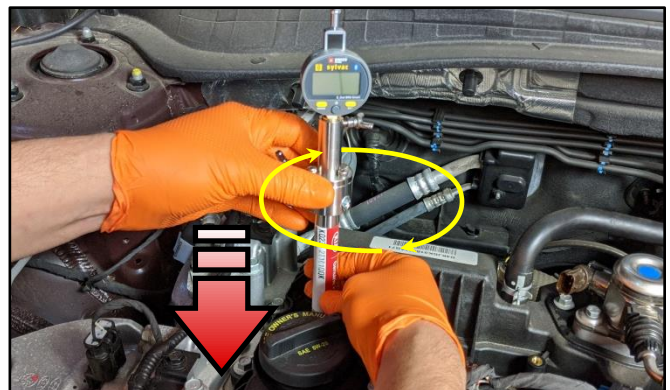
8. **Carefully**, insert the assembled SST Probe Rod and Dial Gauge into the Cylinder 1 spark plug hole and **carefully** turn the SST Crankshaft Rotator **by hand** clockwise until hand tight.

**Damage to cylinder head can occur if spark plug hole is cross-threaded. DO NOT use a wrench to tighten the SST rod.**

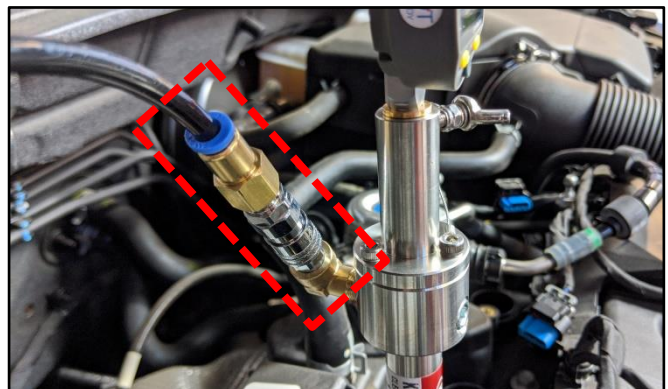
19. Carefully, insert and connect the other end of the Test Hose to the Probe Rod fitting.

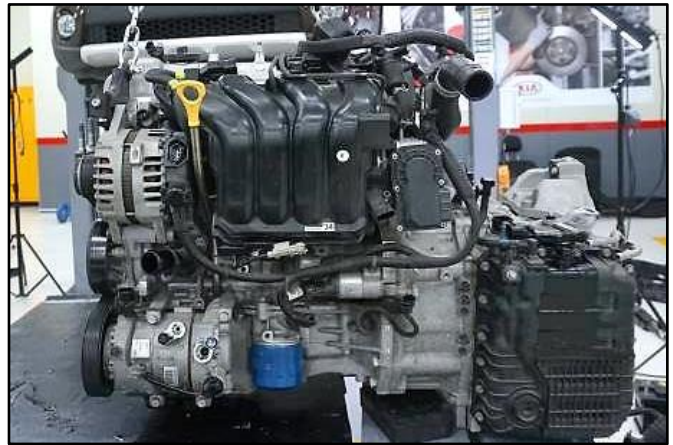
1. Remove the engine assembly by referring to the “Engine Mechanical System → Engine And Transmission (Transaxle) Assembly → Sub & Long Engine Assembly → Repair procedures” chapter in the applicable Shop Manual on KGIS.

**Note:** 1.6L Gamma Engine images shown for reference use only.

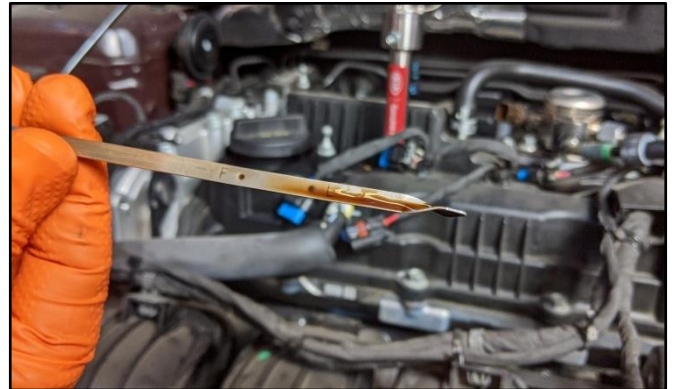
1. Measure and record oil dip stick level.
2. Note oil dip stick reading on the RO.

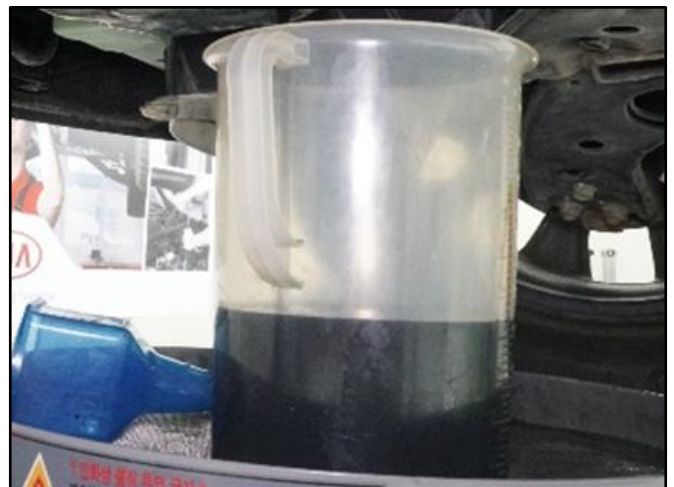
#### **Oil Level Measurement: (Flowchart C)**

1. Remove oil filler cap, remove oil drain plug and drain oil into the supplied measuring container SST067BUCK and check oil level.
2. Record oil level reading.
3. Take photo of the oil level using KDS.

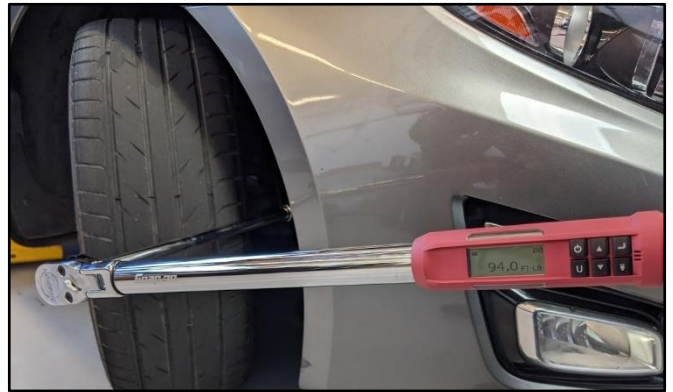
6. Show the engine being cranked and torque specification exceeding 94 lb.ft. torque.
