# HYUNDAI

## Technical Service Bulletin

| GROUP<br><b>CAMPAIGN</b> | NUMBER<br><b>21-01-035H</b> |

**SUBJECT:** AIR FILTER AND NVLD REPLACEMENT  
(SERVICE CAMPAIGN T6H)

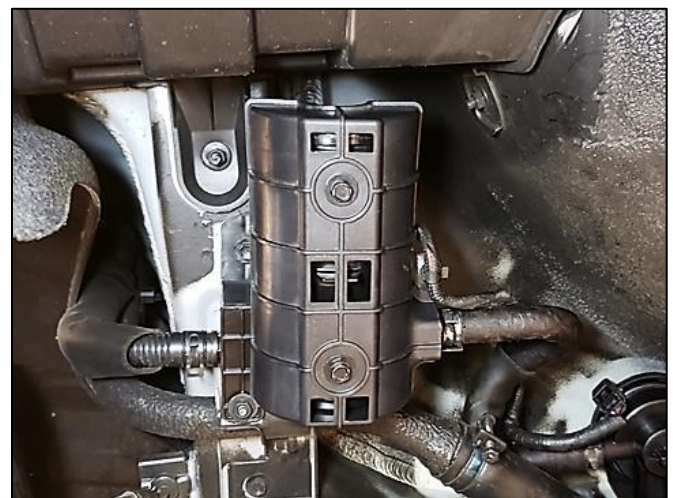
5.B Reinstall the air filter, CCV and removed parts in reverse order of removal.

**Fuel tank air filter installation bolt:**  
**2.3 ~ 3.3 N.m (0.2~0.3 kgf.m, 1.7 ~ 2.5 lb-ft)**
