| <b>Subject:</b><br><br><b>CHECK ENGINE LIGHT ON WITH P3400</b> | <b>Service Alert No.: SA-047/21</b> |
| | <b>Last Issued : 09/16/2021</b> |

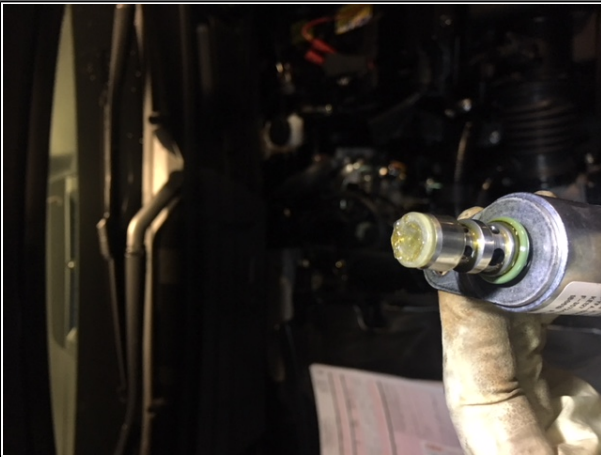
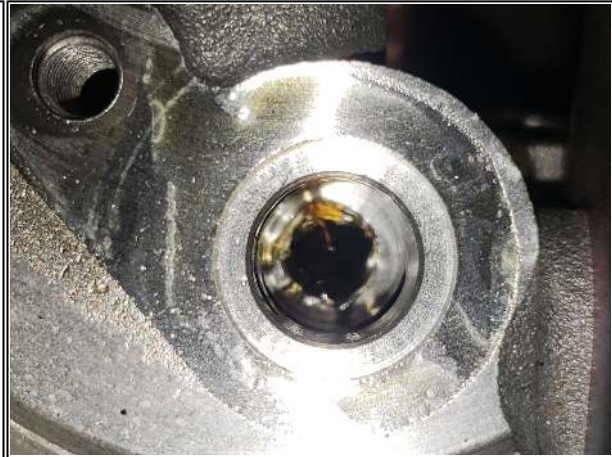
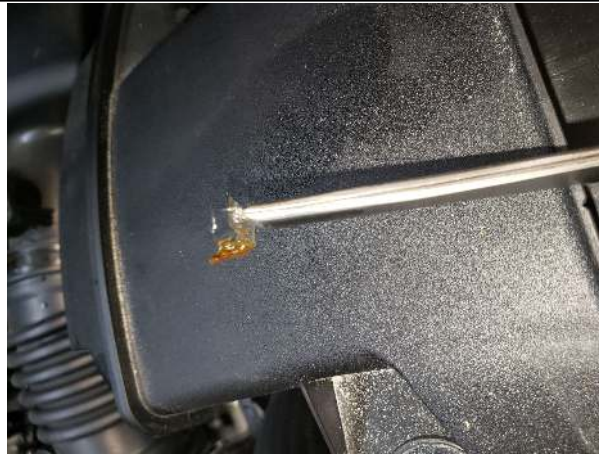
If you receive a customer concern about the CHECK ENGINE light coming on and DTC P3400 (cylinder deactivation system malfunction) stored, the cylinder deactivation oil control valve may be plugged with plastic debris from the oil filter wrapper. The debris may enter the center of the oil filter when poking a hole in the filter wrapper during removal, and then travel through the engine and plug the cylinder deactivation oil control valve.

1. Verify customer concern.
2. Remove the front and rear cylinder deactivation oil control valves and inspect the oil control valves and cylinder head port for contamination or debris (see photo).

- **YES:** Inspect the oil passage for debris and clear the passage if debris is found. A vacuum device such as a brake bleeder may be helpful in removing the debris.
  - If the OCV tip filter is damaged, replace the cylinder deactivation OCV.
- **NO:** Proceed with a normal diagnosis for DTC P3400 on MGSS.
