# Technical Service Bulletin

**35 Gearbox Malfunction warning on, DTC P17F900 with symptom code 22345 is stored in the TCM**

35 21 39 2064312/1 October 20, 2021.

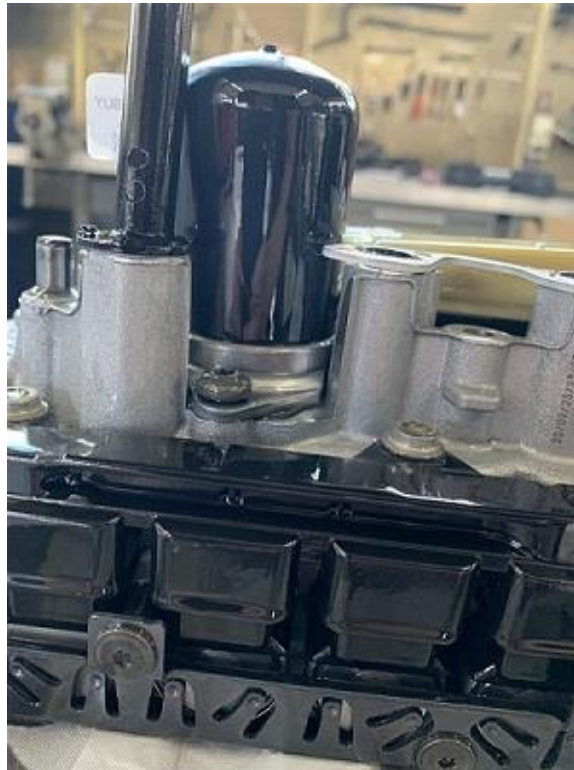
*Figure 4. Loose bolts.*

One or more bolts are loose (Figure 4).

You may also see the securing ring is not flush to the valve body which would mean the bolts are loose.

If the bolts are loose, replace pressure filter 2 along with the bolts as described in the Workshop Manual. Claim Option 1 in the Warranty Table below.

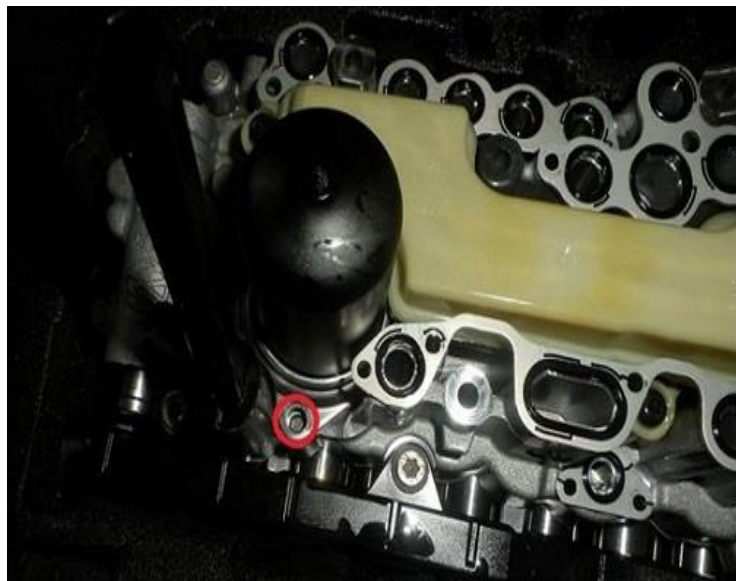
*Figure 5. Bolt head is missing.*

One or more Bolt heads are broken off or missing (Figure 5).

If any of the bolts are broken, replace the Valve Body and reuse the Transmission Control Module per the Elsa Repair Manual. (If no valve body is available for your vehicle replace the Mechatronics unit and note this on the repair order). Claim Option 2 in the Warranty Table below.
