**NUMBER:** 25-002-15 REV. B

**GROUP:** Emissions Control

P0455/P0456 Set In The Powertrain Control Module (PCM)

This bulletin involves replacing the evaporative emissions purge valve hose due to a split in the hose that will prevent the system from sealing.

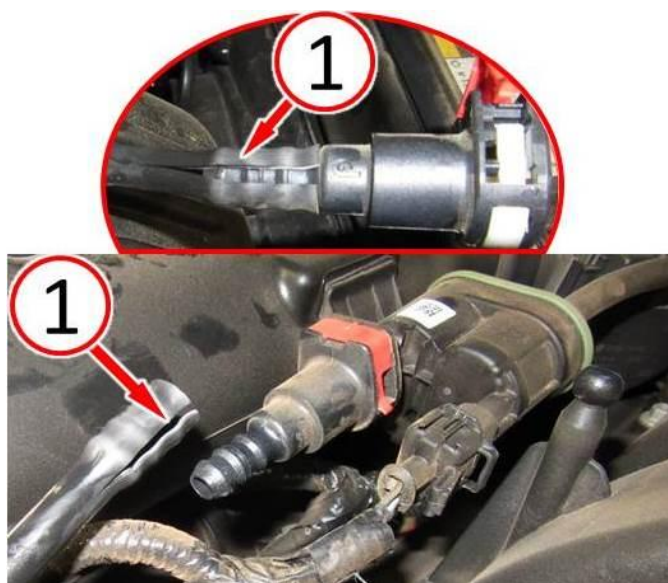
**Fig. 1 Split Purge Valve Hose**

1 - Split Purge Valve Hose

1. \*\*Is vehicle's VIN on the active RRT VIN list?
  - a. YES>>> Proceed to [Step #4](#).
  - b. NO>>> Continue with [Step #2](#).
2. Inspect the purge valve hose for any splits as shown in ([Fig. 1](#)).
3. Were any splits in the purge valve hose found?
  - a. YES>>> Proceed to [Step #4](#).
  - b. NO>>> This Bulletin does not apply. Normal diagnosis should be performed.\*\*

4. Replace the purge valve vapor hose with a new hose. Refer to the detailed service procedures available in DealerCONNECT> TechCONNECT under: Service Info> 25 - Emissions Control, Evaporative Emissions> Lines> Removal/Installation.
