**NUMBER:** 18-011-13

Flash: MIL Illumination P050B and/or Rattle/Clatter Sound on Cold Start-up

2011 - 2013      MK

Compass/Patriot

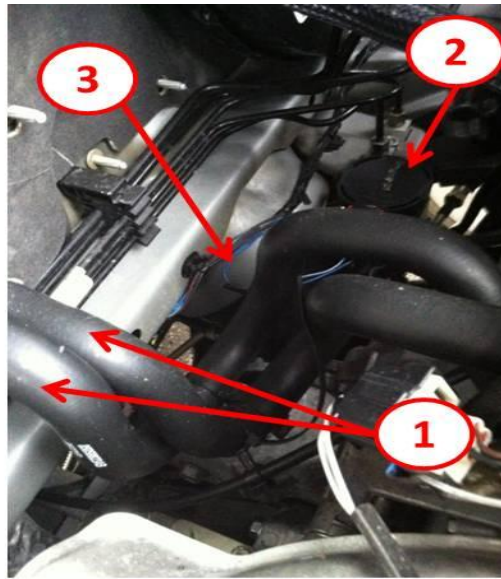
***Fig. 1 Purge Solenoid Wire Harness***

- 1 - Heater Core Supply and Return Hoses
- 2 - Purge Solenoid
- 3 - Purge solenoid Wire Harness

5. Without removing the pressure cap and with system not under pressure, turn draincock counterclockwise to open.
6. The coolant reserve bottle should empty first, then remove the pressure cap.
7. Allow cooling system to drain completely.
8. Remove both supply and return heater core hoses.
9. Install new heater core supply hose (p/n 05058822AB) and heater core return hose (p/n 05058823AB).
10. Install the right wheel inner splash shield.
11. Remove the engine cover.
12. To ensure that the purge solenoid wiring harness ([Fig. 1](#)) does not come in contact with the heater hoses, the wire harness will require a slight modification.

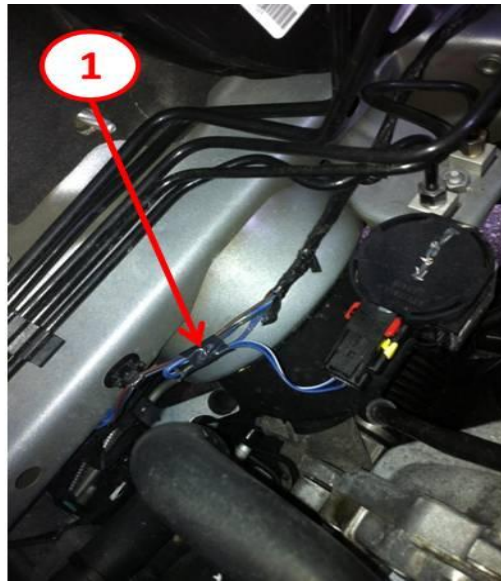
***Fig. 2 urge Solenoid Wire Harness Routing***

1 - Secured Purge Wire Harness

- 
13. Loosely pull the purge solenoid wire harness straight and create a bend in the harness approximately 10mm (0.40 in. or 3/8 - 7/16 in.) away from the harness retaining clip edge. This bend will also create a natural bend after the current spot tape on the harness. Then, apply 3 - 4 wraps of electrical tape securing the bend to the harness as shown in ([Fig. 2](#)).
