## SERVICE BULLETIN

**APPLICABILITY:** 2014-15MY XV Crosstrek Hybrid Electric Vehicle (HEV) **NUMBER:** 16-94-15R

**SUBJECT:** Diagnosis and Repair of DTCs P172A and P0B0B

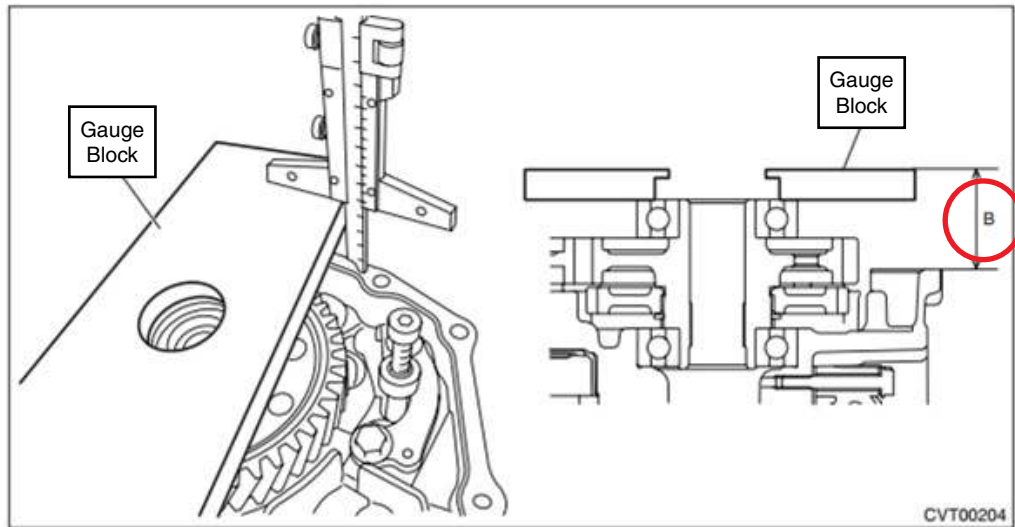
2) Measure the height "B" from the Gauge Block to the mating surface of the transmission case.

$$T \text{ (mm)} = A - B - (0.05 - 0.25)$$

B: Height from Gauge Block to transmission case mating surface

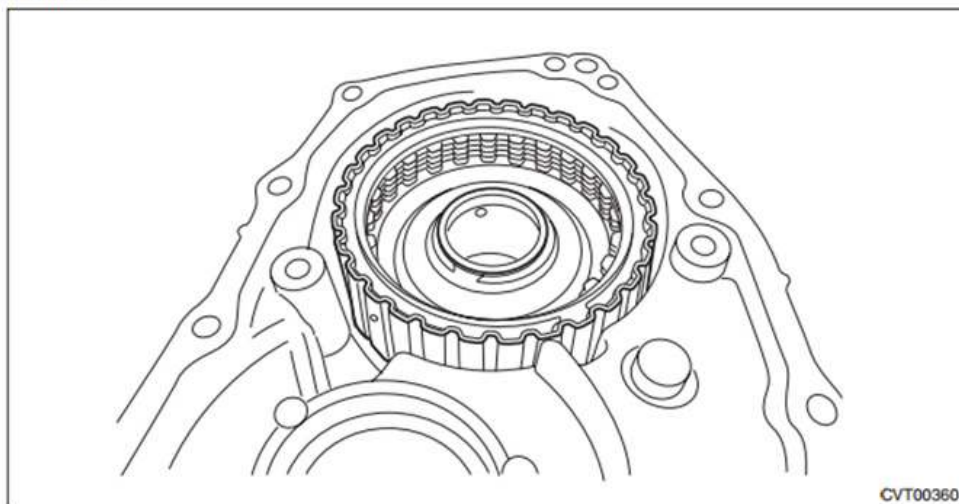
1) Install the transfer clutch assembly to the extension case with the transfer driven gear shims and thrust bearings removed.

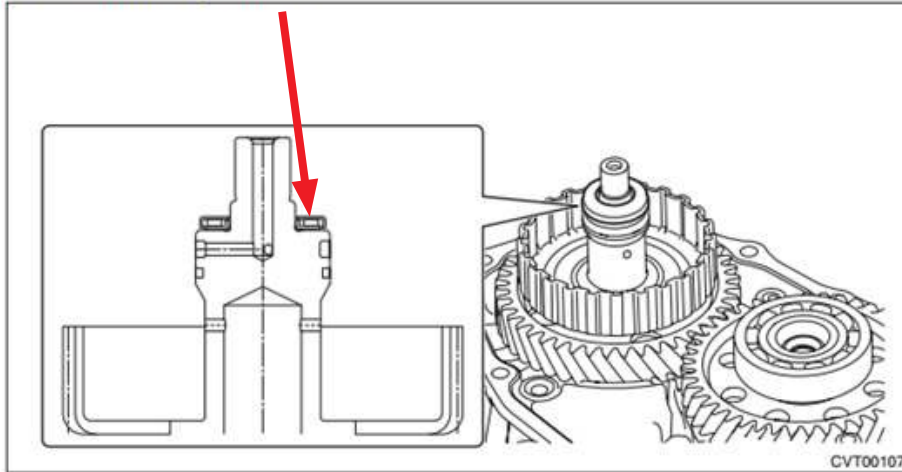
2) Install the thrust bearing to the transfer driven gear.

Make sure to install in the right direction.

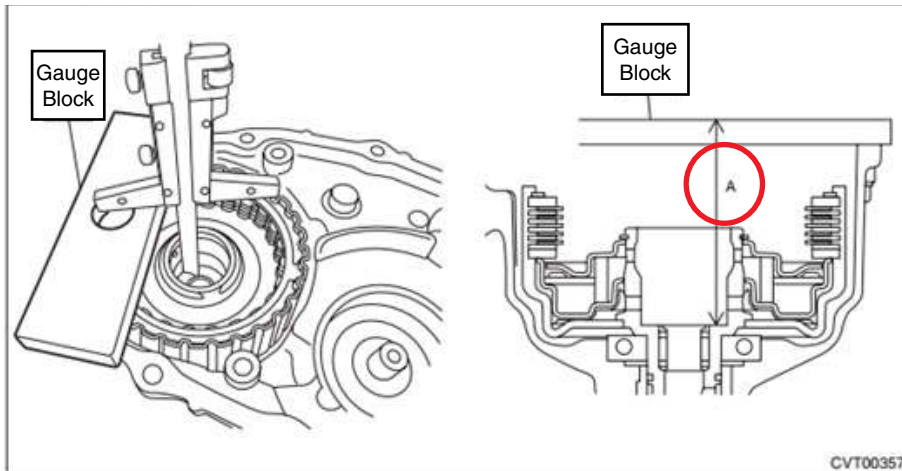
3) Using the Gauge Block, measure the height "A" from the ST end face to the thrust bearing catch surface of the transfer clutch assembly.

$$T \text{ (mm)} = A - B - (0.05 \text{ — } 0.25)$$

A: Height from the Gauge Block end face to the transfer clutch assembly thrust bearing catch surface

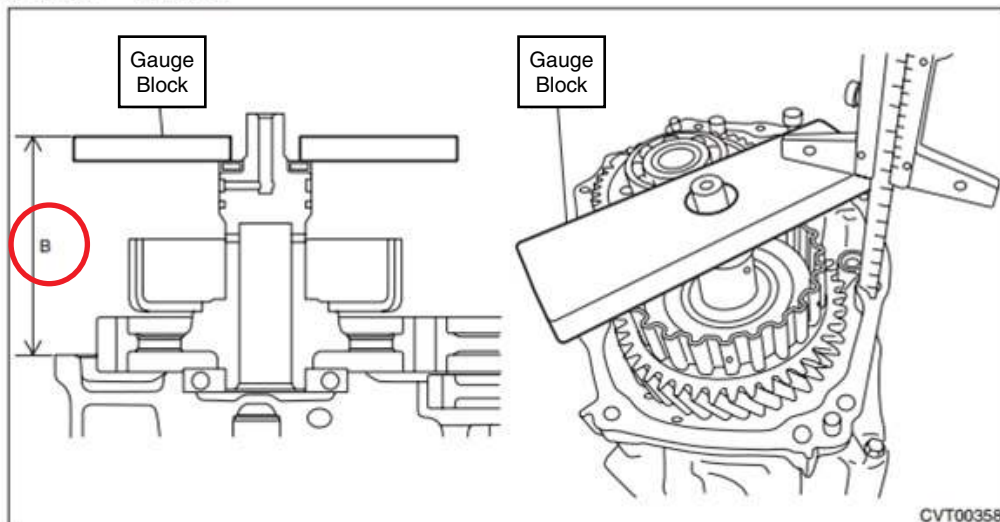
4) Using the Gauge Block, measure the height "B" from the transmission case mating surface to the end of the Gauge Block

B: Height from mating surface of the transmission case to the end of the Gauge Block

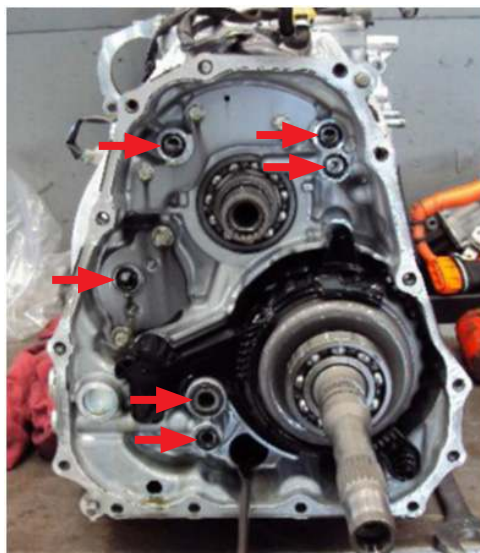
- Once proper spline alignment is confirmed, use some CVT fluid to hold the 6 o-rings in place between the cases during reassembly.

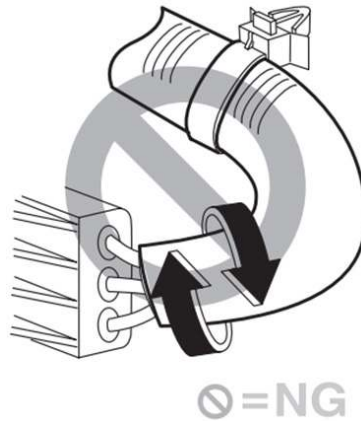
- Use the **GRAY** ThreeBond sealer (004403007) to seal the case assemblies and the **PINK** (K0877YA020) sealer for the small output clutch control valve body fluid pan.
- Torque the 14 case bolts to 18.4 ft. lbs.
- Never twist the electric oil pump harness more than 360 degrees to avoid damaging it.
