MODEL  
**2011-2016MY  
Optima Hybrid  
(TF HEV)**

NUMBER  
**PS515 (Rev 2, 02/28/2019)**

**SUBJECT:** DTC P1B25/P1B77 – 125 AMP HV FUSE INSPECTION

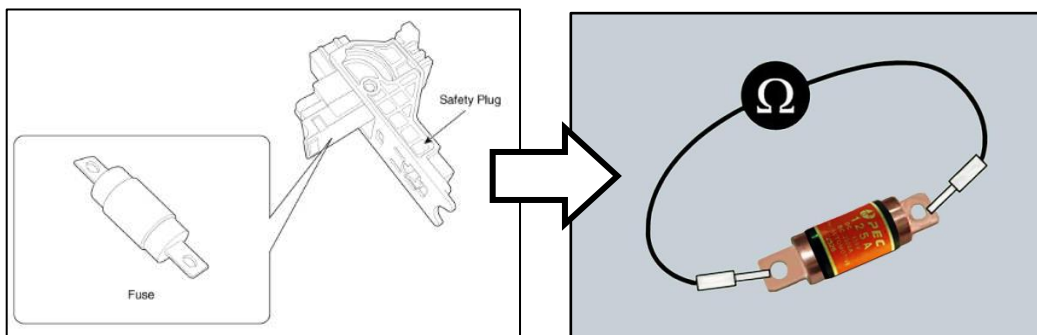
**Measure the resistance while tapping on the fuse (less than  $<1\Omega$  resistance).**

**Specification:**  $1\Omega$  or less ( $68^{\circ}\text{F}$ )

If the measured resistance is not within specification, or the P1B25 DTC is intermittent, replace the 125 Amp HV Battery Fuse with the newer 150 Amp HV battery fuse (part #375F2 4R150).
