# SRS Light ON - B1861 Open in Driver Side Knee Airbag Squib Circuit

Some 2006 – 2008 model year IS250 and IS350 and 2008 model year IS F vehicles may exhibit an SRS light ON condition with Diagnostic Trouble Code (DTC) B1861 (Open in Driver Side Knee Airbag Squib Circuit). Follow the Repair Procedure in this bulletin to address this condition.

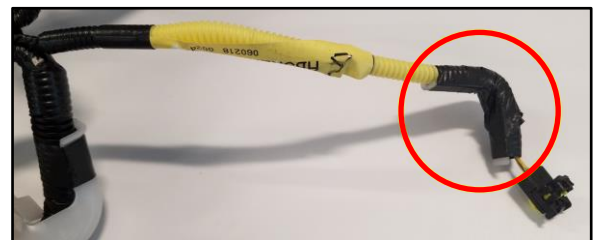
**Figure 1.**

- [2008](#) IS F:  
*Vehicle Interior – Supplemental Restraint Systems – “Supplemental Restraint System: Driver Side Knee Airbag Assembly: Removal”*
3. Cut and remove the tape around the white plastic 90° bend on the driver side knee airbag connector wire harness.

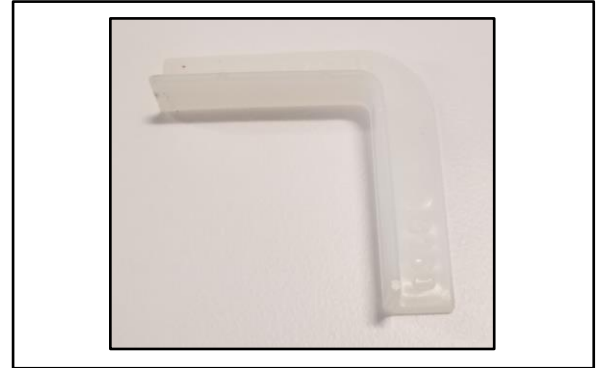
**Figure 2.**

4. Remove and save the white plastic 90° bend.

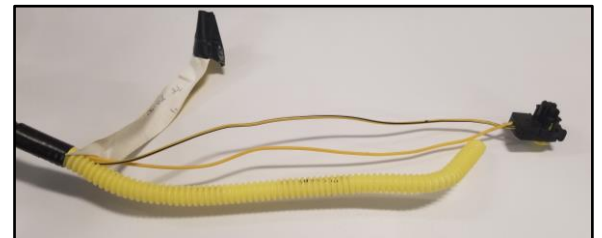
**Figure 3.**

5. Cut and remove the electrical tape along the corrugated tubing up to the middle of the wire harness label, leaving one side of the label attached to the corrugated tubing.
6. Pull the wires out of the corrugated tubing to expose the wires up to the attached side of the label.

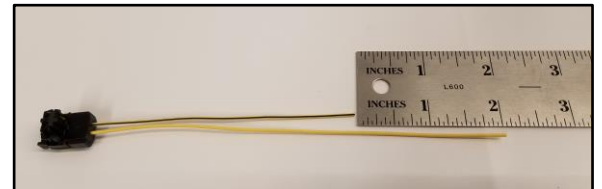
**Figure 4.**

7. Remove the electrical tape holding the two wires together.
8. Cut 2 in. off the yellow with black stripe wire on the wire instrument panel No. 4 replacement connector.

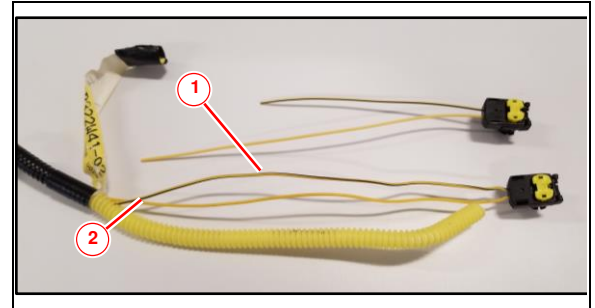
**Figure 5.**

9. Align the wire instrument panel No. 4 replacement connector with the existing wire harness connector.

| 1 | Cut Yellow With Black Stripe Wire Here |
| 2 | Cut Yellow Wire Here |

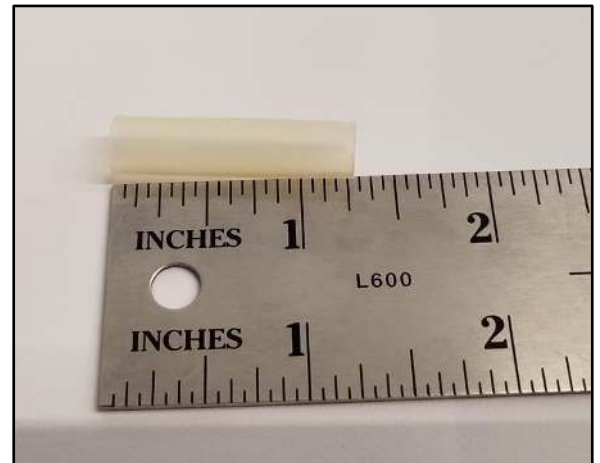
**Figure 6.**

10. Cut the existing wire harness wires to the same length as the wire instrument panel No. 4 wires (make sure each wire matches with the corresponding color wire).
11. Cut the two thermo tubing pieces to 1¼ in. each.

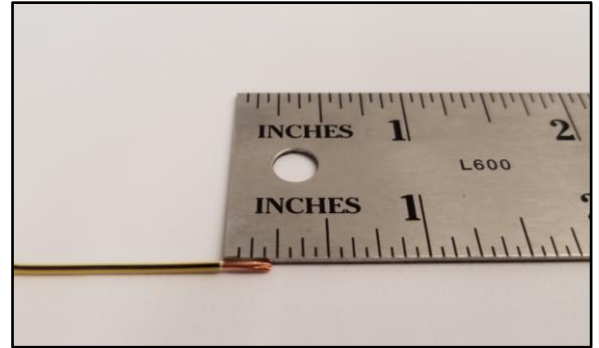
Figure 7.

12. Remove 8 mm (0.32 in.) of insulation from the two vehicle wire harness wires and the two wires on the wire instrument panel No. 4 replacement connector to prepare for crimping.

Do NOT remove more than 11 mm of insulation.

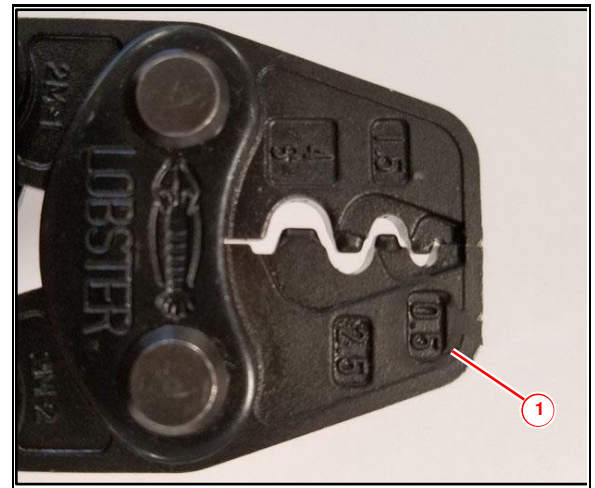
Figure 8.

13. Place the joint repair terminal sleeve into the 0.5 mm crimp die of the SST wire crimper.

The SST wire crimper 09929-00020-01 is the ONLY tool approved to perform this repair. Do NOT use any other tool to crimp the sleeve.

1 Joint Repair Terminal Sleeve Placement

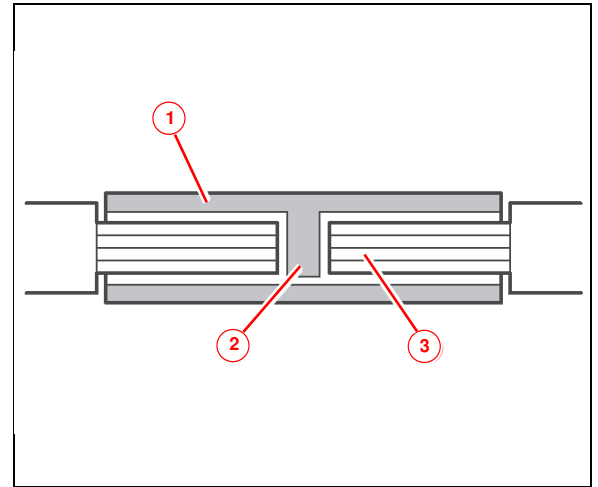
**Figure 9.**

14. Insert the wire instrument panel No. 4 replacement connector wire into the sleeve.

| 1 | Sleeve |
| 2 | Wire Stop |
| 3 | Wire |

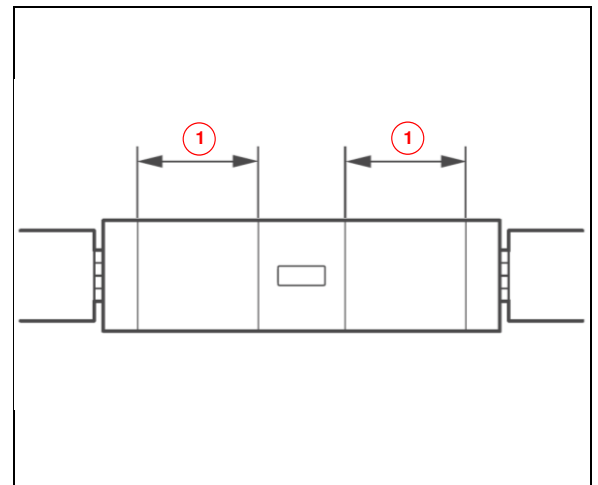
**Figure 10.**

15. With the joint repair terminal sleeve placed correctly into the SST wire crimper, crimp one side of the sleeve in the area shown by closing the handles until they release.

| 1 | Crimp This Portion |

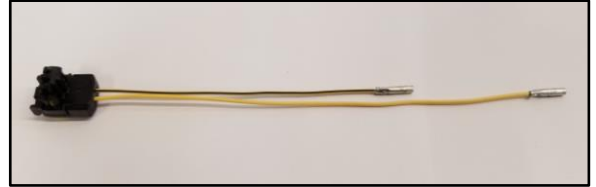
Figure 11.

16. Crimp a sleeve onto each of the wire instrument panel No. 4 replacement connector wires as shown.

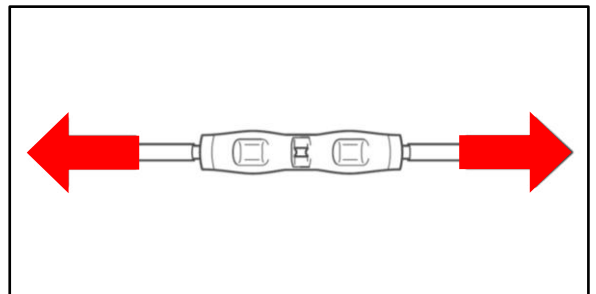
Figure 14.

19. Lightly tug on each connection to make sure the wire is securely crimped.

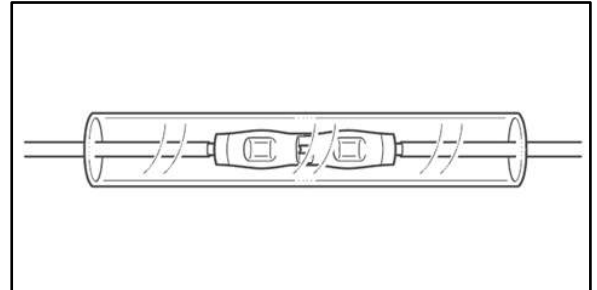
Figure 15.

20. Center the thermo tubing over the center of the sleeve.

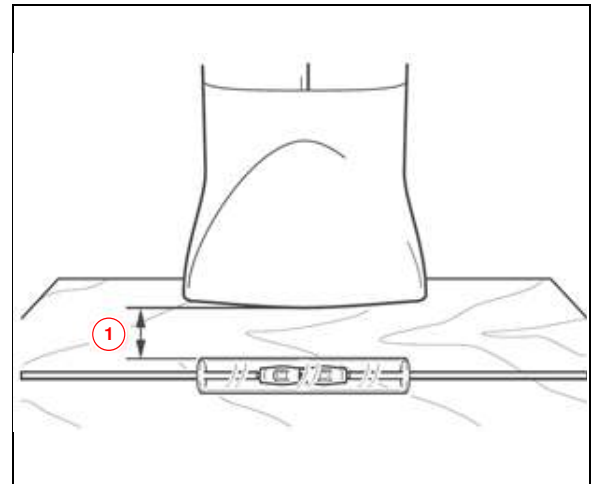
Figure 16.

21. Using a heat gun, heat the thermo tubing until it shrinks and seals the repaired connection.

- When using the heat gun, keep the heat gun about 10 mm (0.39 in.) from the thermo tubing.
- Protect the surrounding areas (i.e., interior panels and carpet) from heat damage.

1 10 mm

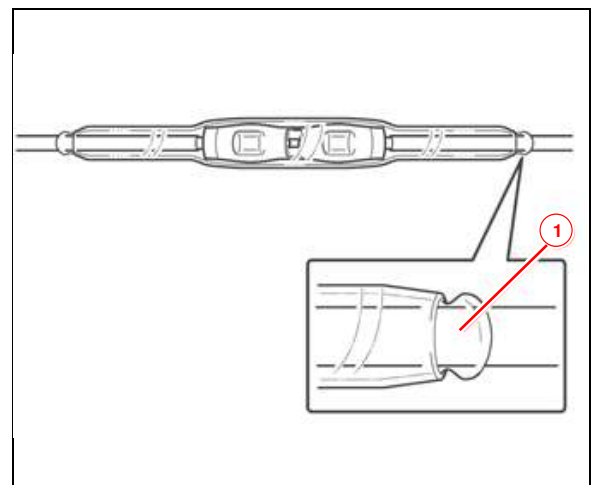
Figure 17.

During the sealing process, adhesive may seep from the thermo tubing. This is a normal condition and part of the sealing properties of the thermo tube.

1 Adhesive

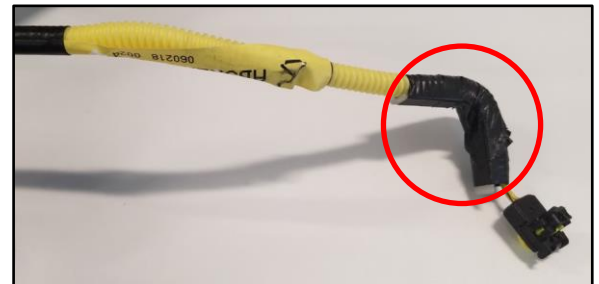
**Figure 18.**

22. Tape the wires together and reinstall the repaired wires in the corrugated tubing.
23. Tape the free end of the wire harness label with electrical tape.
24. Reinstall and tape the white plastic 90° bend.
