# Technical Service Bulletin

## 20 MIL on, DTC P045600 stored in the ECM

20 19 13 2035073/13 April 11, 2019. Supersedes Technical Service Bulletin Group 20 number 15-54 dated October 29, 2015 for reasons listed below.

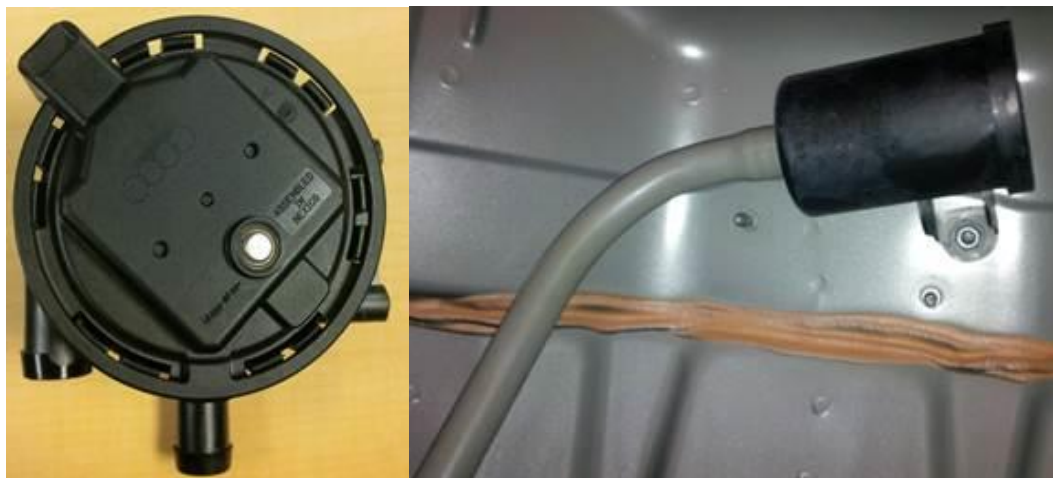
*Figure 1. NVLD pressure sensor (left) and NVLD filter (right).*

1. Ensure that **DTC P045600** (EVAP System Leak Detected NVLD (very small leak)) is stored in the engine control module (ECM), J623 (address word 0001). If **DTC P045600** is not present, this bulletin does not apply.
2. Replace the NVLD pressure sensor G400 and the NVLD filter with the latest part number available (Figure 1).

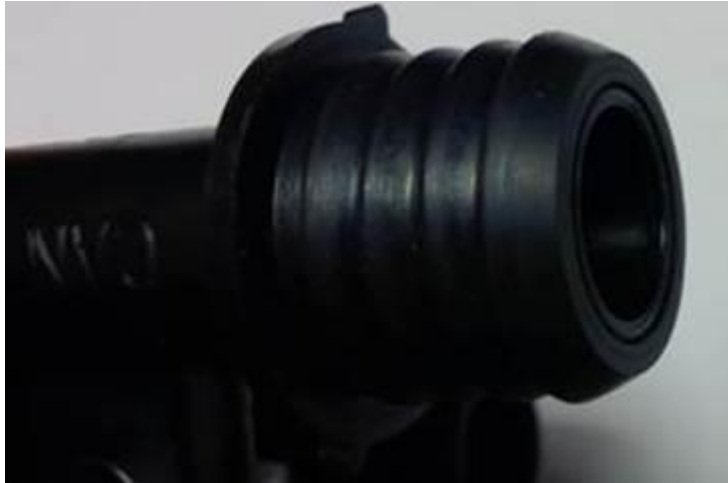
*Figure 2. Align the grommet and sensor outer edges.*

3. Align the grommet and sensor outer edges (Figure 2).

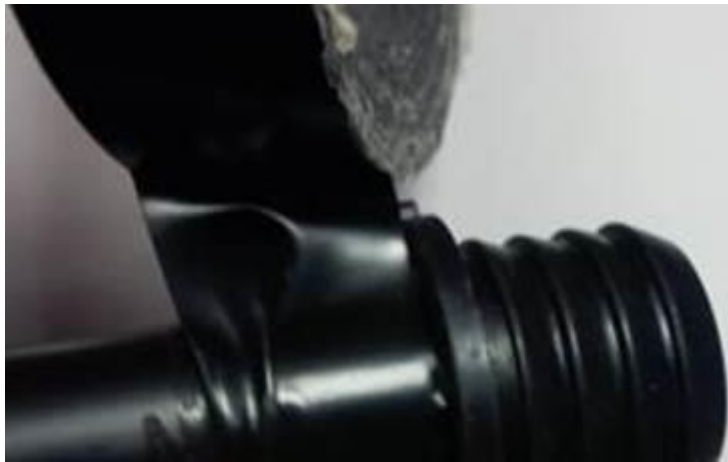
*Figure 3. Wrapping vinyl tape behind the grommet.*

4. To aid installation, wrap several (~10) layers of vinyl tape behind the grommet to ensure that it does not slip during installation (Figure 3 and Figure 4).

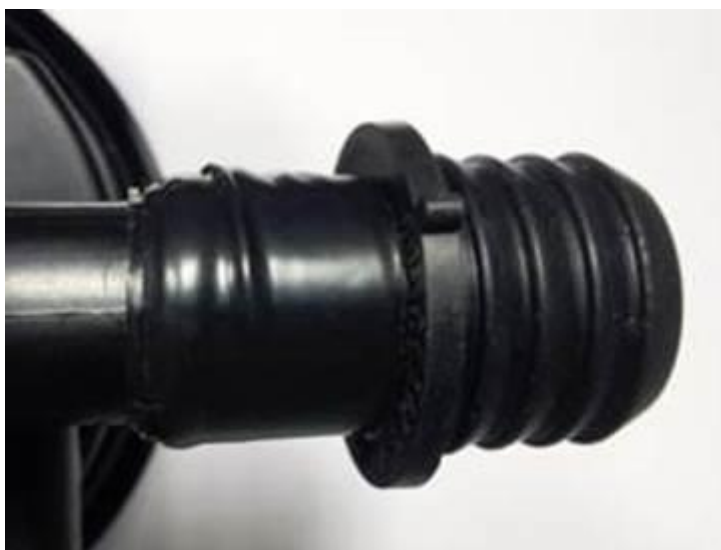
**Figure 4.** Vinyl layer supporting grommet.

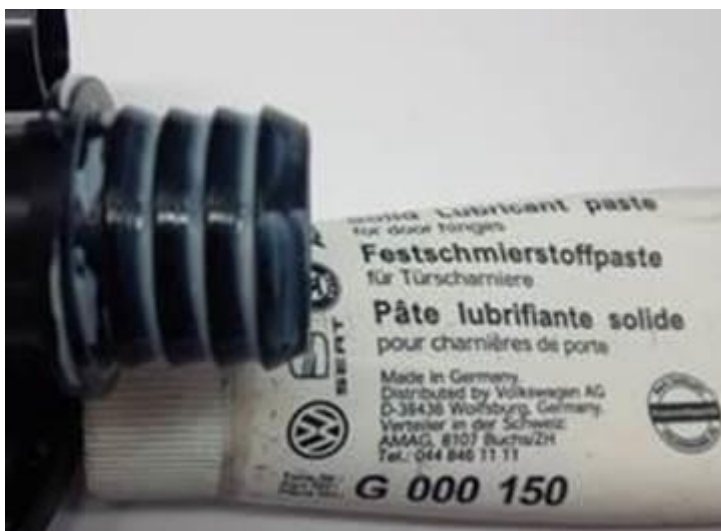
**Figure 5.** Grease film on the outer surface of the grommet.

5. Apply a small amount of grease to create a film on the outer surface of the grommet before installing the sensor (Figure 5).

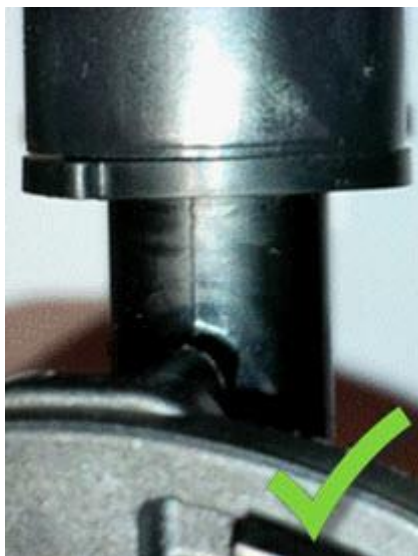
**Figure 6.** Correctly-installed sensor and grommet.

6. When the sensor and grommet have been correctly installed, the grommet and canister will be flush (Figure 6). At this point, the vinyl tape can be removed (or it can be left in place).

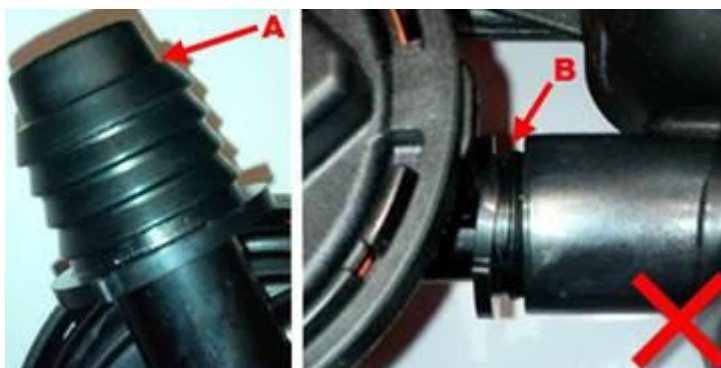
7. An incorrectly-installed sensor and grommet (Figure 7) can cause an EVAP leak and repeat failures. Issues can occur when the NVLD switch is pressed too far into the canister, then pulled back out in an attempt to align the NVLD switch with the mounting holes.

**Figure 7.** Plastic port extending past the grommet (A) causing installation issues (B).

Do not apply any lubricant between the sensor and the grommet.
