# Service Bulletin

Bulletin No.: 16-NA-111

**Subject:** Information on Malfunction Indicator Light (MIL) Illuminated, DTC P0420 and P0430 Set

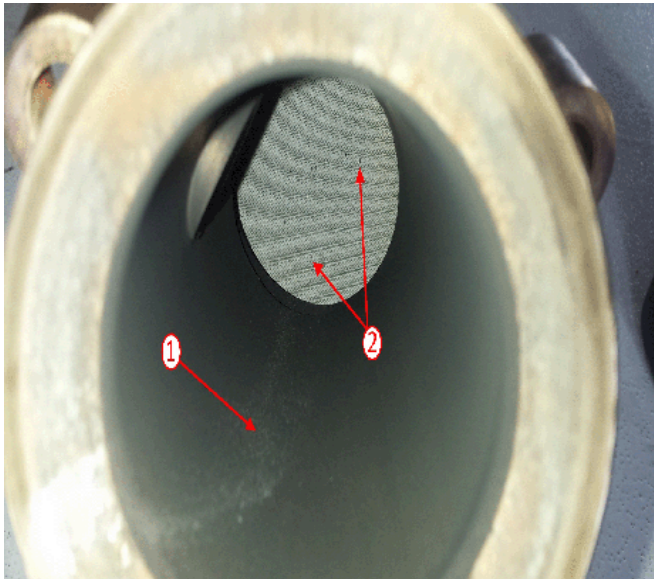
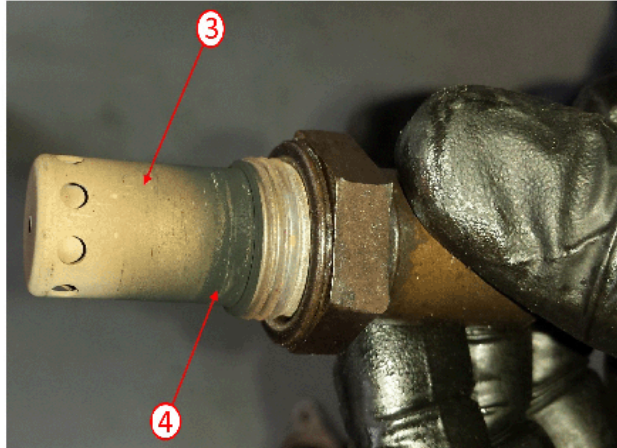
This may be caused by excessive sand and/or debris entering the air filter box and bypassing the seal of the air filter due to not properly sealing, causing damage to the HO2 sensor element (3) and the catalytic converter to become blocked with sand and debris particles (1, 2).

**Do not** replace any of the parts until the air filter housing has been validated to be completely sealed. If the condition is evident, inspection of the air box and air filter seal must be done. Follow the Service Procedure steps in order to verify the sealing of the air filter to housing surface. After validating the air box has been sealed, repair the P0420 and the P0430 codes **as needed**.

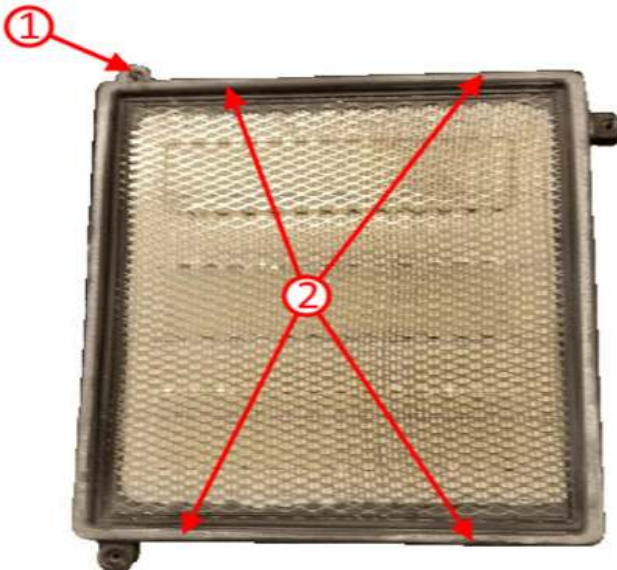
4484793

1. Inspect the air housing cover for any missing tabs and/or fasteners (1).
2. Remove the air filter housing cover and inspect the seal around the air filter (2).

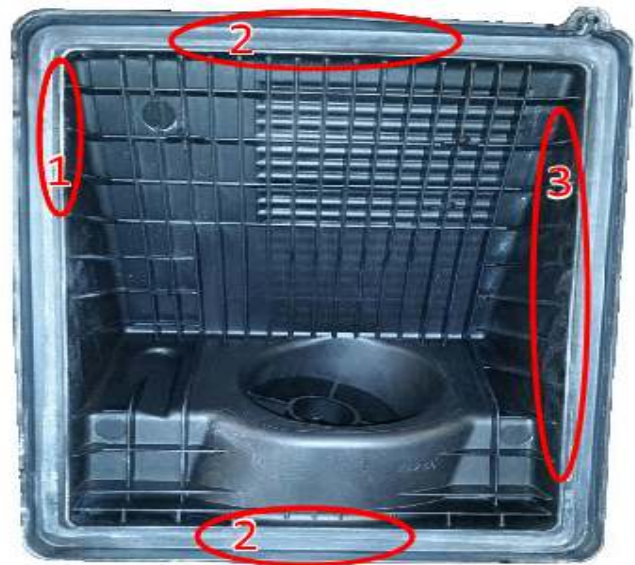
4484775

3. Inspect the air filter sealing surface for signs of not contacting the air filter seal (1, 2).

4. Inspect the air filter housing cover for dirt and/or debris bypassing the air filter (3).
5. Inspect the air cleaner outlet duct for any dirt and/or debris.
  - If dirt and debris has been found bypassing the air filter due to a faulty seal, replace the air filter as necessary.
  - If the air filter housing has been found not properly sealing, refer to *Air Cleaner Assembly Replacement* in SI.
