## LATEST VEHICLE CONCERN FIXES

| DPF Efficiency Below Threshold | 17-19MY RR, RRS, & All New Discovery 3.0L TDV6 |

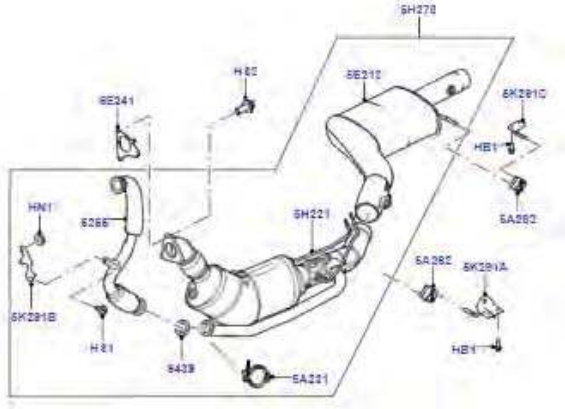
| DPF Efficiency Below Threshold | 17-19MY RR, RRS, & All New Discovery 3.0L TDV6 |
|---|---|
| <p><u>Customer Voice:</u></p> <ul style="list-style-type: none"><li>– Check Engine Light illuminated</li></ul> <p><u>Technical Description:</u></p> <ul style="list-style-type: none"><li>– P2002-00 for DPF Efficiency below threshold is stored in the PCM. This is usually not paired with any Red/Amber warnings for unsuccessful regeneration.</li></ul> <p><u>Status:</u></p> <ul style="list-style-type: none"><li>– Under Investigation</li><li>– Leak check the system and address any leaks. Diagnose all related exhaust codes that could affect DPF efficiency based on TOPIx guidance. If diagnosis leads you to replacement of the DPF, hold onto the part and raise an EPQR. Engineering requires parts for analysis to progress the project.</li></ul> | A technical diagram of the exhaust system for a 3.0L TDV6 engine. It shows the DPF (Diesel Particulate Filter) and various sensors and components. Labels include: SH270, SH241, H82, SH210, SH201C, HE1, SA282, SH221, SH201A, SA282, HE1, SA221, S439, H81, SH201B, and S286. The diagram is a 3D perspective view of the exhaust manifold, DPF, and tailpipe assembly. |
