# Service Alert

**CHECK ENGINE LIGHT COMES ON WHEN DRIVING WITH P3400  
STORED IN PCM**

**Service Alert No.:** SA-015/19

2018 Mazda6  
2018-2019 CX-5  
2019 Mazda3

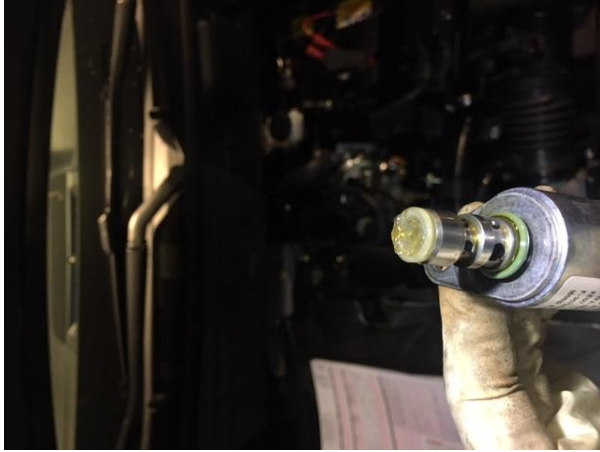
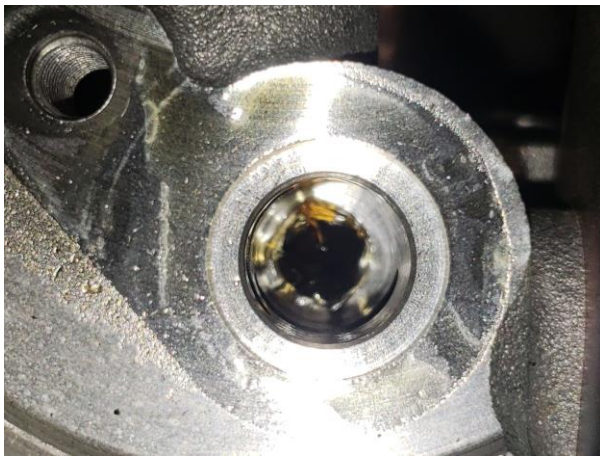
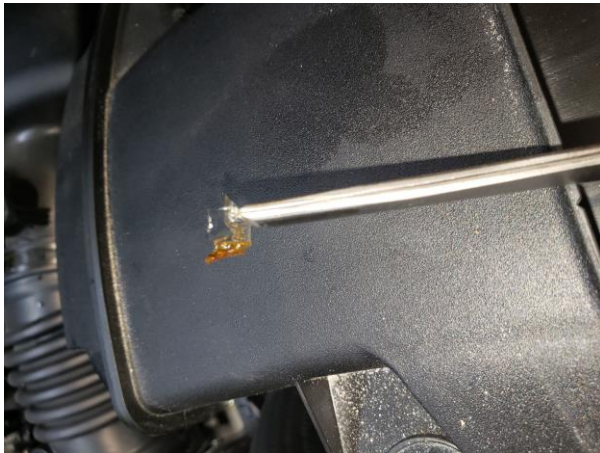
2. Remove the front and rear oil control valves for cylinder deactivation and inspect the oil control valves and cylinder head port for contamination or debris (see photo).

- If contamination or debris is found, photograph your findings and place the solenoid and debris in separate plastic bags for collection. Mark on each bag the location where contamination was found, then contact Hotline for instructions on creating a case where you can attach the photos.
- If there is no sign of contamination or debris, proceed with normal diagnosis for DTC P3400 according to the instructions on MGSS.
