# Preliminary Information

## PIC6306A Service Engine Soon Light with P0446

| Brand: | Model: | Model Years: | VIN: | | Engine: | Transmissions: |
|---|---|---|---|---|---|---|
| Buick | LaCrosse | 2017 - 2018 | All | All | All | All |

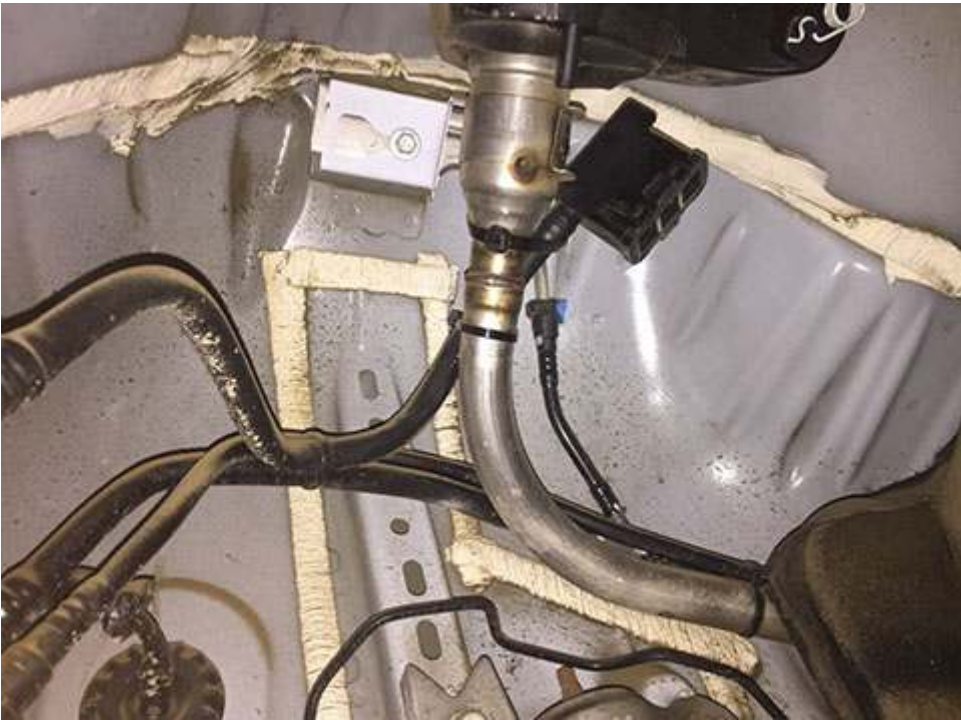
Clean filters in air inlet to EVAP canister, clean line and replace canister.  
Inlet pipe with filter housing is attached to fuel inlet pipe with zip ties.

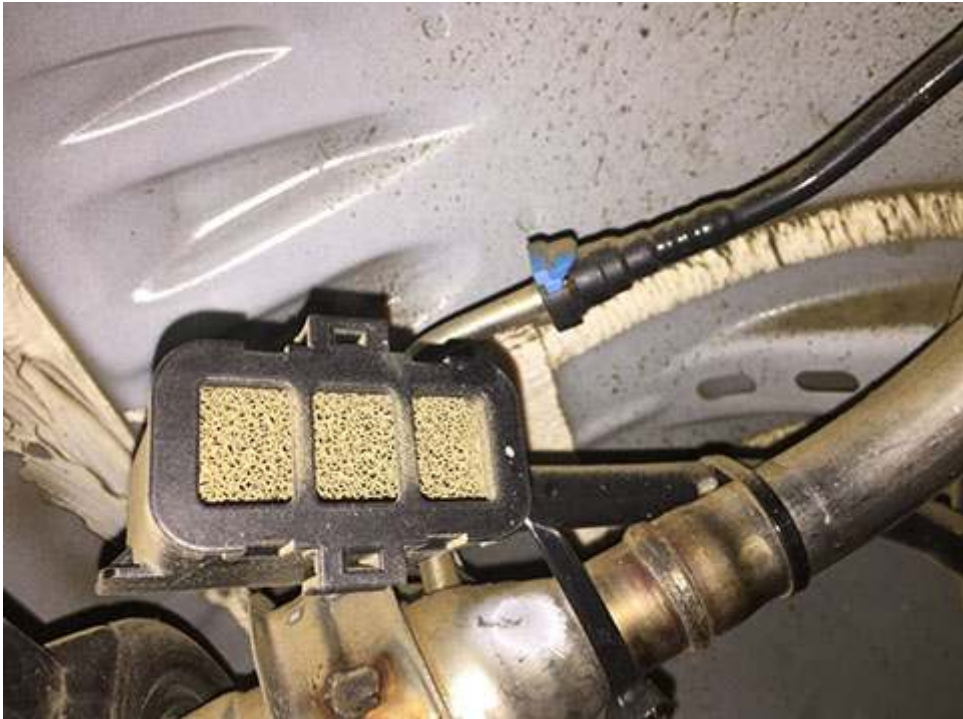
Disconnect air inlet pipe from EVAP canister. Remove the cover from the air inlet housing.

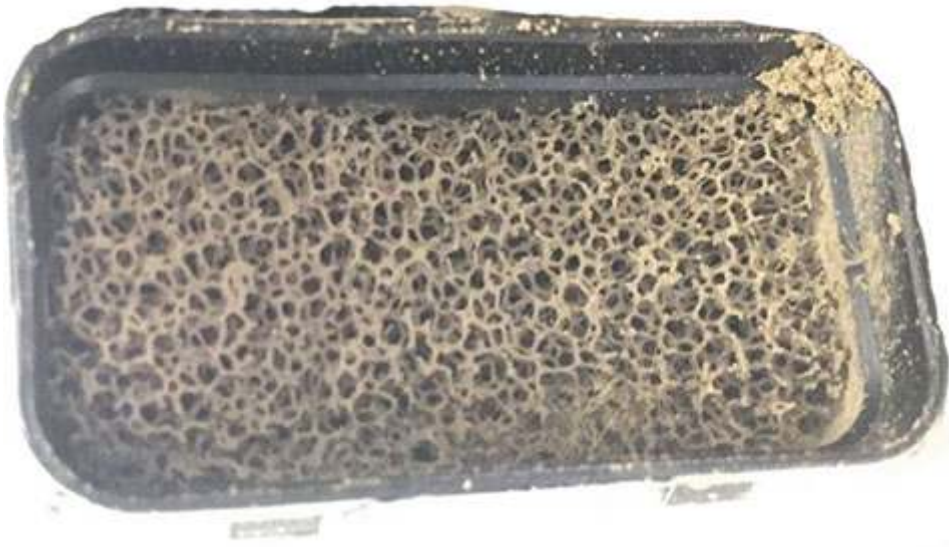
Remove both filters from air inlet and blow dust out of filters with compressed air from shop air supply.
