# Service Alert

**CHECK ENGINE LIGHT ON WITH DTC P061B, SURGING ON  
ACCELERATION, TRANSMISSION WON'T SHIFT PAST 4TH GEAR,  
VARIOUS U CODES SET**

**Service Alert No.:** SA-011/19

2018-2019 CX-5

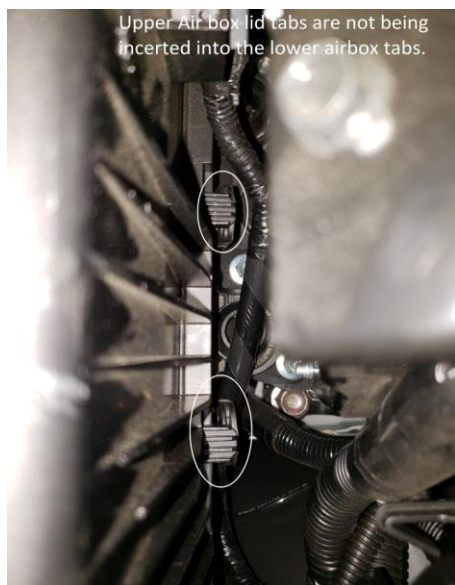
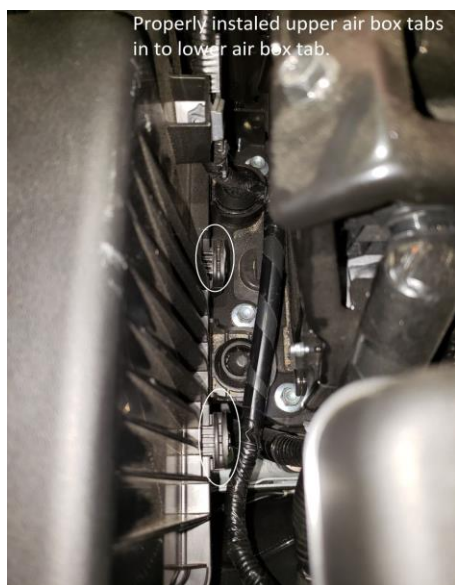
1. Verify the customer concern.
2. Before beginning normal diagnosis, inspect the air cleaner assembly. The three (3) attaching tabs at the lower rear area of the air cleaner assembly may not be properly attached. This could accidentally occur during an air filter inspection or replacement.

1. Open the hood.
2. Grasp the air cleaner assembly by hand and gently pull it toward the front of the vehicle.
  - If the air cleaner assembly moves, inspect the three (3) tabs at the lower rear area of the air cleaner assembly. Ensure that all three (3) tabs are properly attached to the lower air cleaner assembly.

- If the air cleaner assembly is properly attached, perform normal diagnosis according to the instructions on MGSS online.

3. Verify the repair.
