# Service Alert

**CHECK ENGINE LIGHT COMES ON WHEN DRIVING WITH P3400  
STORED IN PCM**

**Service Alert No.:** SA-015/19

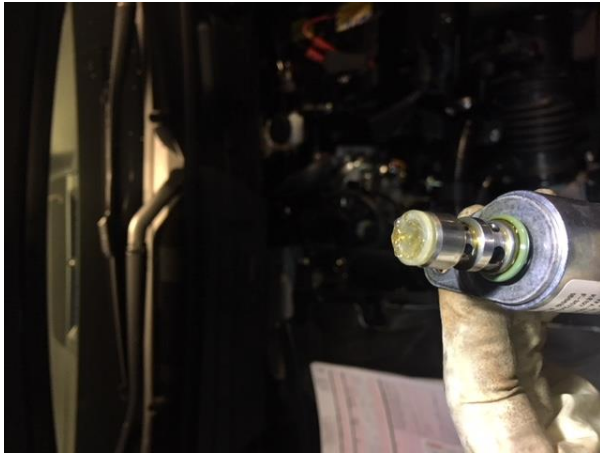
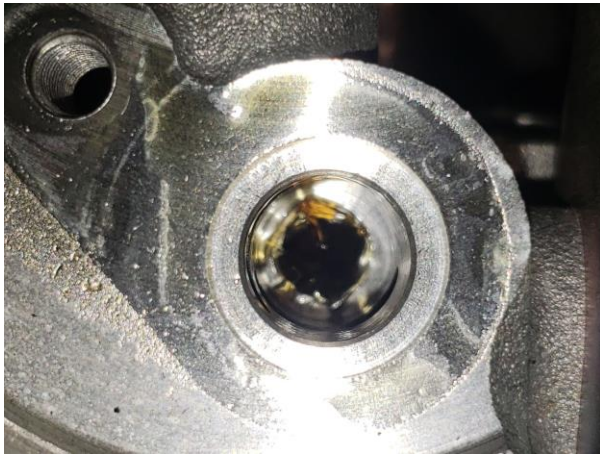
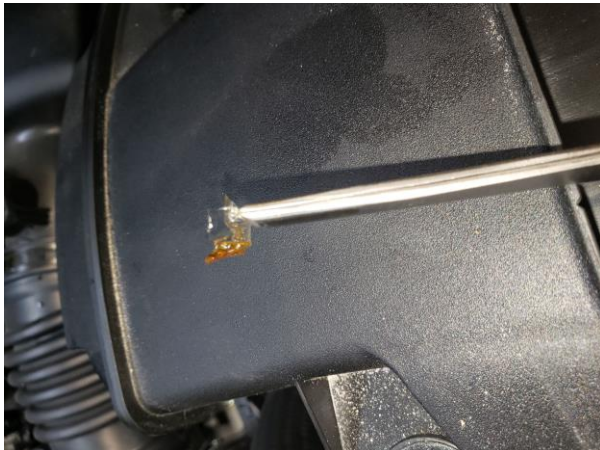
1. Remove the valve cover and inspect for any rocker arms that are broken or have fallen off, especially in the cylinder deactivation area (cylinders 1 and 4). Refer to SA-041/18 if found.
2. Remove the front and rear oil control valves for cylinder deactivation and inspect the oil control valves and cylinder head port for contamination or debris (see photo).
  - If contamination or debris is found:
    - Photograph your findings and place the solenoid and debris in separate plastic bags for collection. Mark on each bag the location where contamination was found.
    - Remove oil filter and drain the oil from it. Place the oil filter in a separate bag for collection.
    - Contact Hotline for instructions on creating a case where you can attach the photos. All of the parts will be collected.
  - Collect service history.

- If there is no sign of contamination or debris, proceed with normal diagnosis for DTC P3400 according to the instructions on MGSS.
