# Preliminary Information

## PIP5634 Malfunction Indicator Lamp (MIL) Illuminated - DTC P0496 Set

| Brand: | Model: | Model Years: | VIN: | | Engine: | Transmissions: |
|---|---|---|---|---|---|---|
| Cadillac | XT4 | 2019 | All | All | 2.0L (LSY) | All |

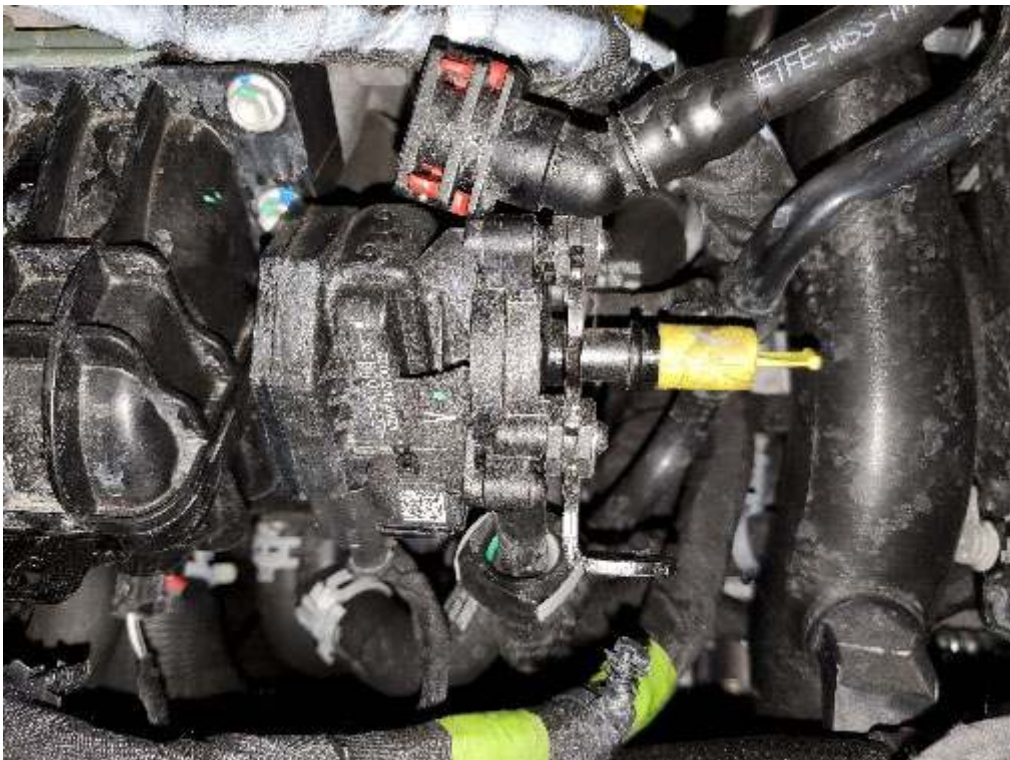
- 7. Separate the Evaporative Emission Front Pipe from the pump.
- 8. Install a plug onto the pump.
- 9. Turn the smoke machine On.
- 10. Look for a leak in the purge pump body (internal o-ring):

- Yes-Replace pump if leak is observed at the pump. Refer to Evaporative Emission Canister Purge Pump Replacement in SI.
- No-Go on to next step.

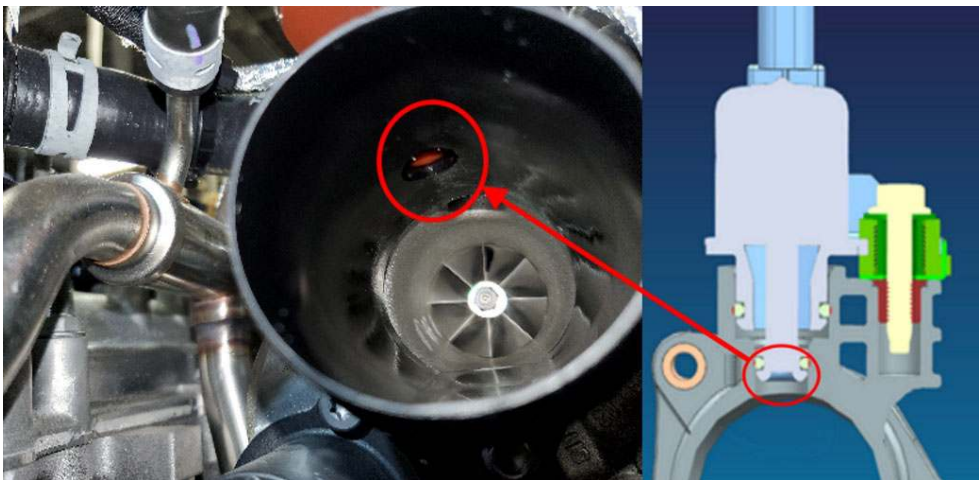
14. Look for an internal valve leak past the valve O-ring into the adaptor, DO NOT REMOVE valve from adaptor:

Important: If a leak is coming from the valve into the adaptor. Do Not separate.

- Yes-Remove/Replace valve and adaptor assembly.>
- If no electrical or air leak was found clear codes and return the vehicle to the customer.
