# Technical Service Bulletin

## 20 MIL on, DTC P045600 stored in the ECM

20 19 16 2035073/14 May 24, 2019. Supersedes Technical Service Bulletin Group 20 number 19-13 dated April 11, 2019 for reasons listed below.

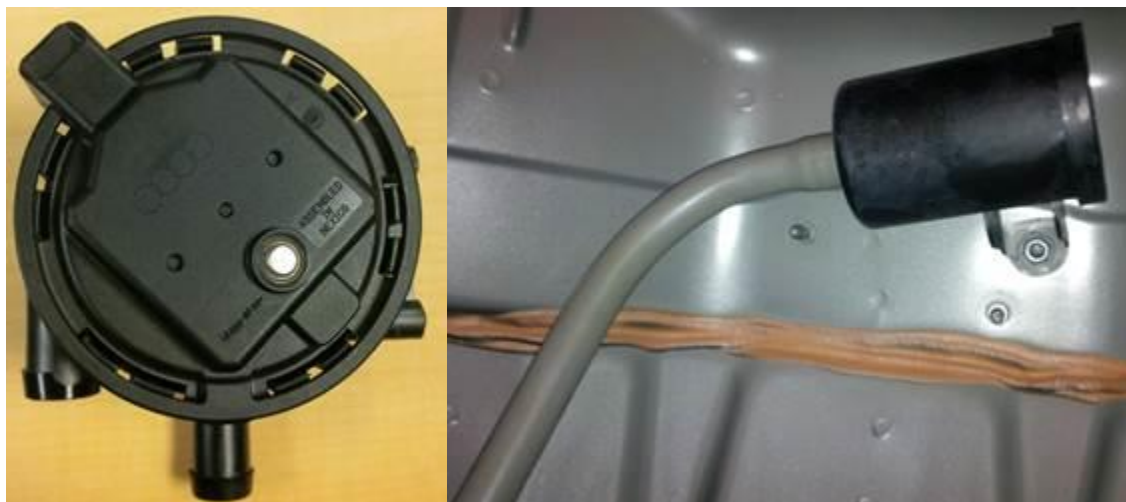
**Figure 1.** NVLD pressure sensor (left) and NVLD filter (right).

1. Ensure that **DTC P045600** (EVAP System Leak Detected NVLD (very small leak)) is stored in the engine control module (ECM), J623 (address word 0001). If **DTC P045600** is not present, this bulletin does not apply.
2. Replace the NVLD pressure sensor G400 and the NVLD filter with the latest part number available (Figure 1).

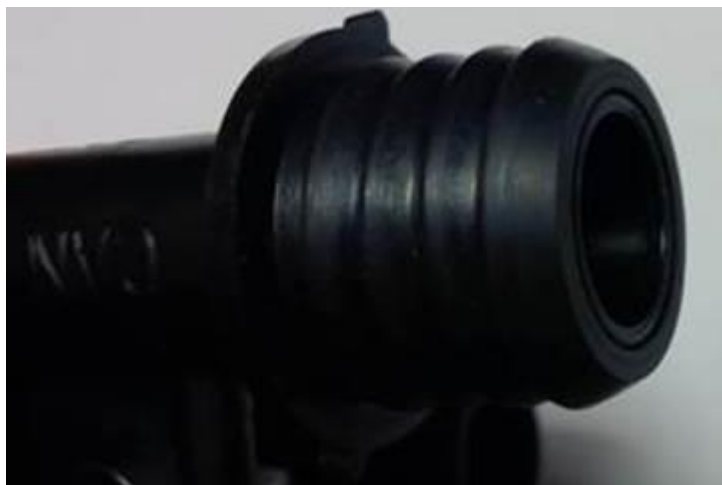
**Figure 2.** Align the grommet and sensor outer edges.

3. Align the grommet and sensor outer edges (Figure 2).

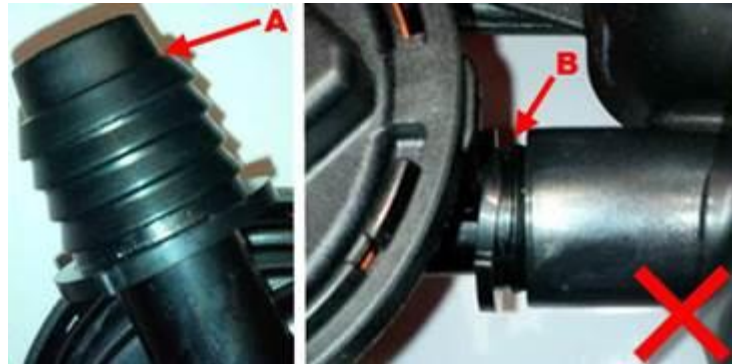
7. An incorrectly-installed sensor and grommet (Figure 7) can cause an EVAP leak and repeat failures. Issues can occur when the NVLD switch is pressed too far into the canister, then pulled back out in an attempt to align the NVLD switch with the mounting holes.

**Figure 7.** Plastic port extending past the grommet (A) causing installation issues (B).

Do not apply any lubricant between the sensor and the grommet.
