| | GROUP<br><b>FUE</b> | MODEL<br><b>2017-2019MY<br/>Niro (DE HEV)</b> |
| | NUMBER<br><b>041</b> | DATE<br><b>August 2019</b> |
| <b>TECHNICAL SERVICE BULLETIN</b> | | |
| <b>SUBJECT:</b> COMBINATION TSB / SERVICE ACTION: AIR<br>FILTER KIT & NVLD REPLACEMENT (SA395) | | |

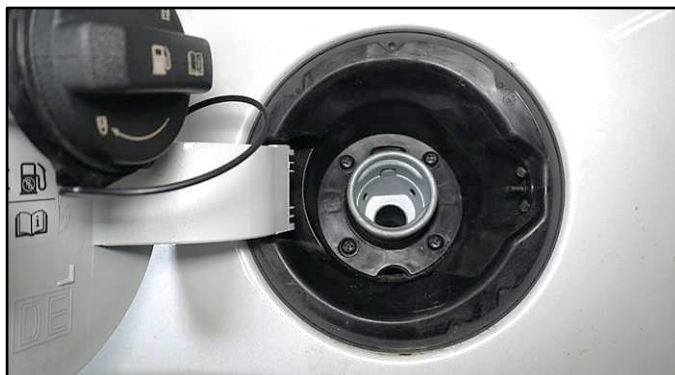
#### **DTC P0456: Evaporative Emission System-Leak Detected (Very Small Leak)**

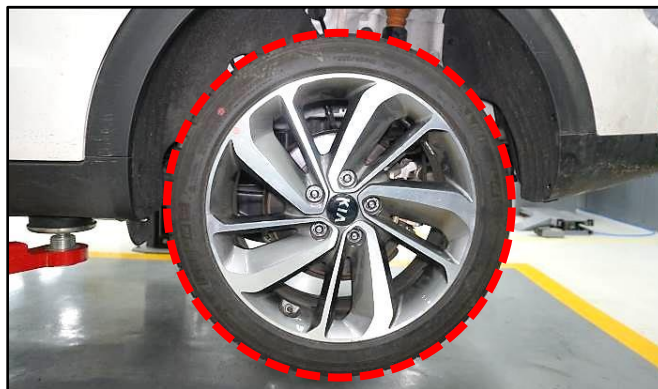
1. Raise the vehicle on a lift and remove the left rear wheel.

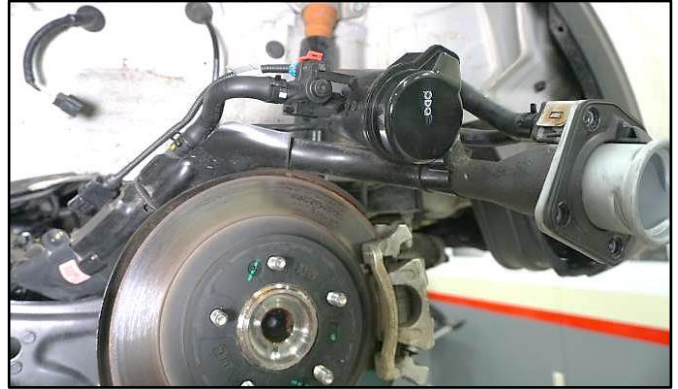
9. Lower the fuel filler neck assembly.
