Preliminary Information

PIT5677A SES MIL / No Start / No Crank / Runs Rough / Reduced Engine Power / VSS / DTC's (Inspect Engine Harness)

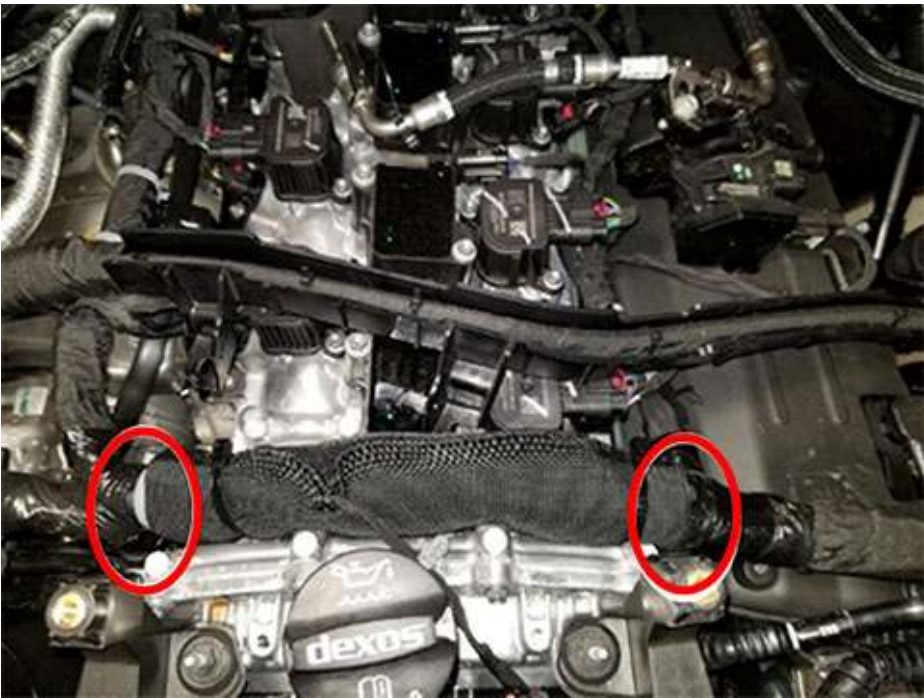
Inspect the engine harness as it crosses over top of the Camshaft Carrier Cover.

Harness damage can occur at any point across the Camshaft Carrier Cover.  
Typical inspection locations shown below.

If engine wiring harness contact is isolated during inspection, use a seam ripper type tool to carefully inspect for internal wiring damage.

If found, repair the damaged wiring following the SI wire to wire repair procedures.

Once repaired, protect the engine wiring harness at all points listed in this PI using Woven Polyester (PET) Electrical/Anti-Abrasive Tape.

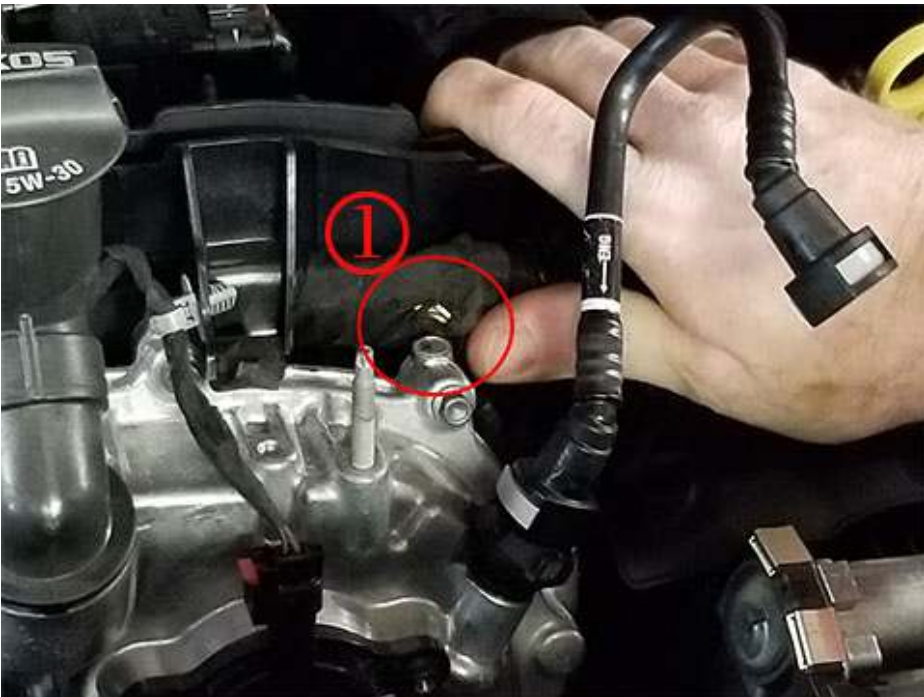
Example of engine wiring harness damage at Camshaft Carrier Cover shown below.

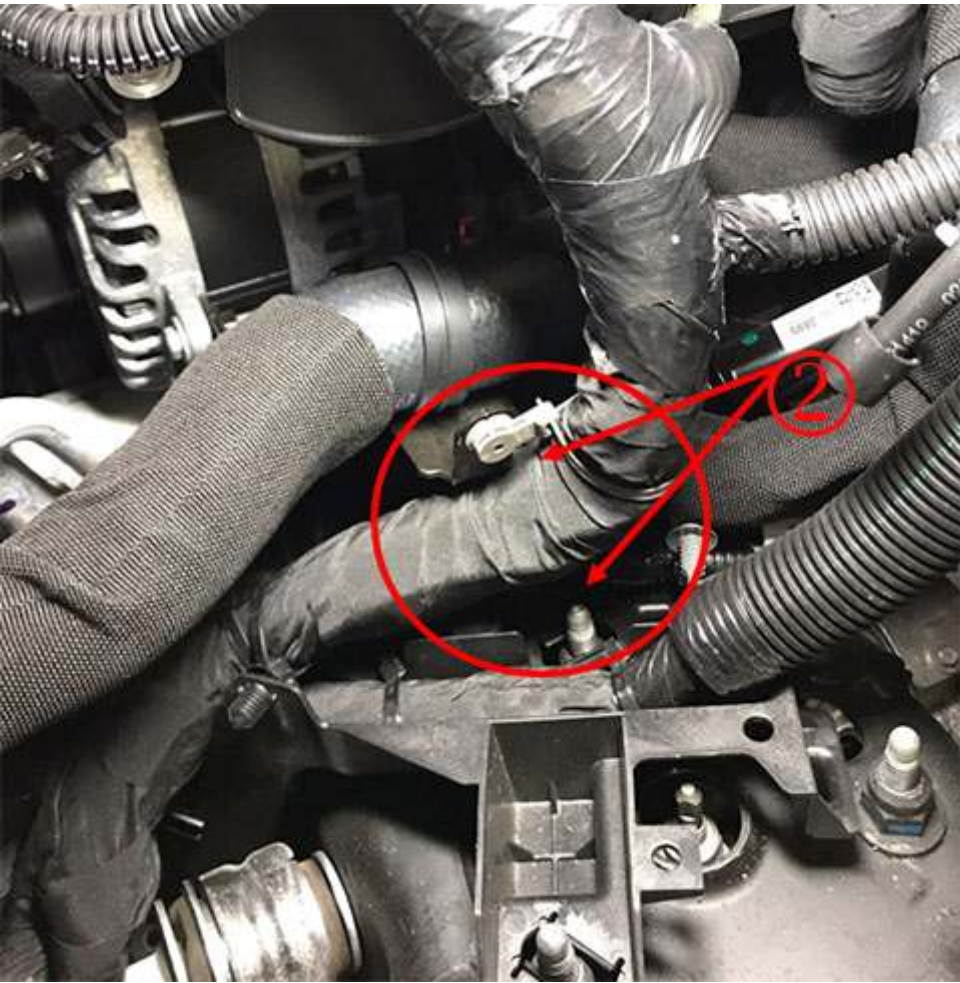
Inspect the engine harness at the Inlet Radiator Hose Bracket and Left Front Coil Spring stud as shown below.

**Note:** Under normal driving conditions, the engine will rock back and forth in its mounts.

This may result in harness contact with this bracket that may not be present during engine off inspections.

Careful visual inspections are necessary to isolate areas of contact.

It may be necessary to disconnect several engine harness connections to reposition the harness for inspections.

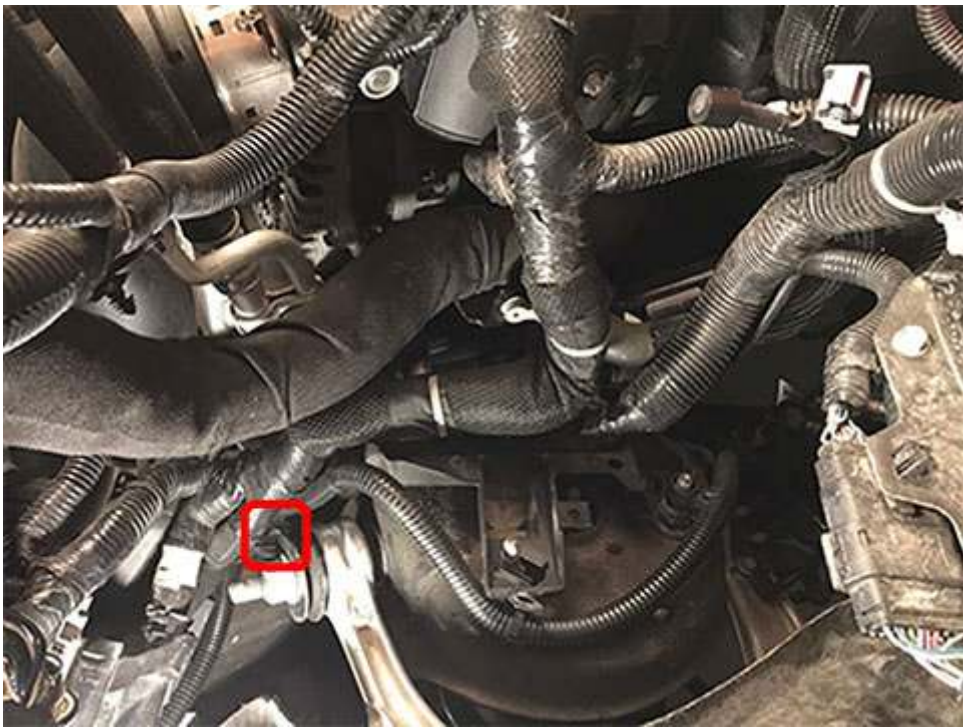
Inspect the engine harness at the Left Front Upper Control Arm Bushing as shown below.
