# Check Air Suspension Message Displayed With C1752 - Replace the Compressor/Motor Assembly

**Market** USA

| YEAR(S) | MODEL(S) | ADDITIONAL INFORMATION |
|---|---|---|
| 2013 - 2017 | LS460 | |

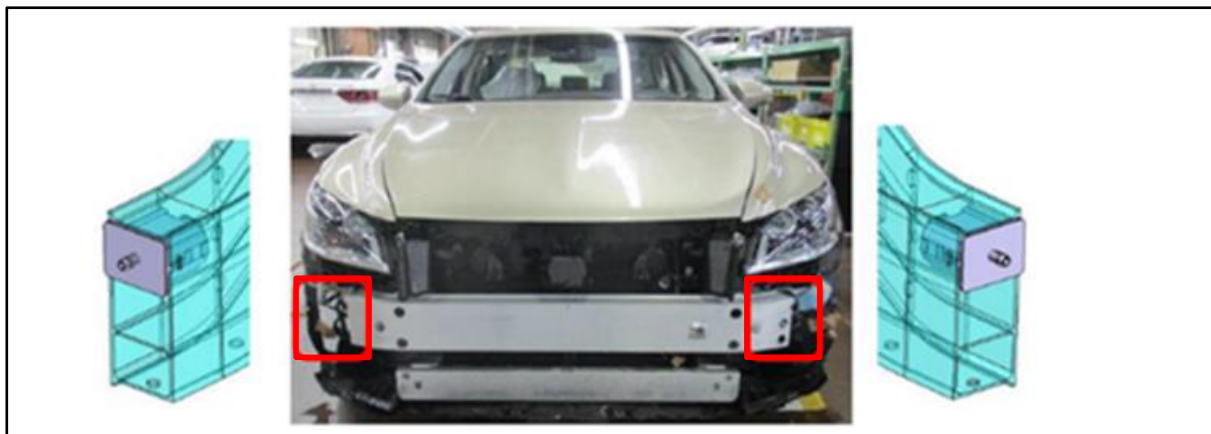
**Figure 3.**

4. Install both filters to each side of the reinforcement.
