Preliminary Information

PIP5407B Code P06DD No Or Low Oil Pressure

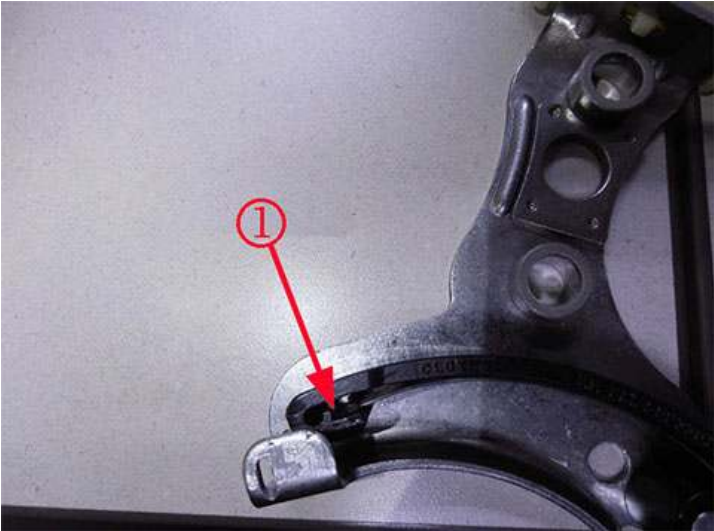
Tensioner spring in timing chain guide may be “short” not fully seating into guide pivot end.

1) Short spring not reaching the pivot

Replace timing chain tensioner guide.

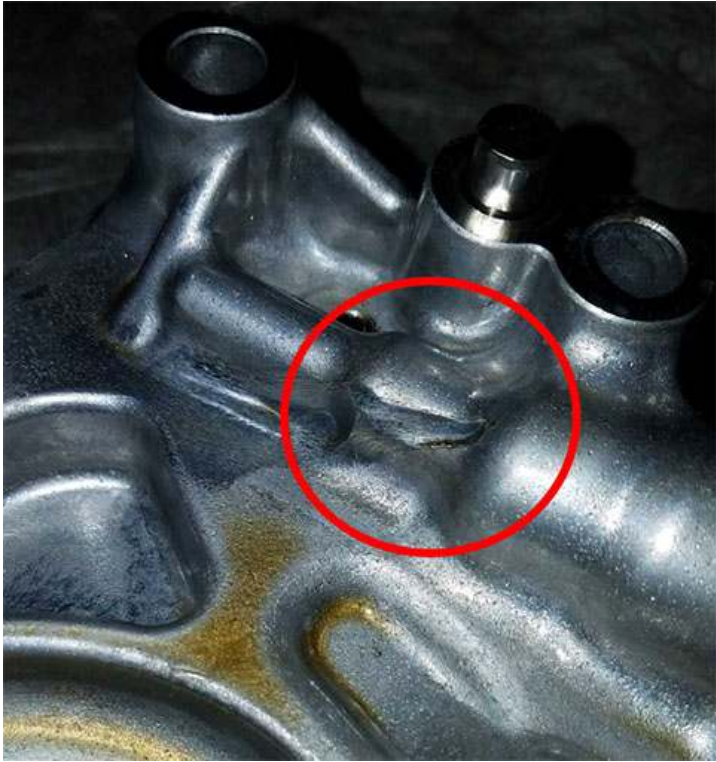
Also a broken tensioner shoe may allow the spring to rub a hole in the oil pump.

The hole in the oil pump

If oil pump face is damaged and or worn thru replace oil pump.

Inspect bearings for damage wear due to debris from oil pump.
