# Technical Journal

**Fresh air hose loose from air filter housing**

REF NO:  
**TJ 31319.3.0**

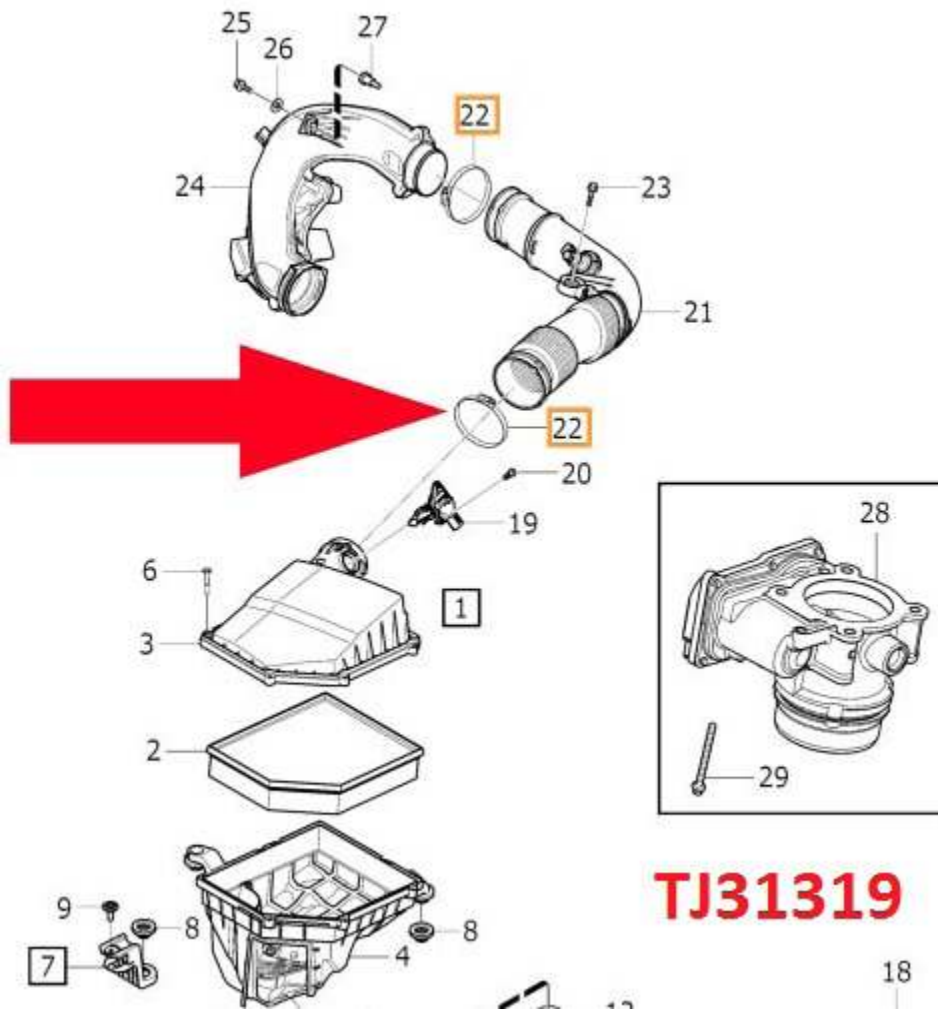
| File Name | File Size |
|---|---|
| TJ31319.jpg | 0.0582 MB |

If the “check engine” indicator is lit and DTC P226200 and/or P02CD00 is posted, this can be caused by loose fresh air hose at MAF sensor.

DTC P200200 may be posted as a consequential failure.

If fresh air hose is loose from air filter housing, install spring clamp P/N 988016 to prevent repeat repair.  
Tightening torque 4Nm.  
See attachment.
