## SERVICE BULLETIN

**APPLICABILITY:** 2017-18MY Impreza  
2018MY Crosstrek

**NUMBER:** 07-123-17

**SUBJECT:** DTC B1661 / B1502, Change to Warning  
Box Assembly

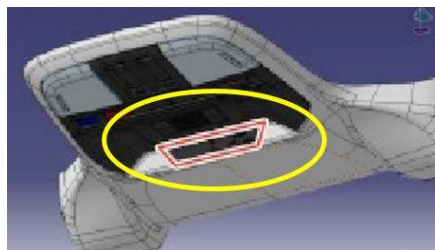
w/ EyeSight

A design improvement has been made to the warning box assembly for improved responsiveness. The warning box is located inside the overhead map light assembly as shown in the illustrations below. The warning box part number has also been changed.

The part number for the new warning box assembly is **85271FL00B**.

When replacing the warning box, follow the current procedure in the applicable Service Manual.

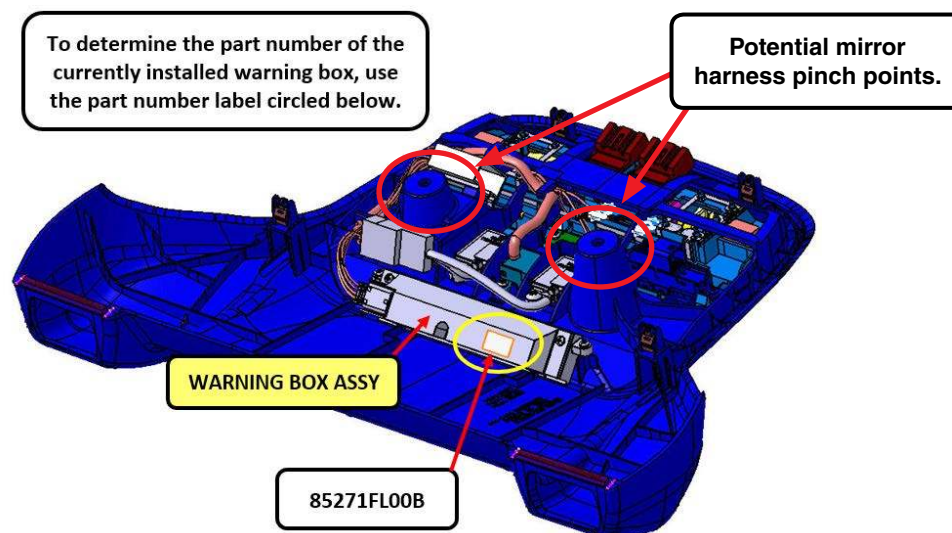
- The replacement part used for this repair should be the warning box component only (part number supplied above), **not** the Map Lamp Assembly or EyeSight Camera Cover assembly.
- When repairing models equipped with EyeSight, it is **NOT** necessary to remove the EyeSight stereo camera to access the warning box, only the cover.
- EyeSight calibration is **NOT** required as part of this repair.
- On models equipped with the accessory auto-dimming mirror / compass / Homelink, use care to avoid pinching the mirror wiring harness during overhead console installation.
- Always confirm all mirror functions prior to vehicle release.
