# How to Identify Modified HV Batteries

All HV Vehicles

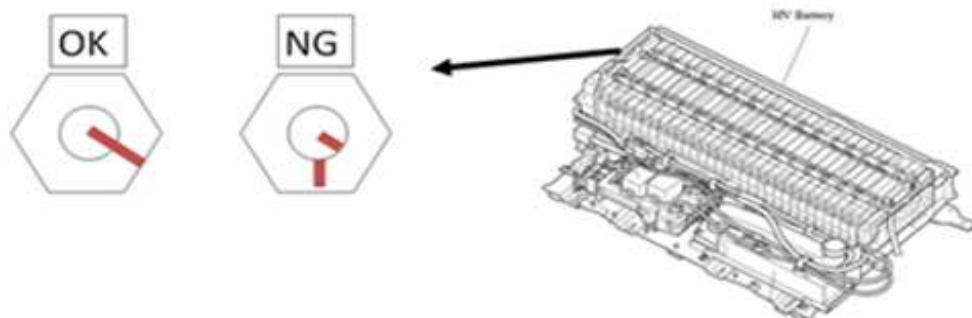
- Remove HV Battery cover and check for offset mar on the bus bar nut and bolt

A vehicle may arrive to the dealer with a MIL "ON" condition and P0A80 or P1AC000 stored in the memory. Some cases have been identified with internal modification done to the HV Battery. Modified or altered parts are not covered under warranty.

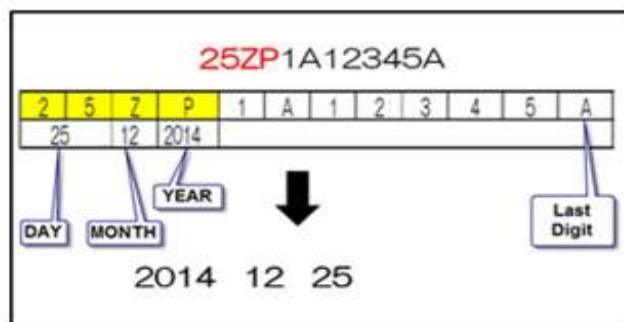
### CELL SERIAL# EXAMPLE

- Remove HV Battery Cover and inspect cells for physical signs of modifications
  - Signs of previous removal of cover and or bus bar
  - Check that the last digit of the serial #s of all cells are the same letter
  - Check all cell serial #s and make sure they are all within 3 months of production date from each other
